AERONAUTICAL RESEARCH COUNCIL

Civil Aircraft Airworthiness Data  
Recording Programme. Special  
events relating to airspeed  
control and handling (February  
1966 to December 1967)

SPECIAL EVENTS RELATING TO AIRSPEED CONTROL AND HANDLING  
(FEBRUARY 1966 TO DECEMBER 1967)

The CAADRP Special Events Working Party  
(Co-ordinated by G. E. King, R.A.E.)

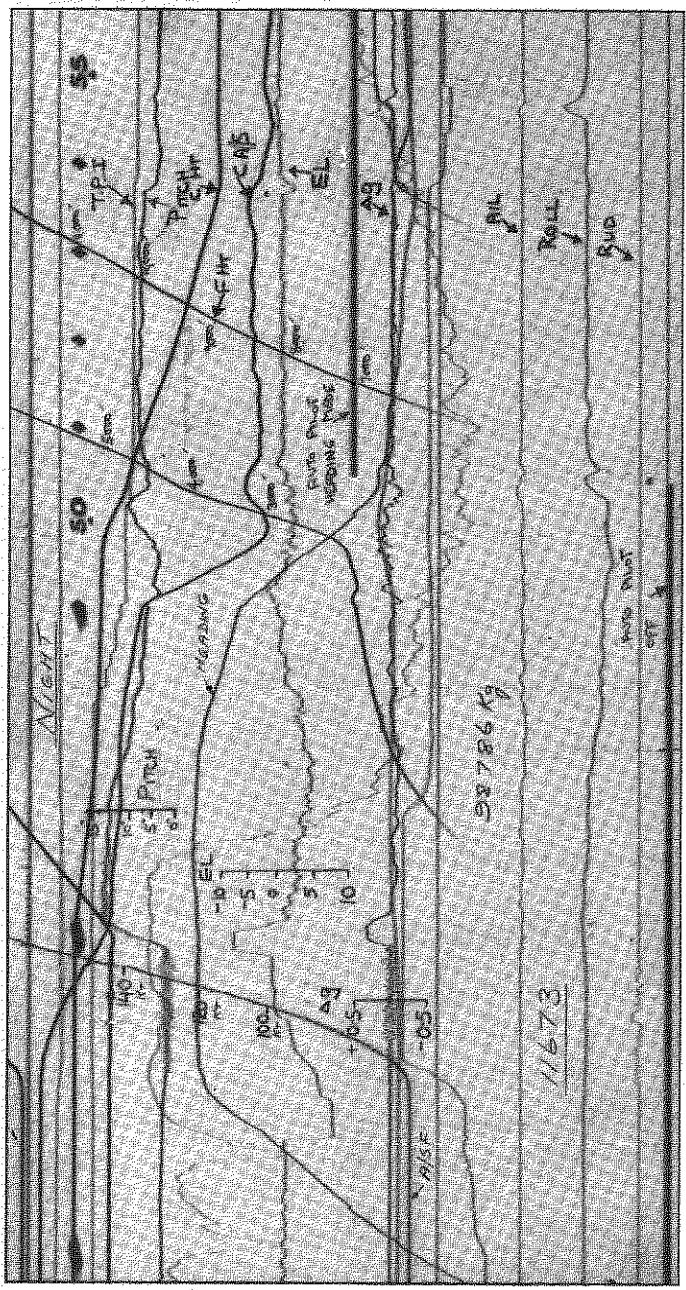
Fig.2. Event in flight 11673

The take-off from Antigua was achieved by a rotation at high speed and immediate unstick. Rotation should have been initiated at 126 kt for this weight but was delayed for 4 seconds (152 kt). (See Fig.2.)

It is not known why the aircraft did not rotate at  $V_R$ . However the initial climb out is carried out with careful regard to pitch attitude, which results in good airspeed control. This demonstrates that an accurate climb out can be achieved even after a late rotation by strict adherence to the correct operating technique.

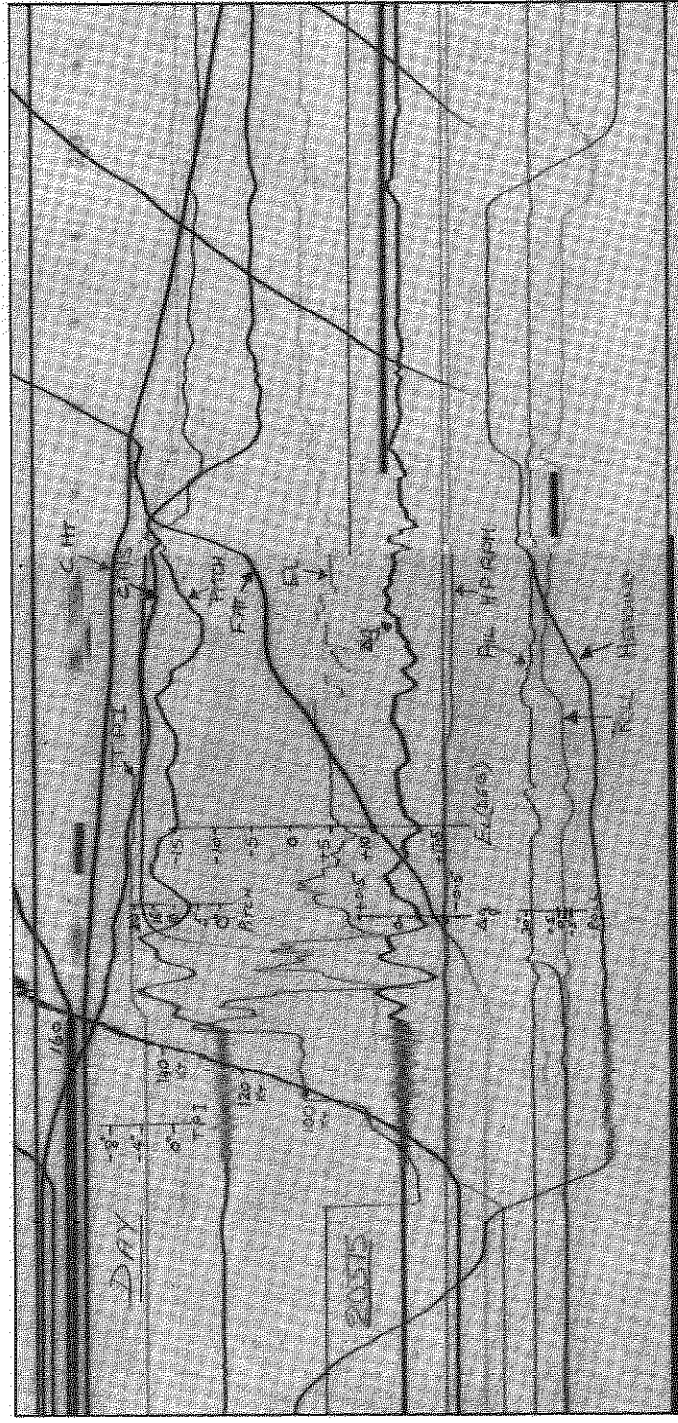
Fig.3. Event in flight 20375

(ii) Pitch oscillations of the order of  $\pm 5^{\circ}$  can occur, as shown in Figs.3, 7 and 12. In these cases it is difficult to believe that the aircraft is being flown by reference to pitch attitude.

During the initial climb out from Lima in calm weather, the pitch attitude varied between  $6^{\circ}$  and  $18^{\circ}$  at 10 seconds period; this necessarily produced changes in normal acceleration and rate of climb (See Fig.3).

Integration of the acceleration trace shows that the aircraft was always climbing but the rate of climb varied between 580 and 2200 ft/min. The oscillation may have been initiated by the operation of trim (tailplane incidence) at unstick, but an accurate climb out can be achieved on this aircraft type even with gross mis-trim by strict attention to pitch attitude after unstick (see paragraph 3.2.1).

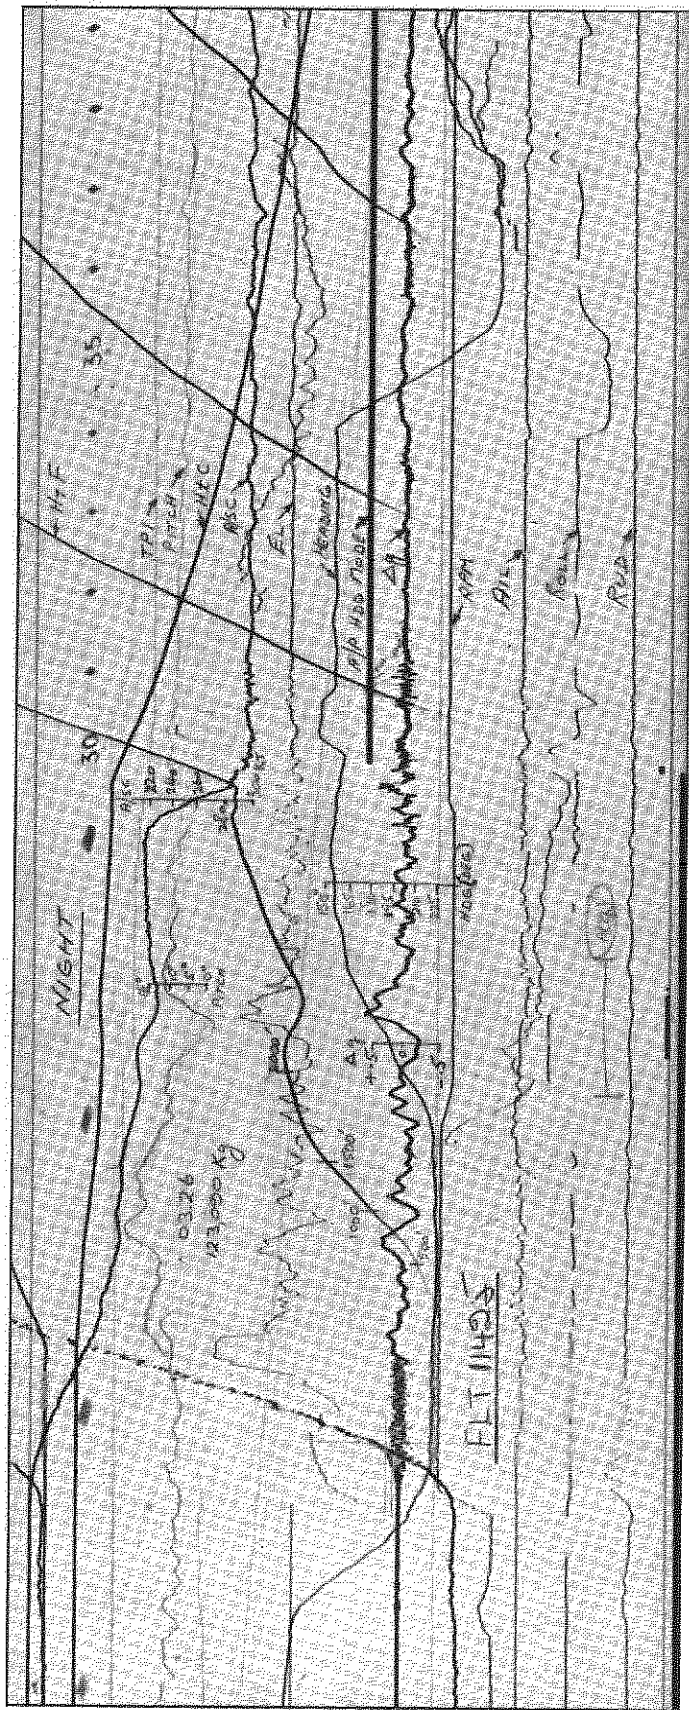
Fig.4. Event in flight 11425

As power was reduced for noise abatement during the climb, the aircraft entered a 120°/min turn and continued to climb at a reduced rate. The airspeed then started to fall and the aircraft was pitched down progressively to 3° nose down. The airspeed then started to build rapidly and +0.65 g increment was pulled to prevent flap limiting speed (229 kt) being exceeded. (See Fig.4.)

A manoeuvre load of +0.65 g increment is an infrequent event, but this was produced in following a noise abatement/air traffic requirement in good weather at night. The event appears to be caused by excessive pilot work load i.e. turn, levelling off, noise abatement procedure and possibly radio calls simultaneously. This indicates the desirability of making departure procedures as simple as possible.

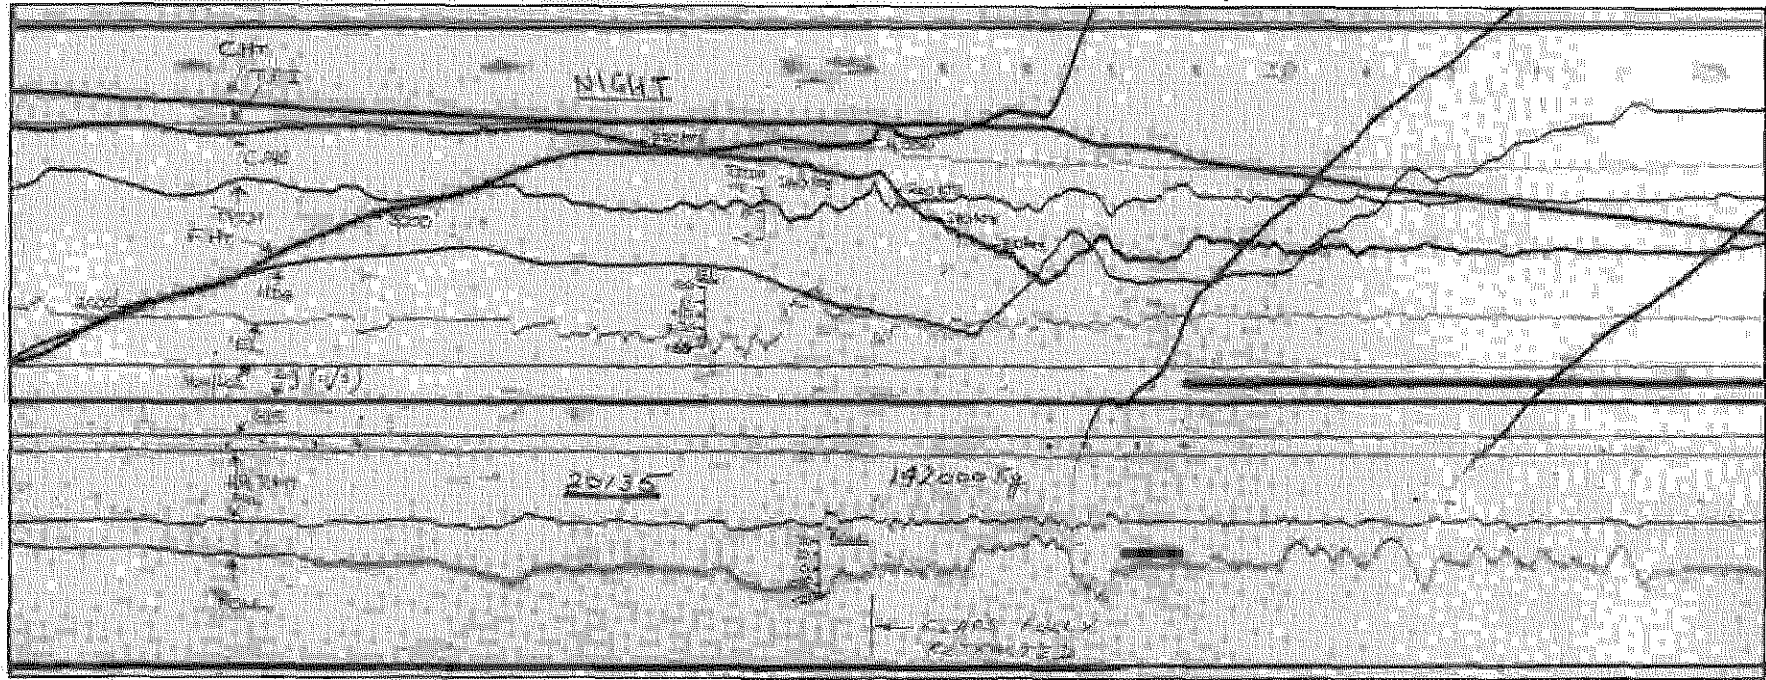
Fig.5. Event in flight 20135

(i) Fig.5 shows one of the largest exceedences of flap limiting speed so far recorded. Smaller exceedences occur not infrequently because the small margin between maximum flap speed and minimum clean aircraft speed presents the pilot with a difficult task at a busy period in the flight.

The flap limiting speed of 229 kt was exceeded by 23 kt with 6° flap at 4000 ft during climb out from New York. Note that the acceleration trace is unserviceable. (See Fig.5.)

The flap raising technique on this aircraft type is a difficult one at high weight due to the small difference between the maximum speed with flap and the minimum speed without flap. This event shows one of the largest speed exceedences so far recorded in similar circumstances.

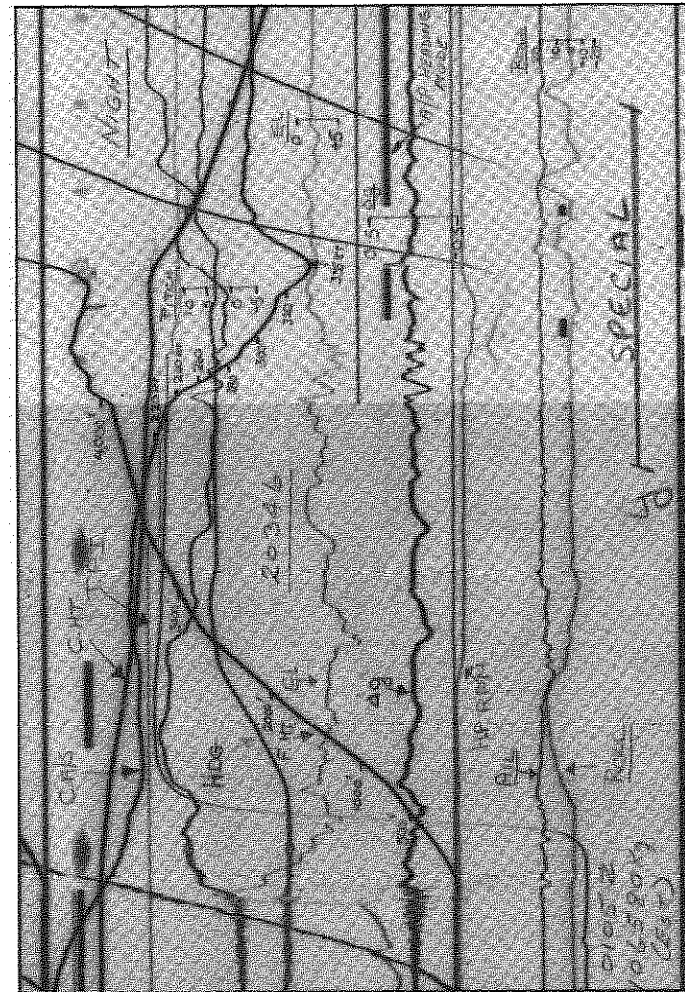
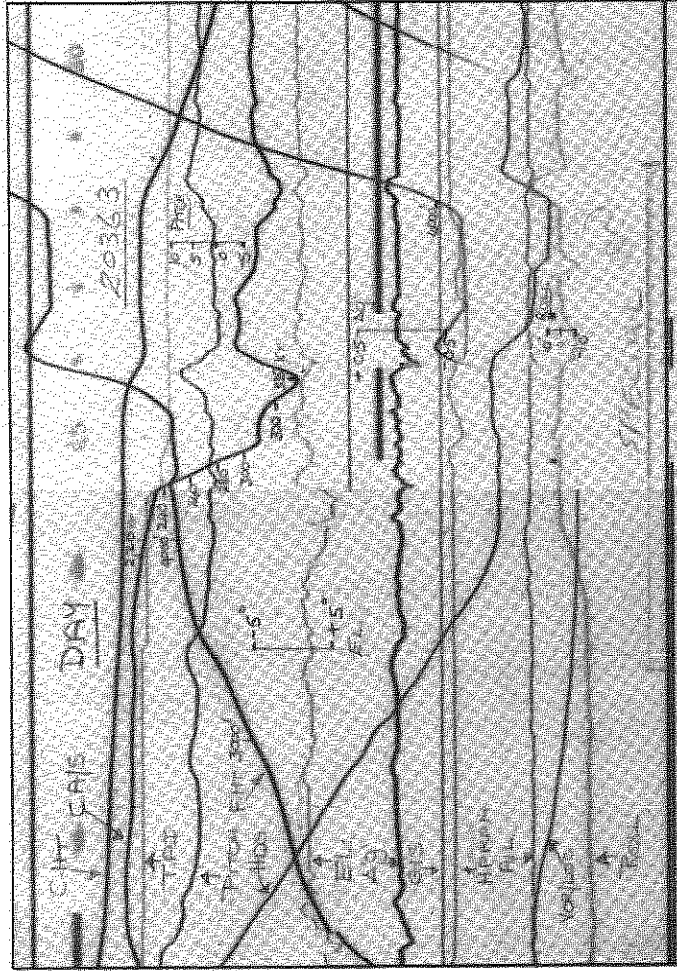
Figs.6a and 6b are examples of a speed exceedence during climb caused by engaging the autopilot before the correct pitch attitude was achieved.

Following flap retraction, the indicated airspeed was allowed to reach 335 kt.  
(See Figs.6a and 6b.)

Power was applied before the correct pitch attitude was achieved and with autopilot engaged the rate of pitch change available is limited. The normal climb out speed is 290 kt with  $V_{mo}$  at 333 kt.

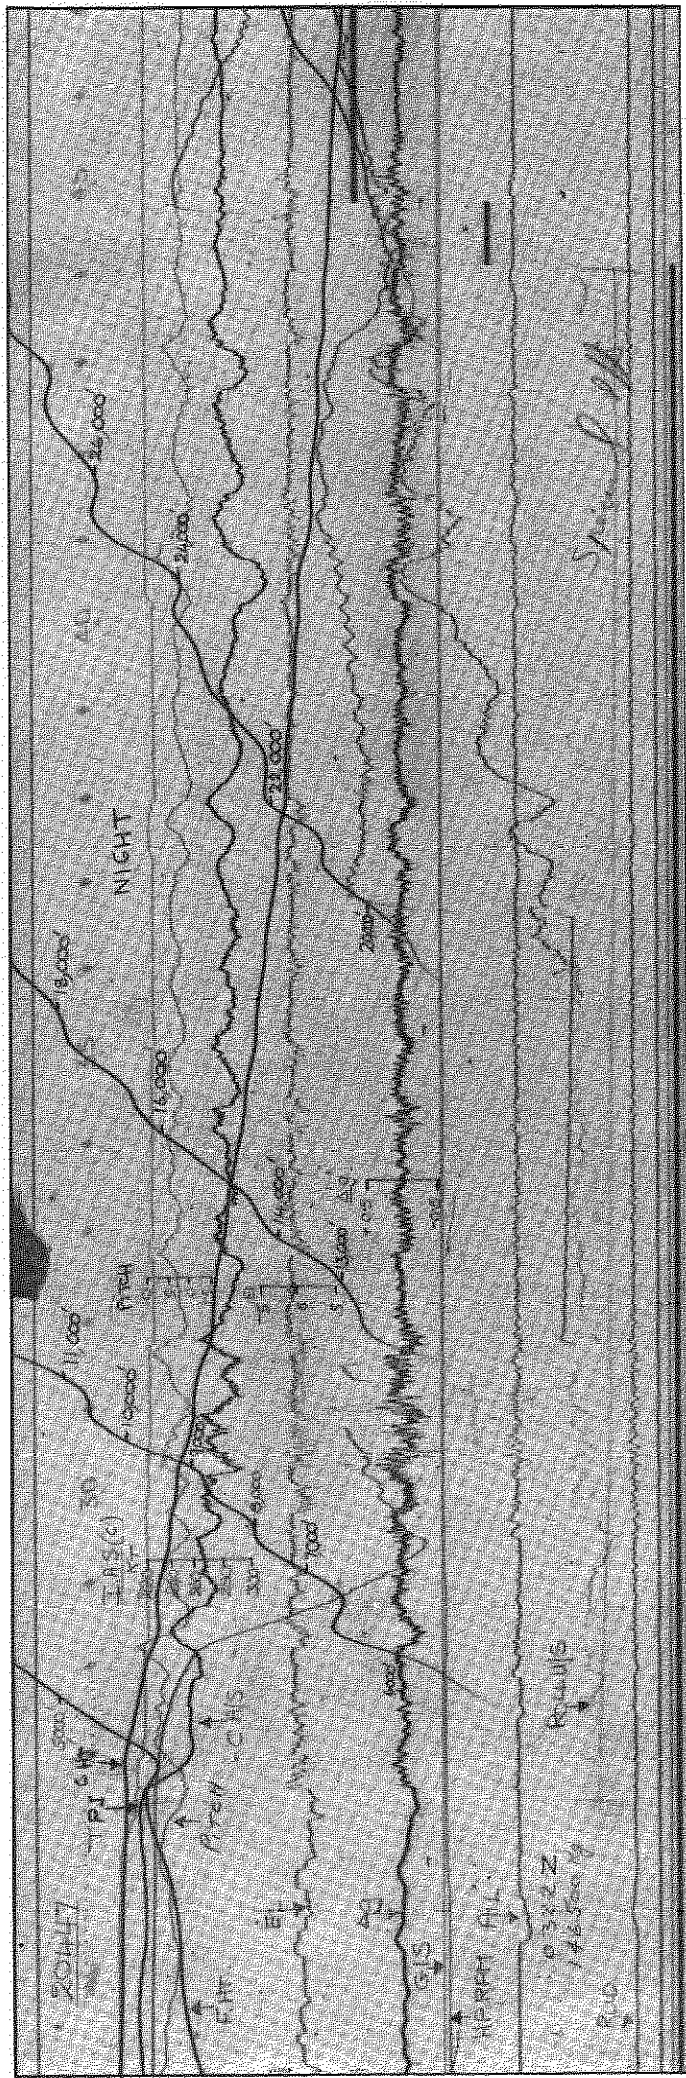
Fig.7. Event in flight 20447

The aircraft was flown with autopilot off during the climb and pitch changes of up to  $12^{\circ}$  occurred with the rate of climb varying between 3800 ft/min climb and 500 ft/min descent. There was light to moderate turbulence present. (See Fig.7.)

The precise flight path obtained during climb when using the autopilot (see Figs.3 and 4) is not possible with the autopilot off, but the deviations in this event appear to be excessive. They were caused by failure to maintain a constant pitch attitude.

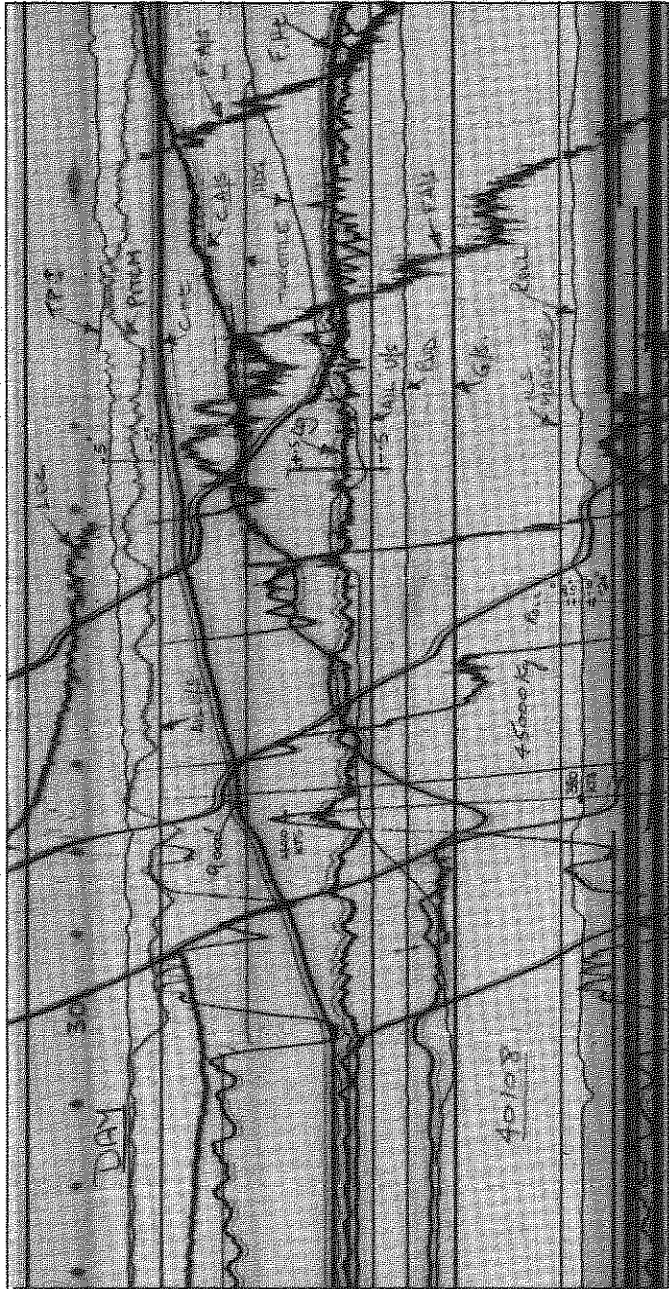
Fig. 8. Event in flight 40108

Figs.8, 9 and 10 are examples of a speed exceedence during descent whilst on autopilot. The use of the rate of descent lock to generate high rates of descent appears to be undesirable. The airspeed lock is much to be preferred.

During the descent, the indicated airspeed reached 401 kt with a rate of descent of 6400 ft/min after the autopilot had been disconnected at 390 kt.  $V_{mo}$  is 380 kt ias. (See Fig.8.)

"The initial descent was carried out using rate of descent lock to achieve a high rate of descent at 370 kt. A turn was initiated while still on rate of descent lock, which necessarily caused an increase in airspeed. After the autopilot had been disconnected a further increase in airspeed took place and this was caused by the correct decision to level the wings before easing out of the drive."

The descent procedure has now been changed and speed lock is used in descent.

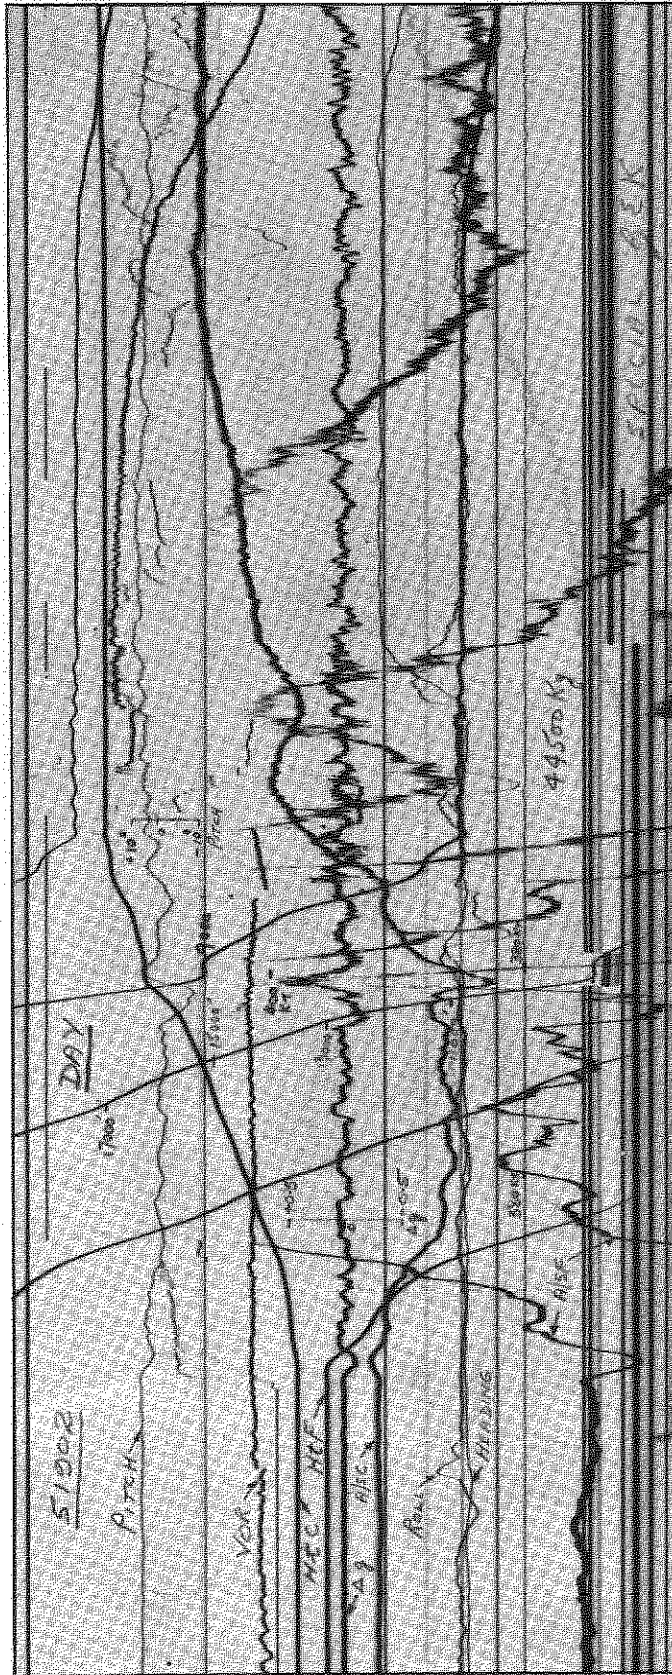
Fig.9. Event in flight 51902

During the descent, the indicated airspeed reached 400 kt with a rate of descent of 8000 ft/min after the autopilot had been disconnected at 390 kt.  $V_{mo}$  is 380 kt ias (see Fig.9).

This is a similar incident to 3.3.1.

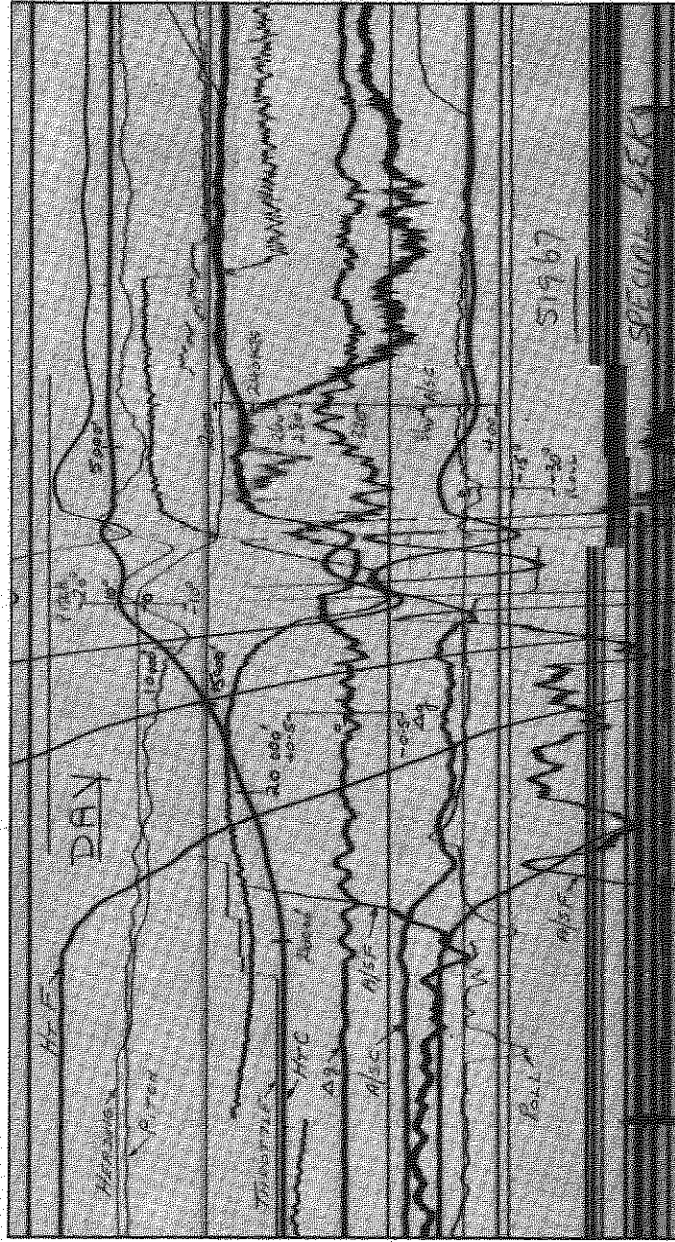
Fig.10. Event in flight 51967

During the descent the indicated airspeed reached 390 kt with a rate of descent of 8000 ft/min. This was terminated by a manoeuvre of +0.2 g increment at the end of which the aircraft entered a 25° bank turn. The rate of descent then increased again to 5200 ft/min at which point the autopilot was disconnected and the wings levelled before pulling a manoeuvre of +0.5 g increment. The extremes of pitch attitude reached were -12° and +14°. Throughout the period the airspeed was reducing to allow operation of droop/flap. (See Fig.10.)

The event was almost certainly caused by overcontrolling with the autopilot speed selection control whilst on speed lock.

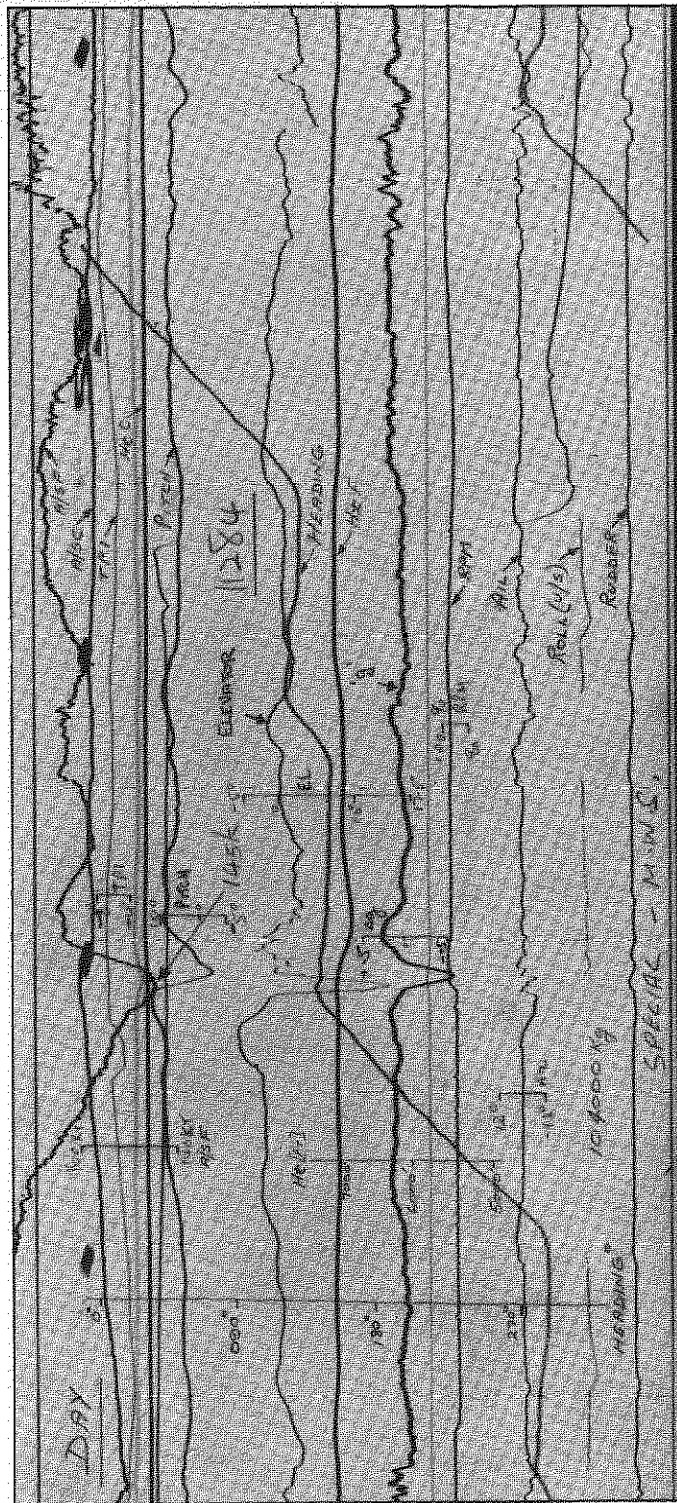
Fig.11. Event in flight 11284

(iii) Figs.11, 16 and 17 are examples of low airspeeds being reached under manual control. They occurred in high work load situations i.e. aircraft positioning during a hold; radar controlled approach in turbulence; keeping watch for aircraft known to be in the vicinity, but not in radio contact.

During a hold at 6300 ft, the aircraft was pitched down 14° to produce a rapid speed increase from the lowest value of 145 kt. (See Fig.11.)

It would appear that either the low airspeed was noticed only at the end of a procedure turn, or the undercarriage warning horn operated causing the pilot to take vigorous corrective action.

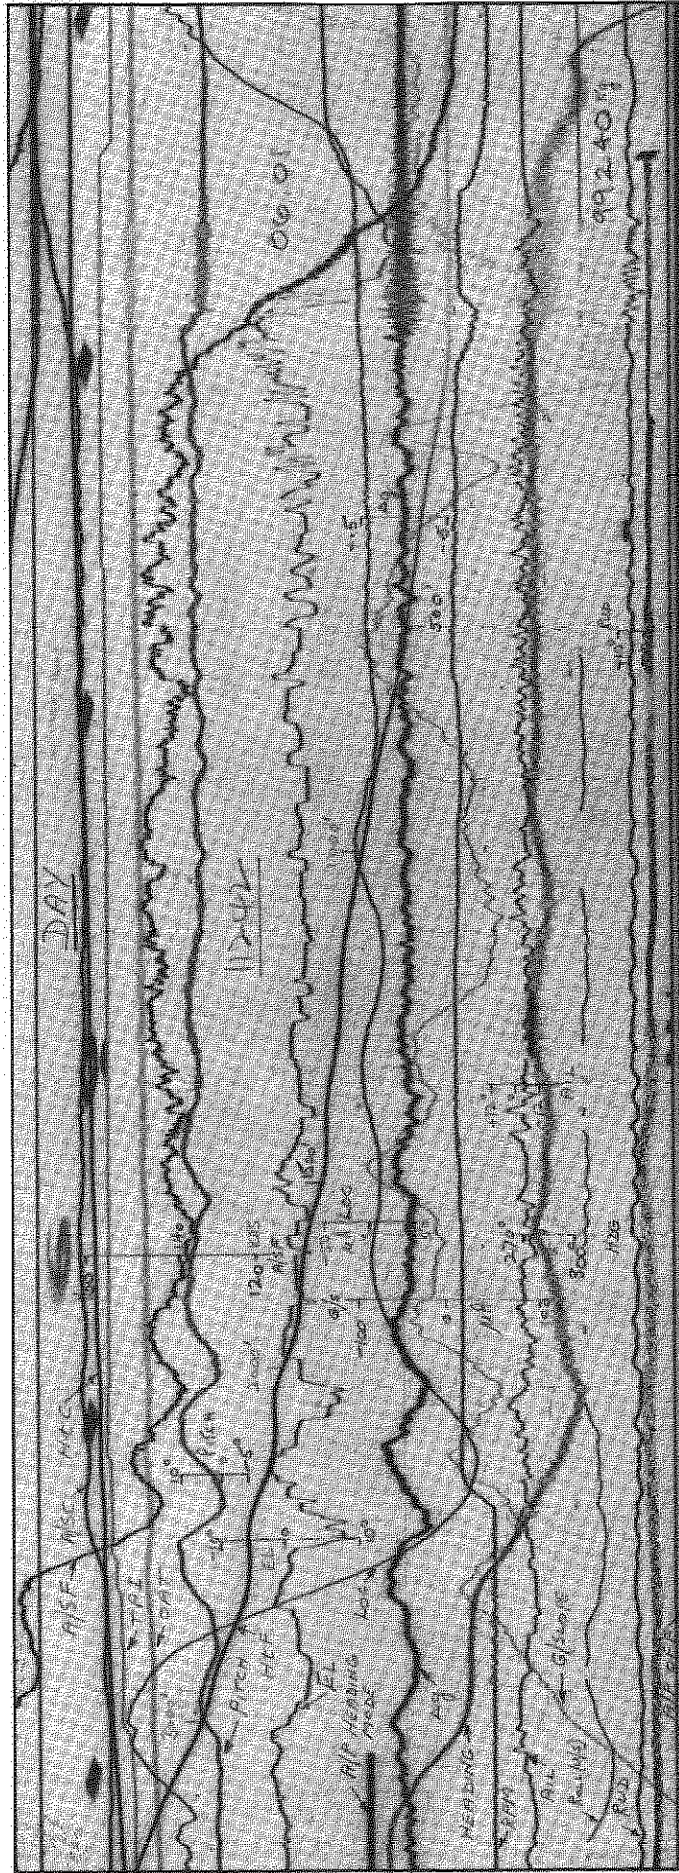
Fig.12. Event in flight 11242

A pitch oscillation of  $\pm 5^\circ$  amplitude developed at about 2000 ft altitude during a manual ILS approach (see Fig.12).

There was conflict between the elevator and trim during localiser capture and this may have produced the changes in pitch. The glide slope was joined from above which introduces further difficulties.

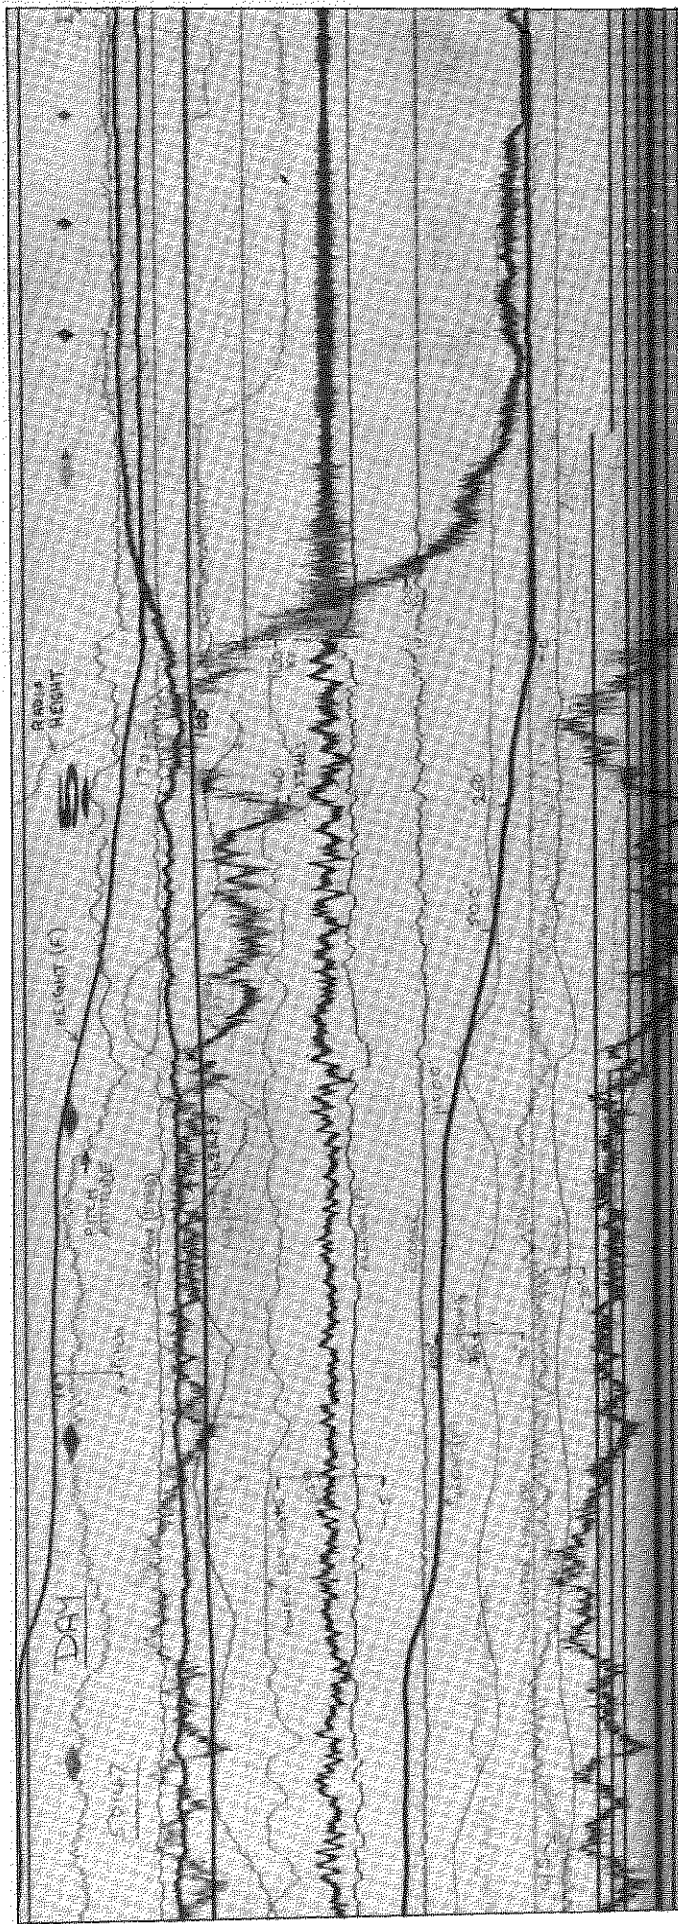
Fig.13. Event in flight 50147

In the first two instances the auto-throttle reached the limit of authority and was overridden by the pilot. However, the ability of the auto-throttle to give the required power at all times is currently being improved.

During the final approach the indicated airspeed fell to 137 kt whilst the auto-throttle, having reached the limit of authority, was overridden by hand to full throttle. (See Fig.13.)

The fall in airspeed was probably caused by wind shear which the auto-throttle was inadequate to deal with, as no pull up manoeuvre was initiated just prior to the reduction. The power was set to the minimum for 5 seconds before the loss in airspeed; this may have aggravated the slow response of the auto-throttle.

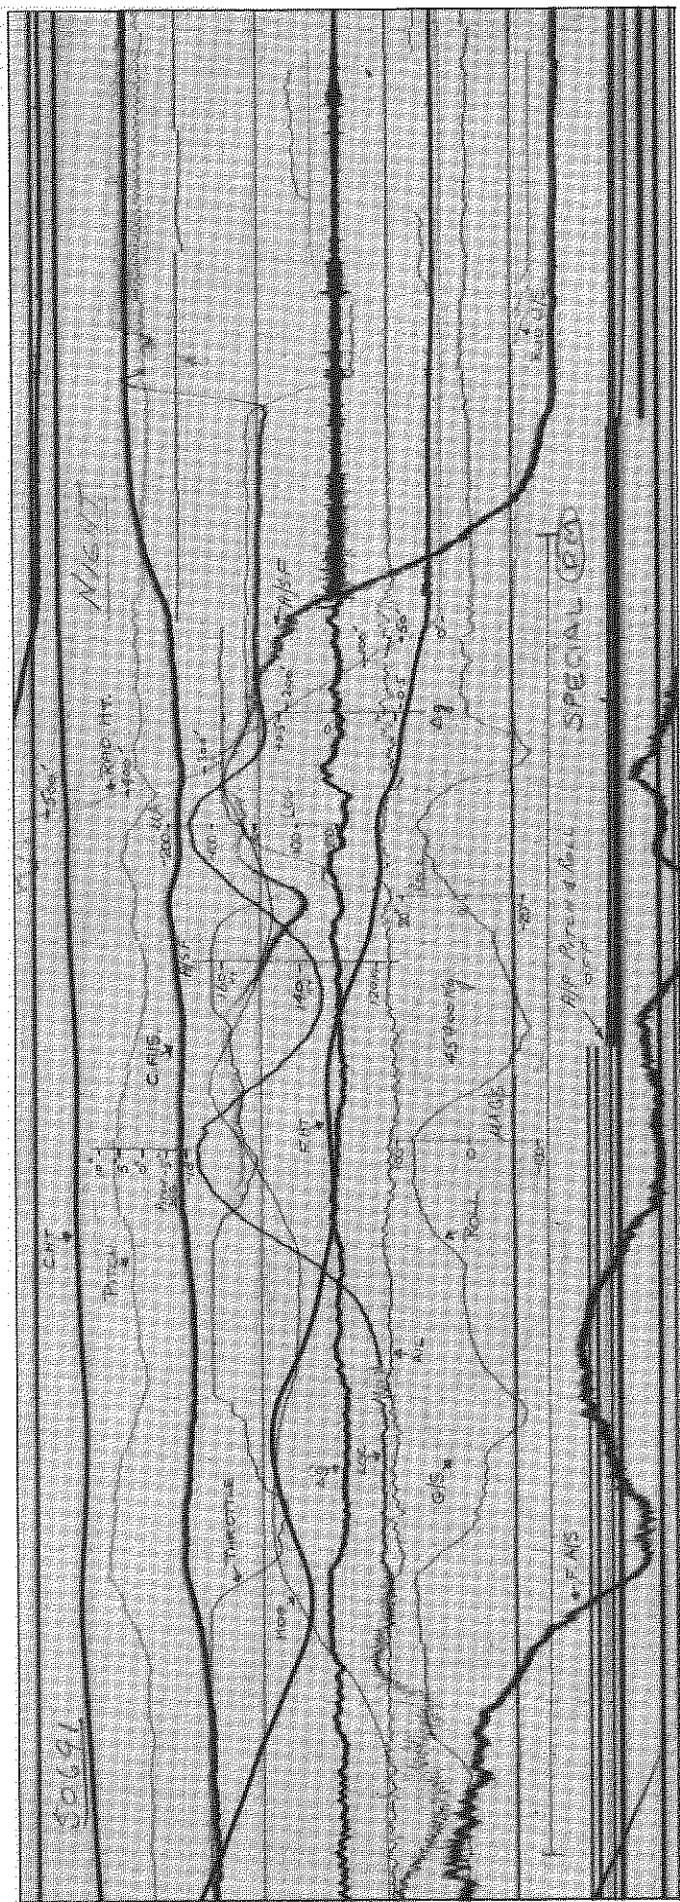
Fig.14. Event in flight 50691

During a manual ILS approach into Paris, the auto-throttle reached the limit of its authority when the airspeed fell to 138 kt. (See Fig.14.)

The first part of the approach was coupled (i.e. the autopilot was following the localiser and glide slope signals), but was disconnected through poor following. The manual following was still no better and the low airspeed occurred in this region, probably because of a sluggish auto-throttle.

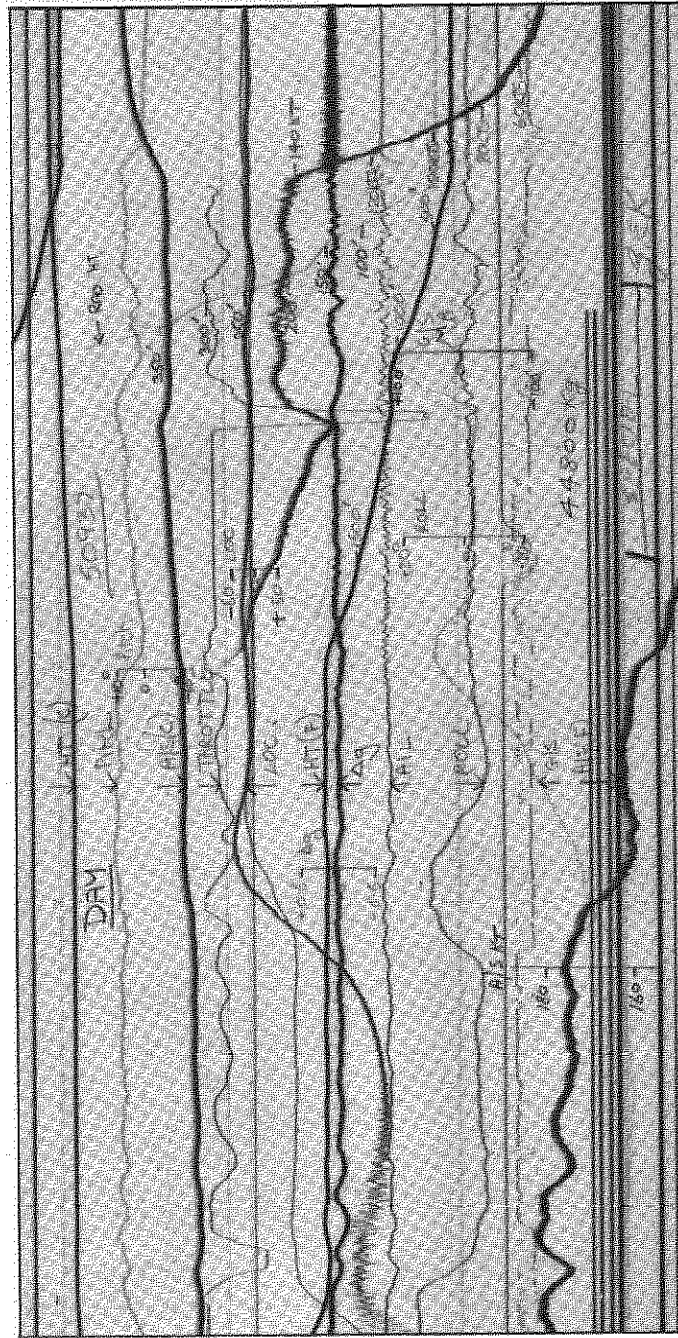
Fig.15. Event in flight 50937

In the third case the auto-throttle stopped altogether and this was not noticed by the pilot until a low airspeed had been reached. It is possible that the pilot's airspeed scanning rate is reduced when on auto-throttle.

During the approach into Paris, the auto-throttle remained at a constant setting for 35 seconds allowing the airspeed to fall from 153 kt to 130 kt before full power was applied by the pilot. (See Fig.15.)

It is not known if the stall warning operated. It should have been set above 125 kt, i.e. at least 8% above the stalling speed of 116 kt.

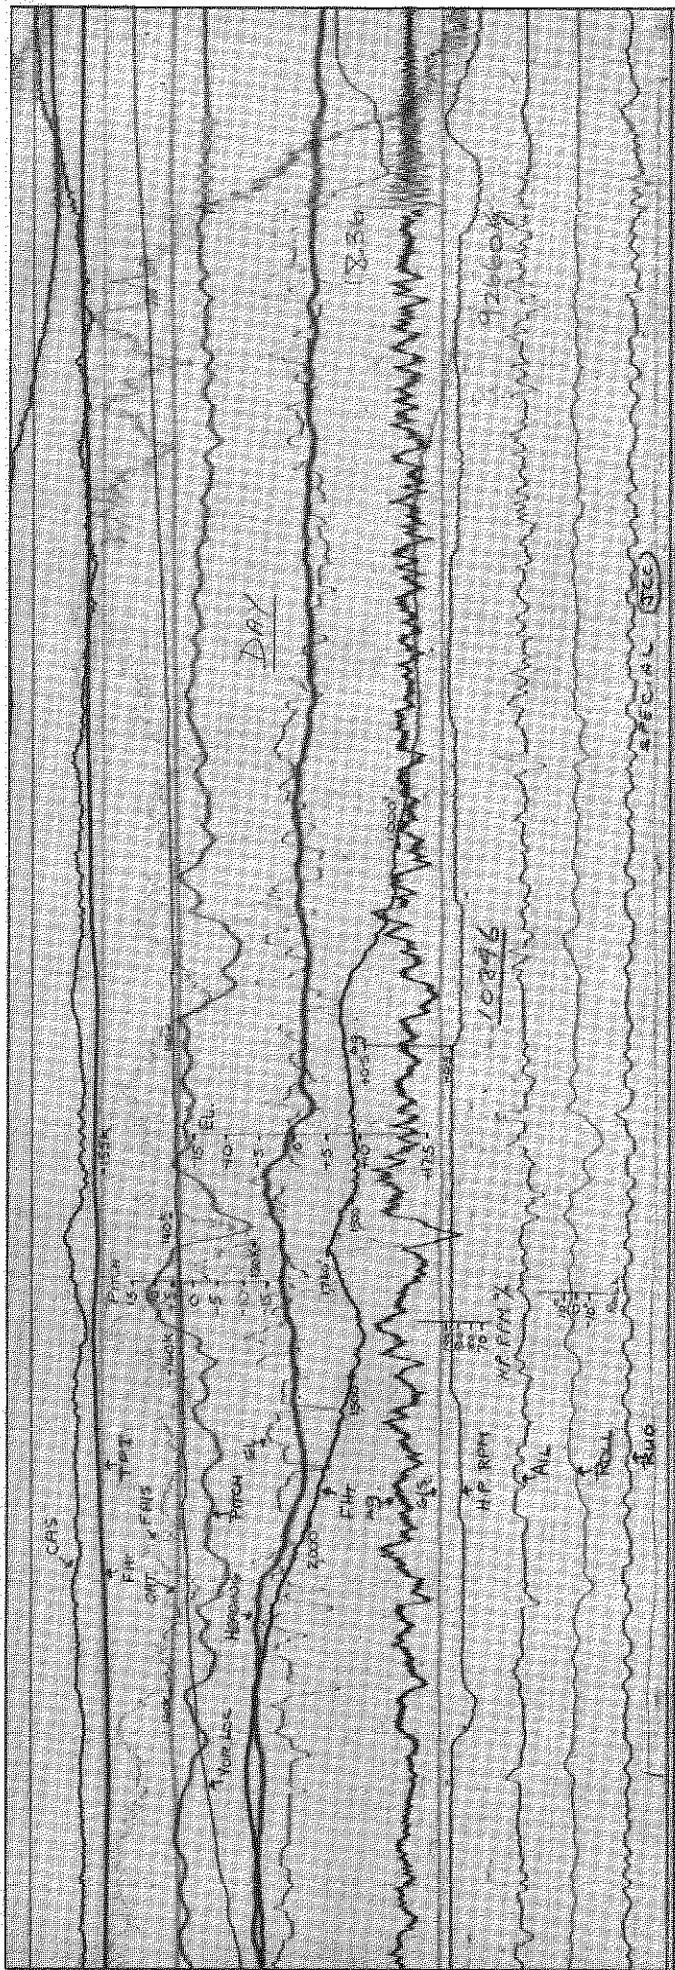
Fig.16. Event in flight 10846

During the approach into New York the airspeed fell to 120 kt at 1500 ft. The sequence of events over the preceding 25 seconds was as follows:-

- (1) Power was increased and the airspeed built to 155 kt.
- (2) The aircraft was pitched up progressively to 12° nose up.
- (3) The airspeed fell to 128 kt.
- (4) The control column was moved rapidly forward.
- (5) The airspeed continued to fall and did not increase until 8° nose down and 120 kt had been reached; at this time the normal acceleration increment was -0.6 g.
- (6) The aircraft continued to pitch down with increasing airspeed and finally reached 12° nose down.  
(See Fig.16.)

This event appears to have been caused by slow pilot reactions to pitch changes, but the situation may have been aggravated by long wavelength turbulence or wind shear.

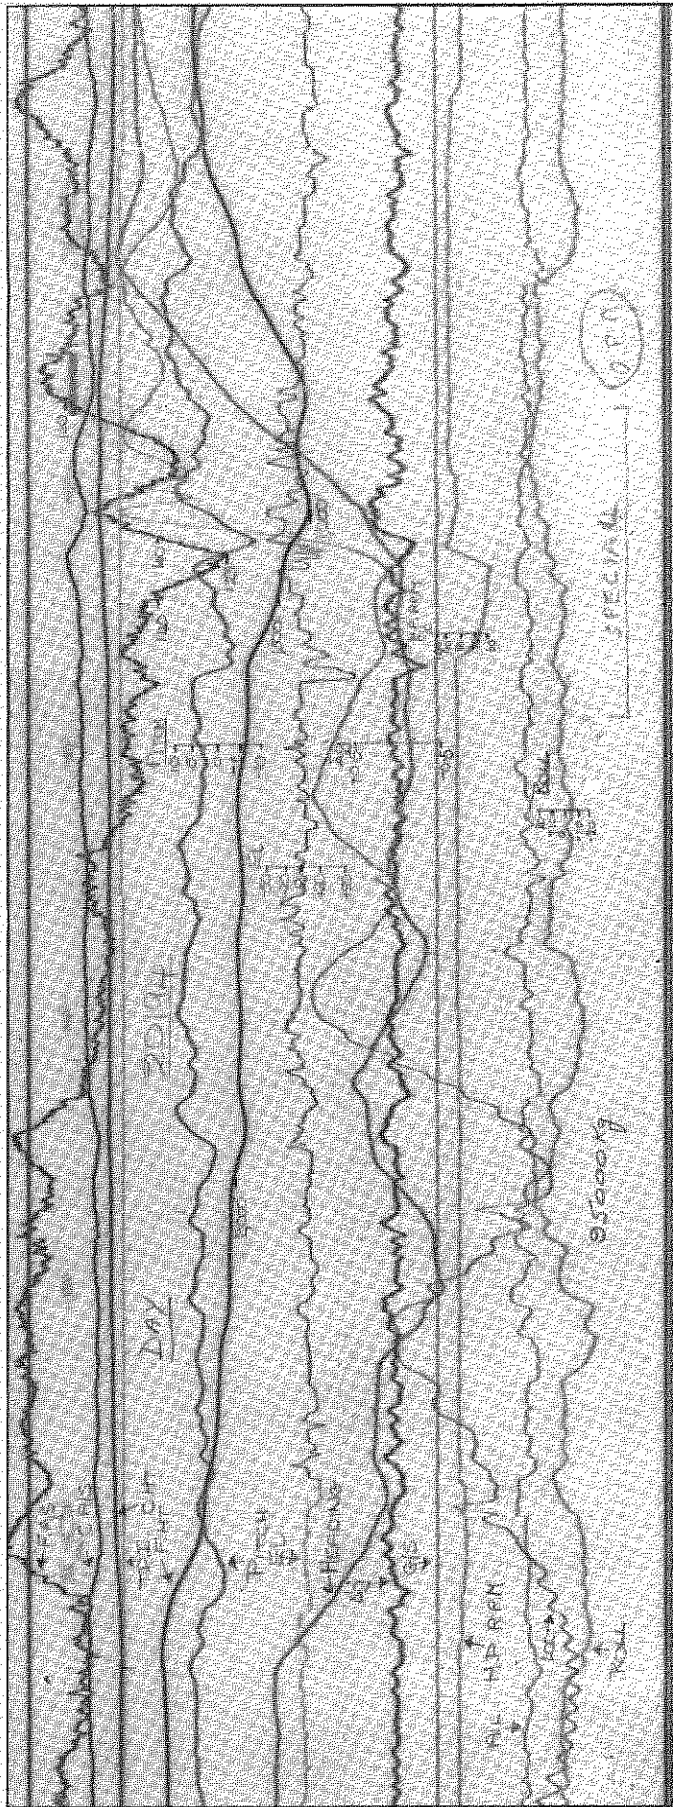
Fig.17. Event in flight 20194

During the approach into Chicago, the airspeed fell to 123 kt. Threshold speed for this weight is 128 kt. (See Fig.17.)

The airspeed fell to a low value because of distractions, but the recovery did not involve the large manoeuvres of 3.4.1 and 3.4.6.

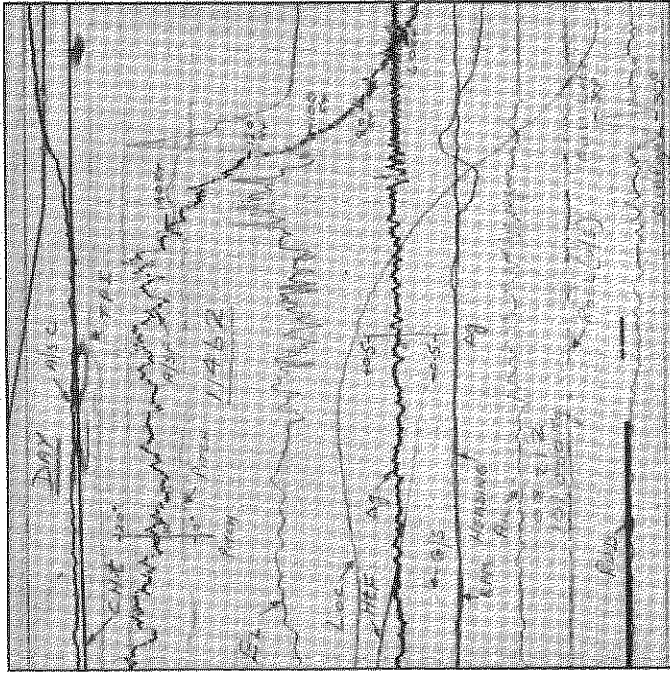
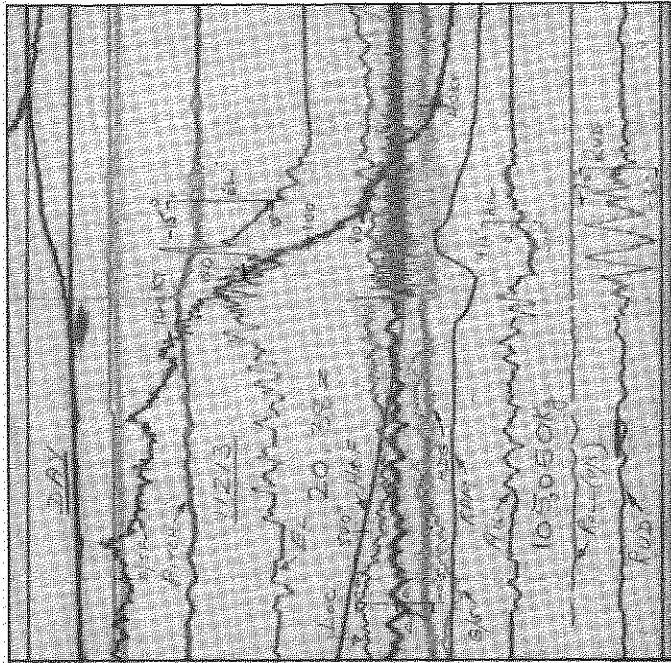
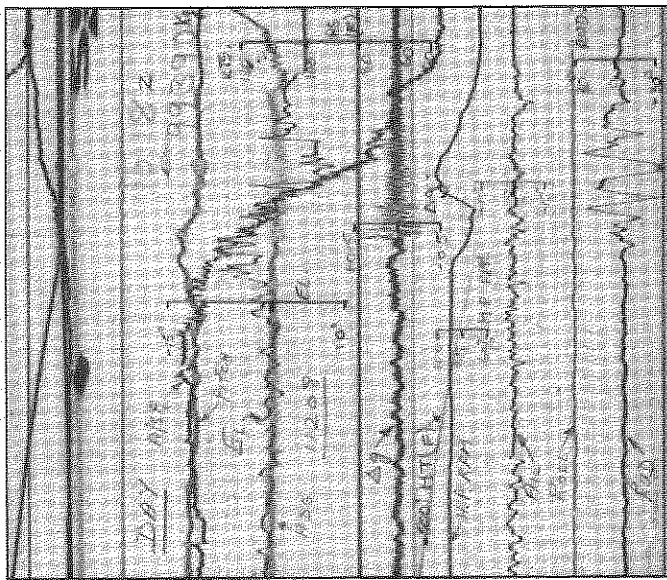
During the ground roll, full left and right rudder was used (see Figs.18a, 18b, 18c).
