MINISTRY OF SUPPLY
AERONAUTICAL RESEARCH COUNCIL
REPORTS AND MEMORANDA

Service Failures in Aircraft Structures Associated with Fatigue, Repeated or Dynamic Loads

J. B. B. Owen, D.Sc., M.Sc., A.F.R.Ae.S.

*Reports and Memoranda No. 2688**

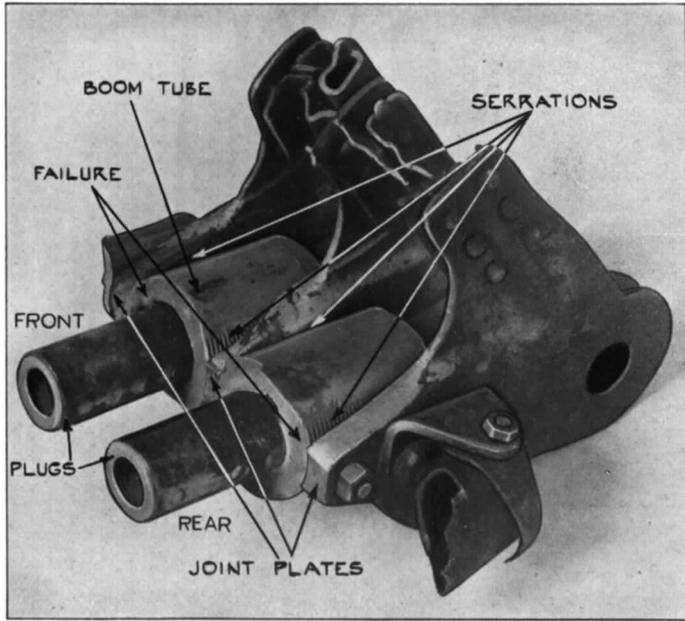
2. *Fatigue Type Failures.*—2.1 *A Spar Boom Failure.*—The spar booms, in which the failures described here occurred, are made up of a number of lengths of round section tube joined together by plates. Load is transferred from the tubes to the plates mainly through vertical serrations in both. Fig. 1 shows a typical joint in which the boom has failed and pulled off the plugs now seen protruding. A 'close up' of a fractured boom is shown in Fig. 2 from which it will be observed that there are two main areas of failure¹; the first extending from OO to LL and L, characterised like a fatigue fracture by its smoothness and orientation in the plane normal to the boom length, and the second the rest of the boom, which is more typically tensile in character. The first area, however, shows definite 'tide marks' which are absent from specimens subjected to the usual laboratory fatigue tests, but recent laboratory tests have produced tide marks. The stress cycle employed was 4.65 ± 0.7 tons/sq in. 500,000 times followed by 3.25 ± 1.75 ton/sq in. tension 50,000 times. Failure occurred after this had been repeated 22 times, *i.e.*, a total of 12 million cycles had been reached. In the usual type of fatigue test at 5 ± 0.5 ton/sq in. cracks were first noted after 2.5 million cycles and failure occurred after 5 million cycles. These stress figures refer to the mean stress in the boom adjacent to the joint and make no allowance for stress concentrations in the joint.

From the data available on laboratory life, flight life and measured boom stresses, it appears that service failures are probably due to either (i) the boom stress raises being more vicious, particularly in service aircraft which failed after comparatively few flying hours, or (ii) occasionally very high built-in stresses were present due to the method of tube manufacture or the technique of assembling the aircraft, plate and joint serrations, say, being forced together.

FIG. 1. A spar boom failure.

Considerable improvement in the laboratory life of booms was obtained by arranging that the change of section at the joint was more gradual. The boom material was also changed from one which obtained its strength by cold working, which produced cracks on occasions, to one which obtained its strength properties by heat treatment. These changes seem to have increased aircraft life considerably. The increasing use of concrete runways and the rigorous inspection instituted may also have had considerable influence. The precise nature of the loads causing the failures remains obscure and some tests on the usual type of sleeved joint have indicated that this, unless carefully designed, is not in laboratory test superior to the serrated joint.

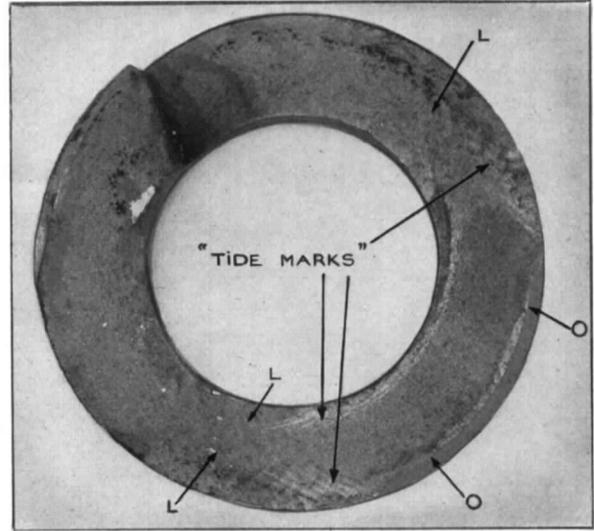
Buckling of the web has occurred at this corner as seen around the crack F. Such cracks had frequently the appearance of fatigue as in Fig. 5 between F and G but exhibited tide marks as in the spar boom failure in Fig. 2. This was not always the case as in Fig. 6 where only AB and CD are characteristic of fatigue. The intervening portion suggests that high magnitude loads have played a part in the failure. Cracks occurred when the corner F in Fig. 5 was sharp and also when it was well radiused. Fortunately the longest cracks examined ran into adjacent holes and did not continue through them. Thus although such webs, which are continuous in a shallow wing and deep fuselage, are clearly undesirable, no serious trouble occurred.

FIG. 2. Enlarged view of fractured boom.

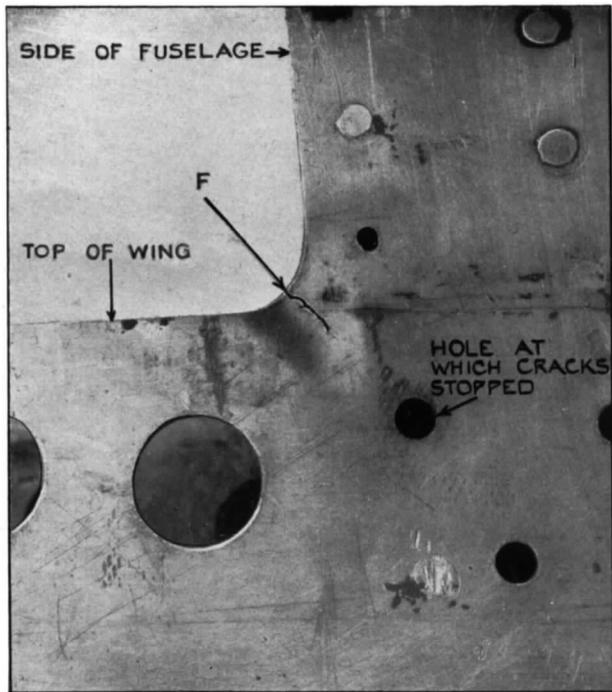
2.2 Web Cracks.—The centre section web of some wings rises above the spar booms and forms part of a fuselage bulkhead. Fig. 4 is a close-up of such a web. The boom root bolts pick up the large holes seen in the figure. The web frequently cracked, as at F, in the fillet which merges the web proper into the fuselage ring proper. This was probably due to stress concentration at the corner where the web changes in depth.

The stress concentrations leading to the web crack of Fig. 4 and the frame cracks in Fig. 11 might be classed as stress concentrations due to faulty outline design, whereas the others seem to be due to imperfections in detail design. The magnitude of stress concentration effects is usually difficult to estimate even when the loading is known. Data on load fluctuations is scanty and so too is information on the behaviour of materials under diverse load cycles. Stress lacquers and strain gauges may, however, give the designer information on the intensity of stress concentrations to supplement his experience on designing to avoid stress concentrations.

FIG. 4. Cracked web.

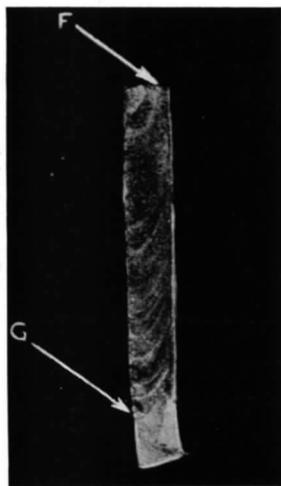
FIG. 5. Web fatigue crack.

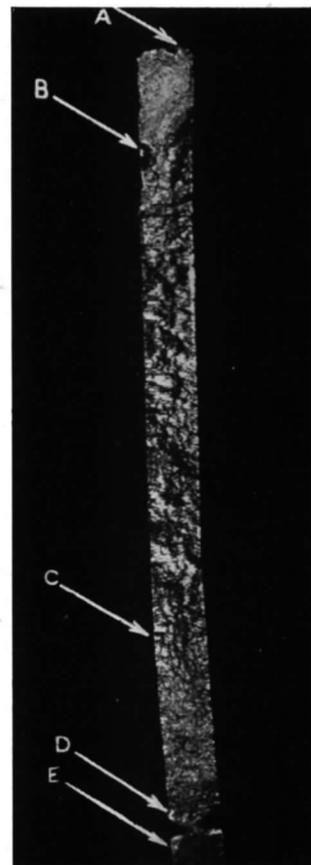
FIG. 6. Web crack.

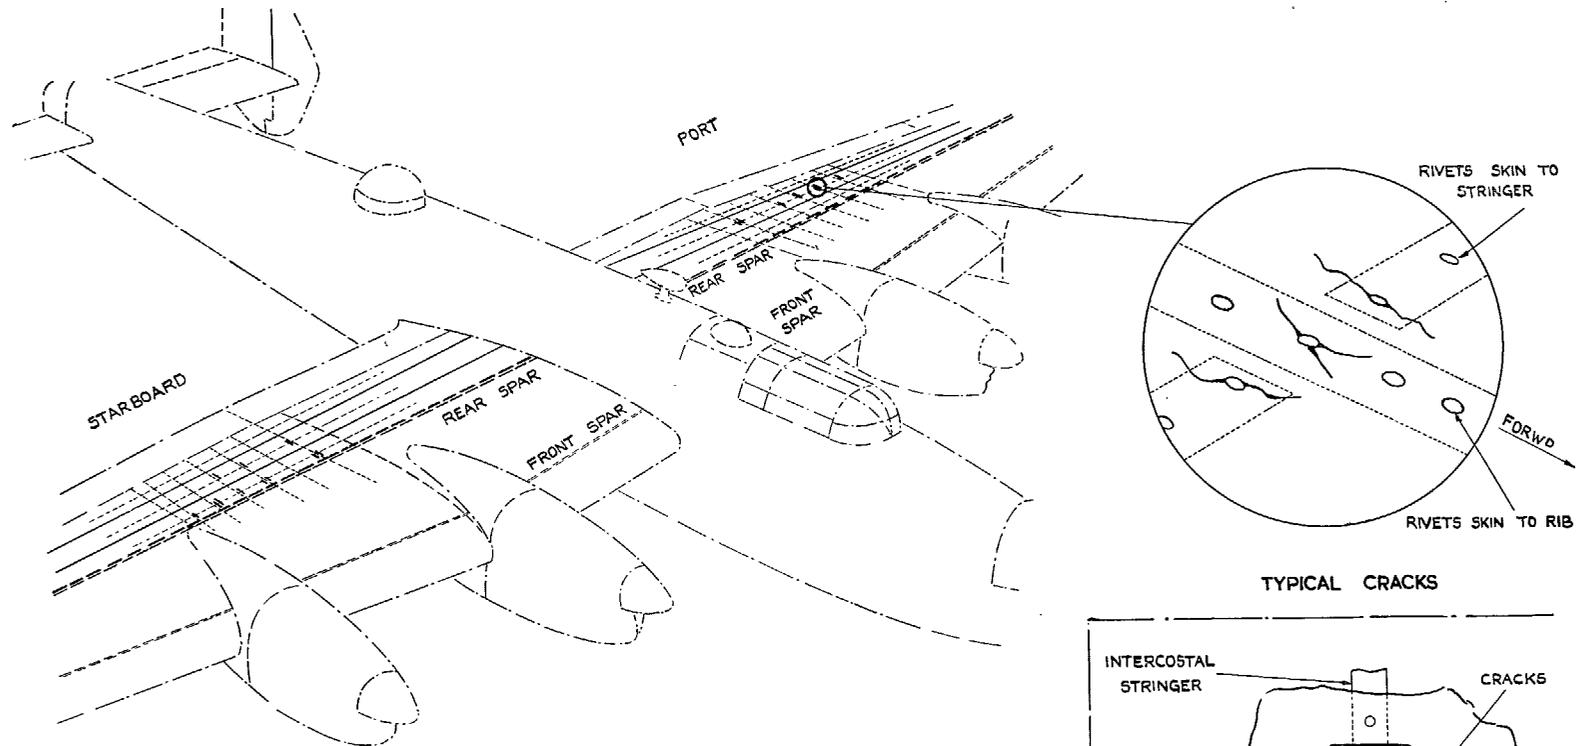
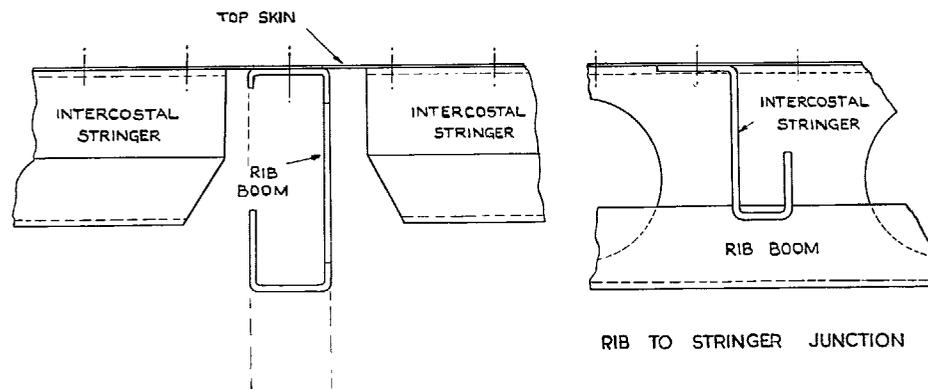
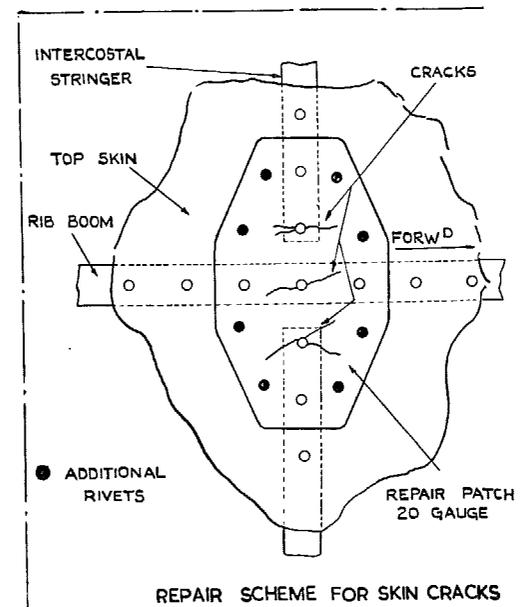
2.3 Cracks in Flat Plates.—These web plate cracks, when the radius is ample, may be considered as due in part to flat plates buckling in compression where not supported, here by the spar flange or the fuselage frame. Cracking was more common where stringers were interrupted at frames or ribs. Such cracking⁴ is shown diagrammatically in Fig. 7 and is probably due to severe engine vibration causing panel panting coupled with stress concentration due to the transfer of stringer end load by the flat plate skin.

LOCATION OF SKIN CRACKS ON MAINPLANES

FIG. 7. Wing skin cracks.

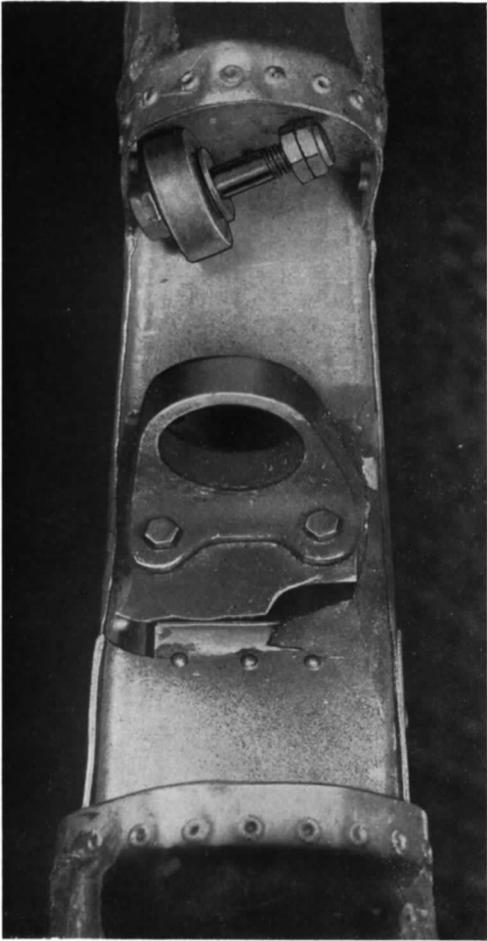
Cracking has also occurred where hinge bracket bending loads are transferred first into the web as in Fig. 8 with no adequate members to take the loads into the main structure. Shear and bending stress concentration probably play a part in this failure.

FIG. 8. Rudder hinge failure:

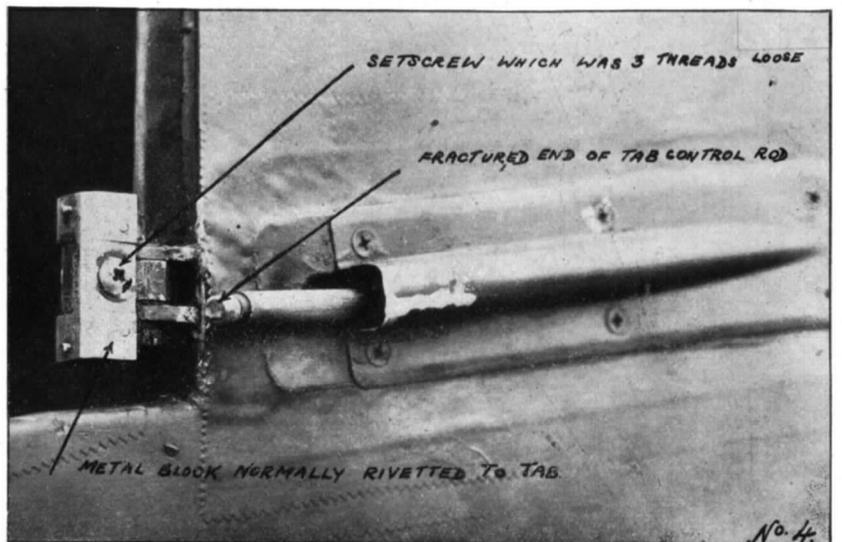
2.5 Rudder Failure Due to Excessive Tab Gear Backlash.—The rudder failure⁹ of Fig. 10 is an example of a fatigue type failure although it may also be due to repeated loads of greater intensity than those associated with fatigue. A tab operating rod failure through a screw thread and cracks in a cut-out in the rudder spar which run through holes provided for lacing the fabric are seen in the lower figure. The failure was probably associated with backlash in the tab and when this was restricted no further failure was reported.

FIG. 10. Rudder failure.

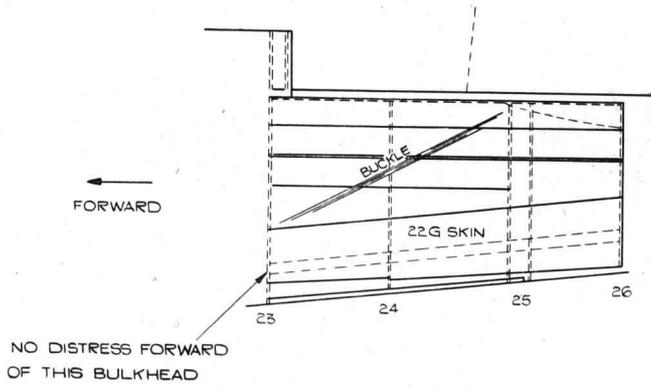
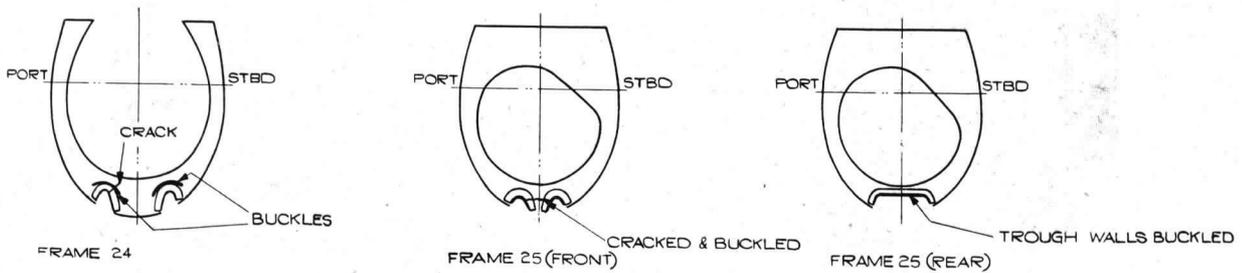
4. *A Suspected Repeated Loading Failure of a Fuselage.*—Fig. 11 is a diagram of the aft part of the fuselage concerned and shows the cross-sectional shape. The bottom of the fuselage between frames 23 and 25 has two troughs which converge towards frame 25 and between frames 25 and 26 become one trough. (These troughs are provided to house an arrester hook and its V-shaped attachment structure). Several service defects, which occurred in varying degrees of severity, are indicated in Fig. 11. Many fuselages had buckles in frame 25 between the troughs and had no other defect. The next stage of failure was buckling at both frames 25 and 24 with possibly cracks in frame 25 and rivets starting to pull. In more developed cases the trough walls aft of frame 25 had buckled, frames 25 and 24 had buckled and cracked, and a deep permanent buckle ran diagonally down the fuselage side. Fig. 12 is an internal view of the type of damage at frame 25, Fig. 13 that at frames 24 and 25 and Fig. 14 the external appearance of a fuselage.

FIG. 11. Aft fuselage defects.

A possible source of the loads causing failure was tail wheel shimmy caused by the shimmy dampers becoming inoperative. Action was taken to remedy this fault and also to strengthen the fuselage. Reports of trouble then ceased. If is, therefore, not known whether shimmy

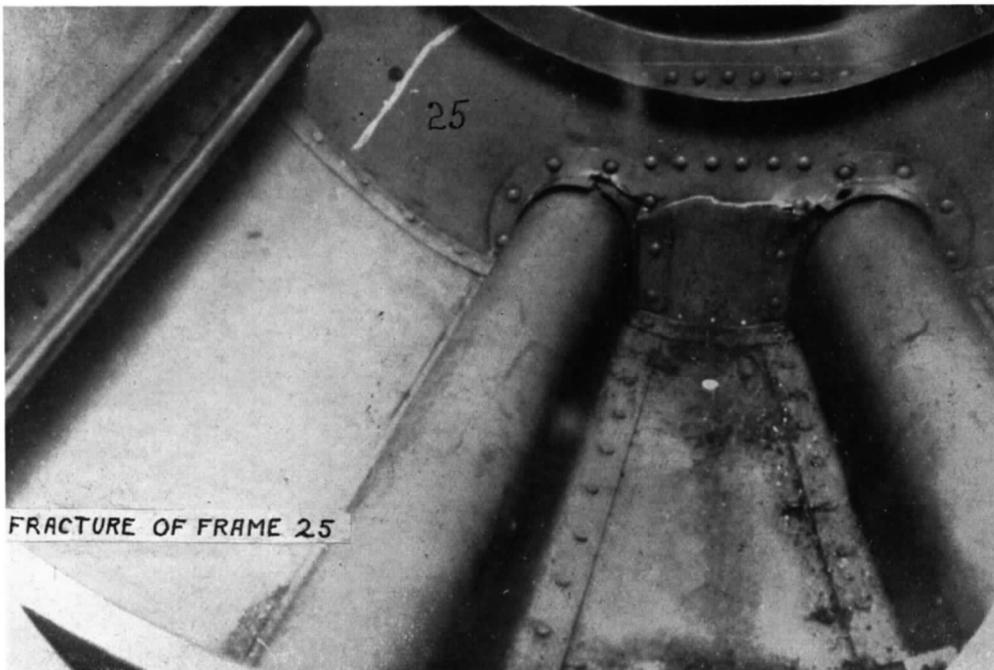
FIG. 12. View showing damage at frame 25.

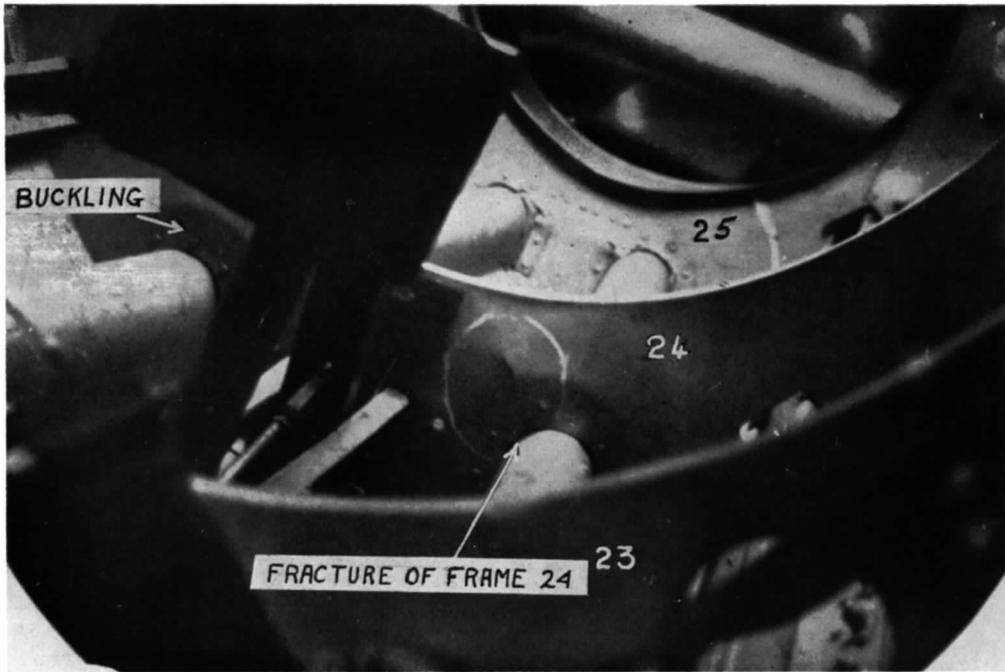
FIG. 13. View showing damage at frames 24 and 25.

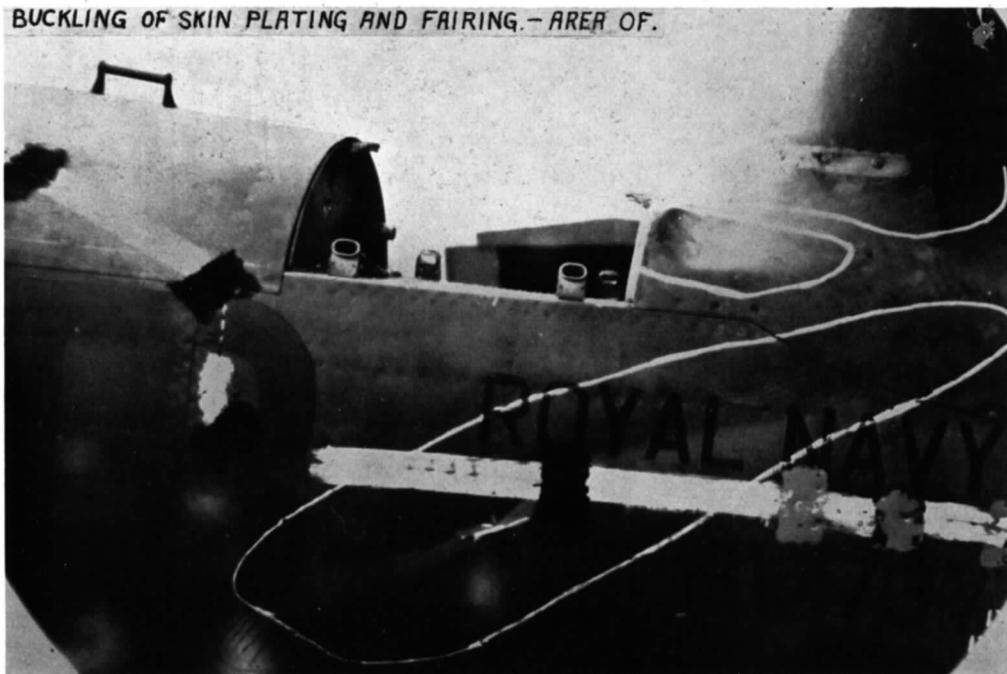
FIG. 14. External buckle on fuselage.

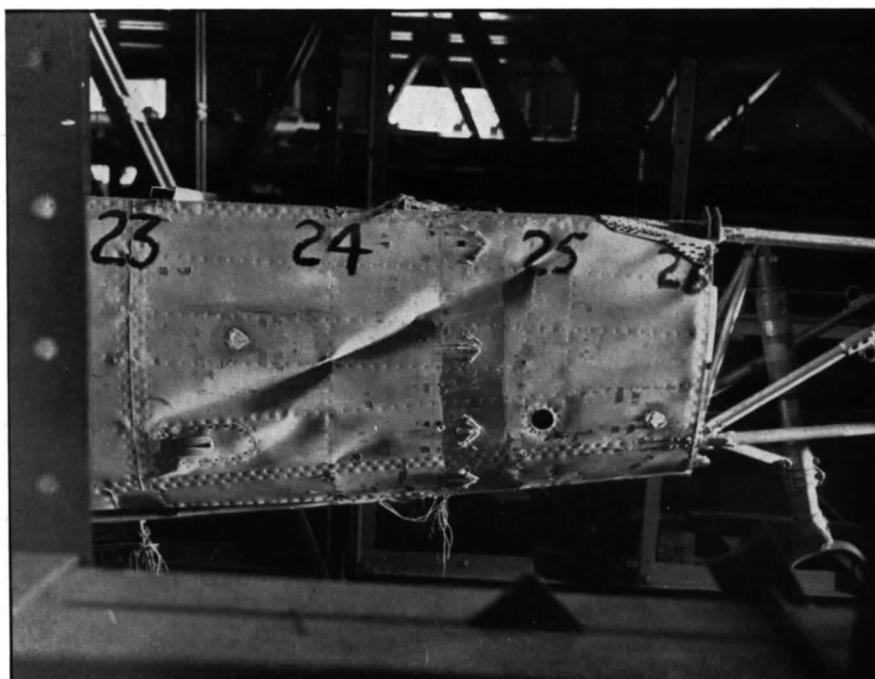
In a static test¹² done on the fuselage the external buckling shown in Fig. 14 was reproduced as indicated in Fig. 15 but only after frame 25 had been artificially cut to resemble the service damage shown in Fig. 12. The fuselage had also been previously heavily loaded, the magnitude of the loads exceeding those which were later necessary to cause the heavy fuselage buckles shown in Fig. 15. This heavy loading in the previous test had failed to produce failure at frame 25 as in Fig. 12 although some slight buckling occurred at this frame. In fact the tail wheel unit structure which was used to apply shear and torsion loads to the fuselage failed; a condition which was not common to those service incidents which exhibited only slight defects. With frame 25 artificially damaged the tail unit was strong enough to break the fuselage; but whether this was primarily due to cutting this frame or to previous heavy loading is not established. It is apparent, however, that in service something was happening which differed from what occurred in the first static laboratory test, and resulted in the buckling and cracking of successive fuselage frames. While it is possible that another fuselage may have behaved differently from the test fuselage (insofar as, for example, the frames were initially buckled, or the applying of torsion loads through the fin and tail plane attachments produced a different distribution of loads at frame 25) it seems more probable that under repeated and reversed loading actions a different result from that obtained in the static test would have occurred. Evidence of this is found in the progressive nature of the fractures and defects suggested by the various degrees of damage sustained as already described, in the rubbing together of the fractured faces of frame 25 and in the buckling on both port and starboard edges of the crack that were revealed on close examination.

FIG. 15. - Fuselage failure in test.
