**Andover C. Mk. 1
Airfield Criteria Trials**

J. Howell

A and AEE, Boscombe Down

SUMMARY

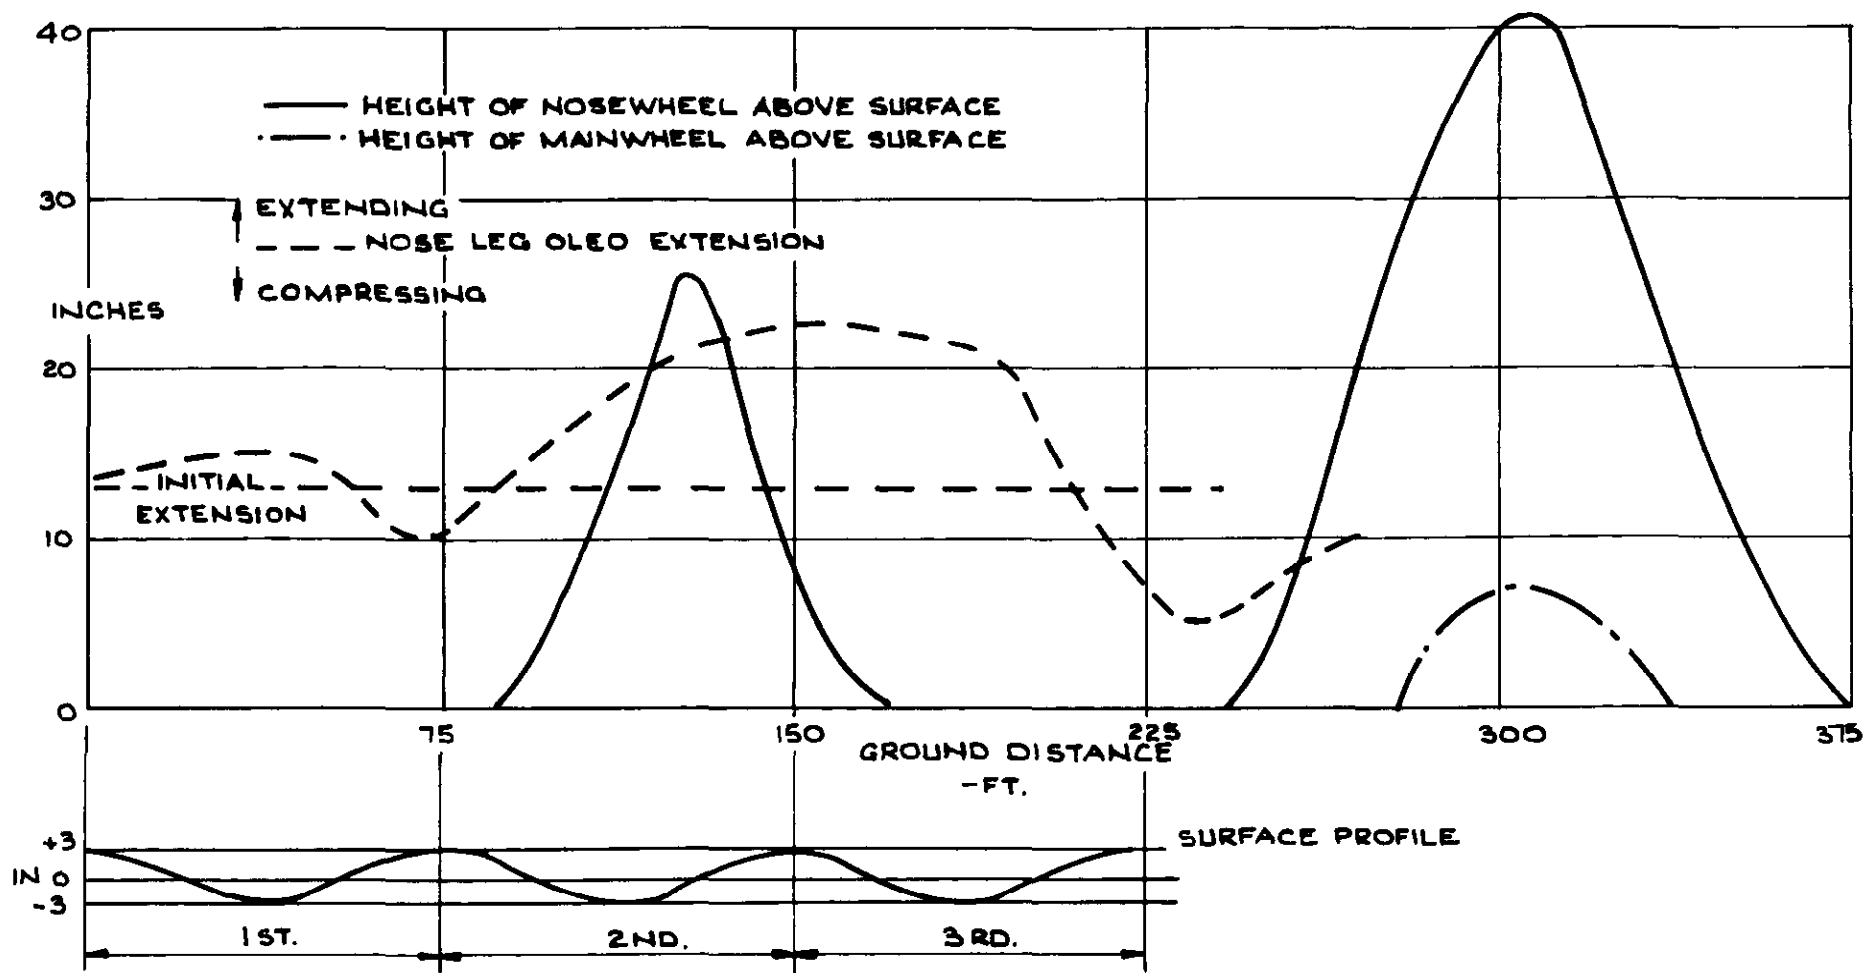
FIG 32.

PITCHING ON 75 FT UNDULATIONS WHEN ACCELERATING THROUGH 44 KT.

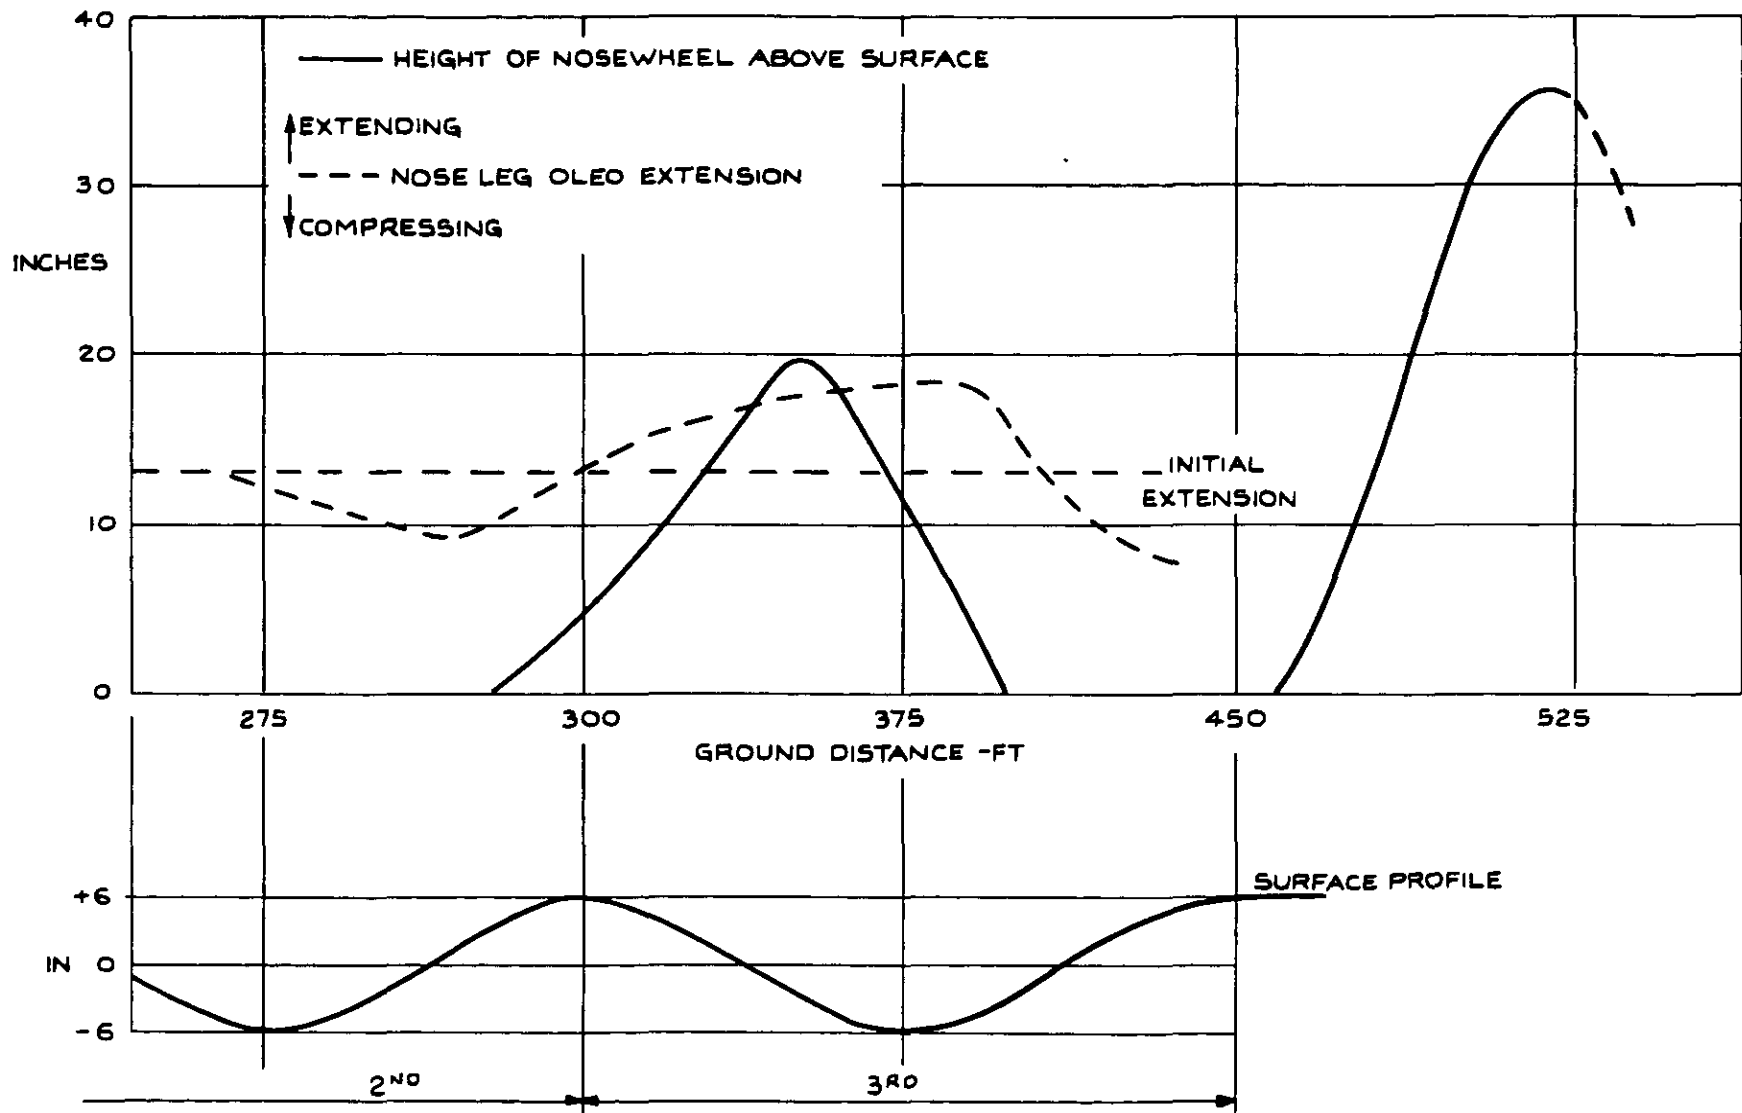
FIG. 33

PITCHING ON 150 FT. UNDULATIONS WHEN ACCELERATING FROM 55-63 KT.

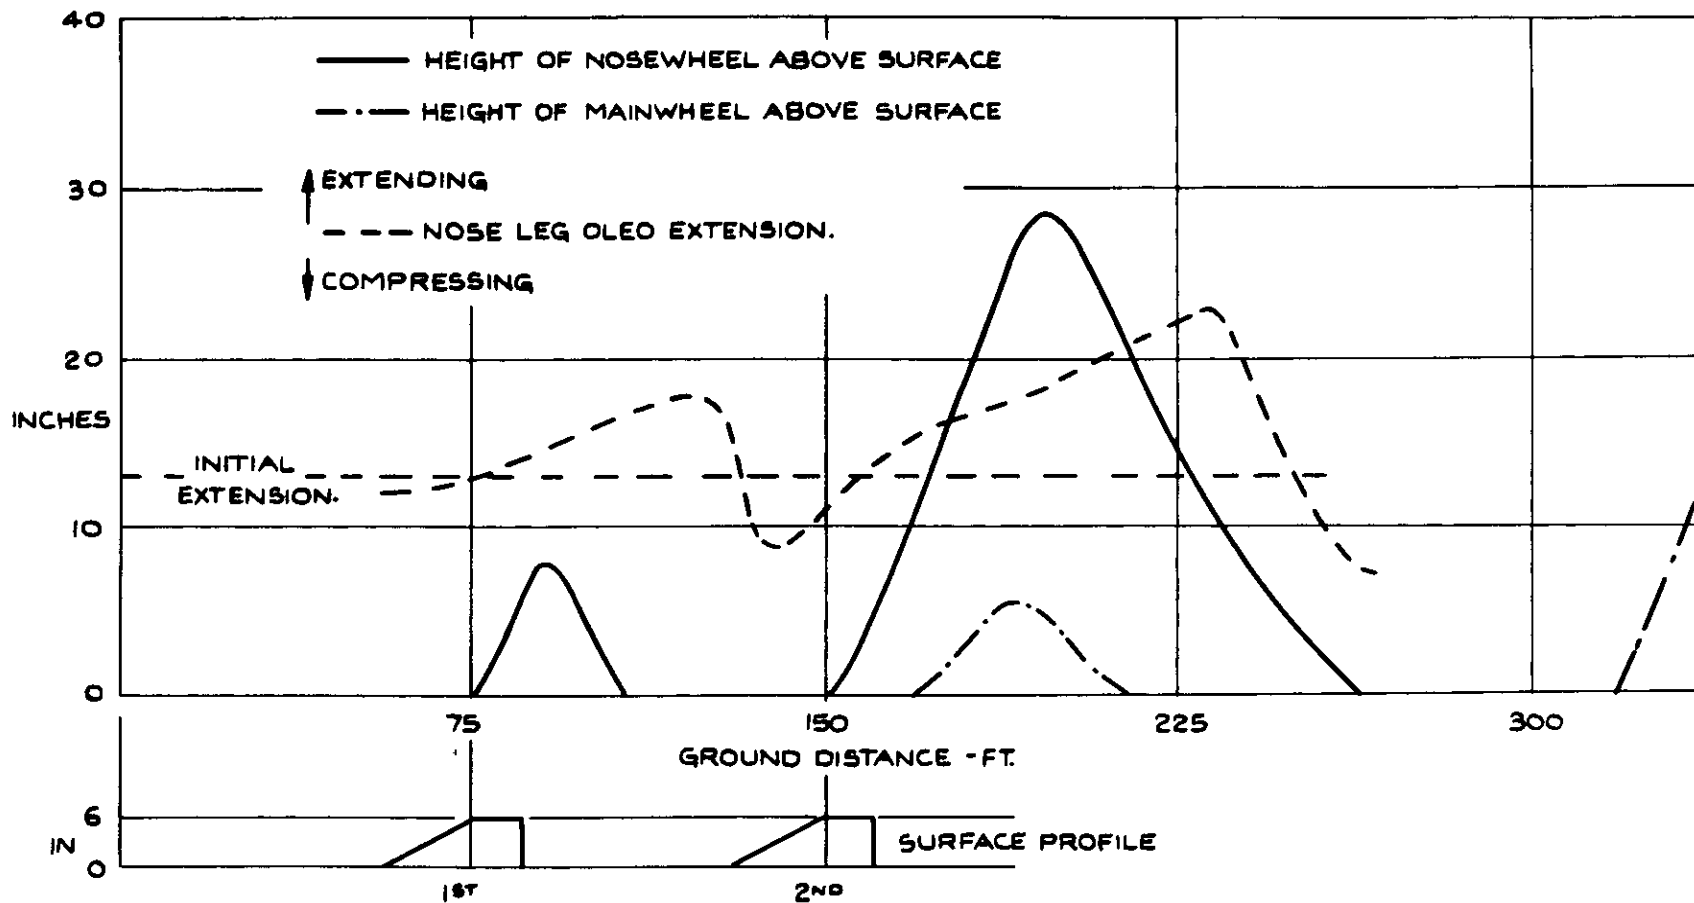
FIG. 34

PITCHING ON 6 IN, 1 IN 50 RAMPS SPACED AT 75-FT ACCELERATING THROUGH 40 KT.
SIMULATION OF 75 FT. SINUSOIDAL UNDULATIONS.

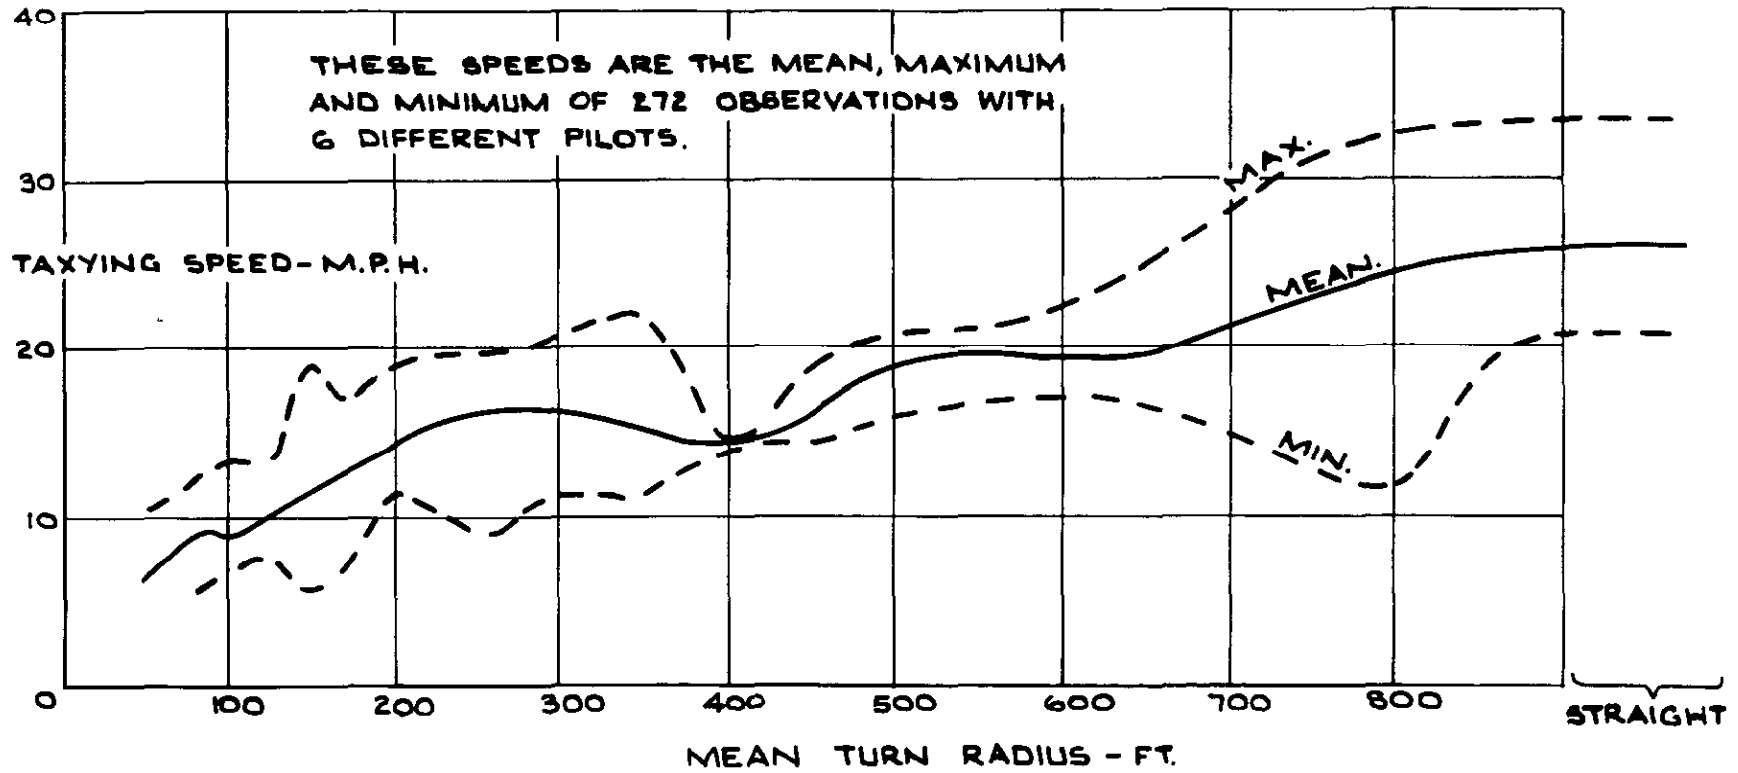
FIG 35

GROUND MANOEUVRING SPEEDS.

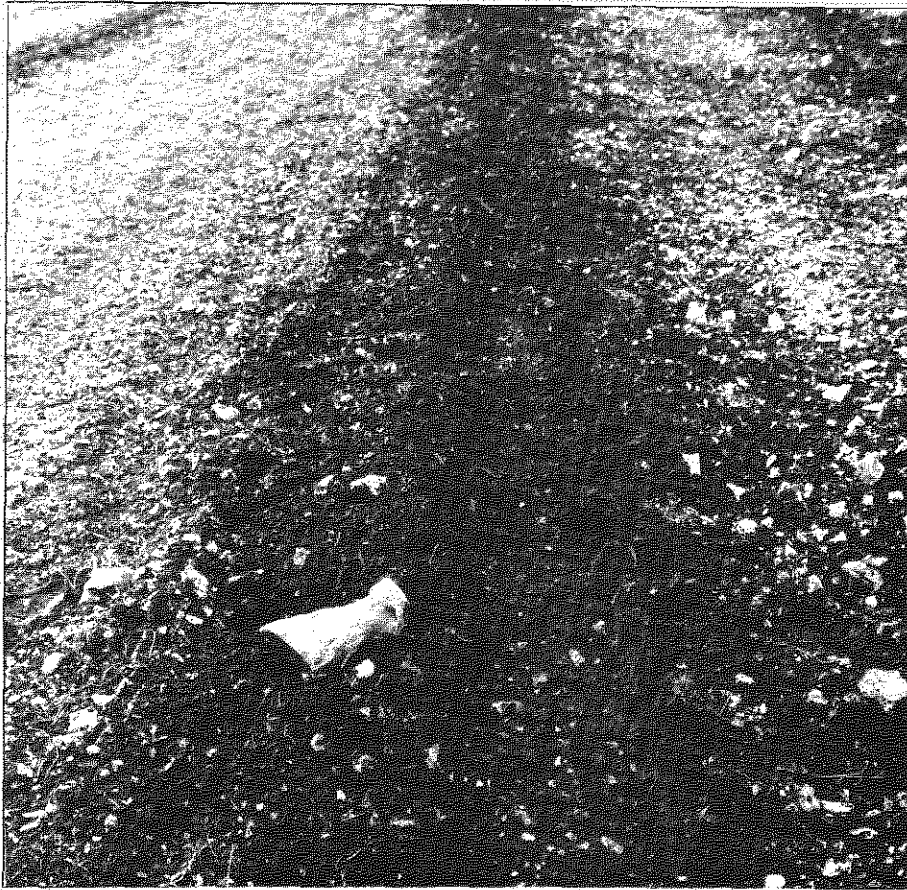
FIG. 9. PLOUGHED LANDING STRIP AT A. & A.E.E.
GENERAL SIZE OF FLINTS COMPARED WITH WHEEL TRACK.

As described in para.3.3.3 the soil of the test strip contained a high proportion of flints of various sizes and this gave rise to a problem in relation to tyre, propeller and airframe damage. It was considered at one time that the tests might have to be abandoned, but by a process of stone-picking to remove the larger obstacles and frequent harrowing and ploughing to provide a fresh soil layer,

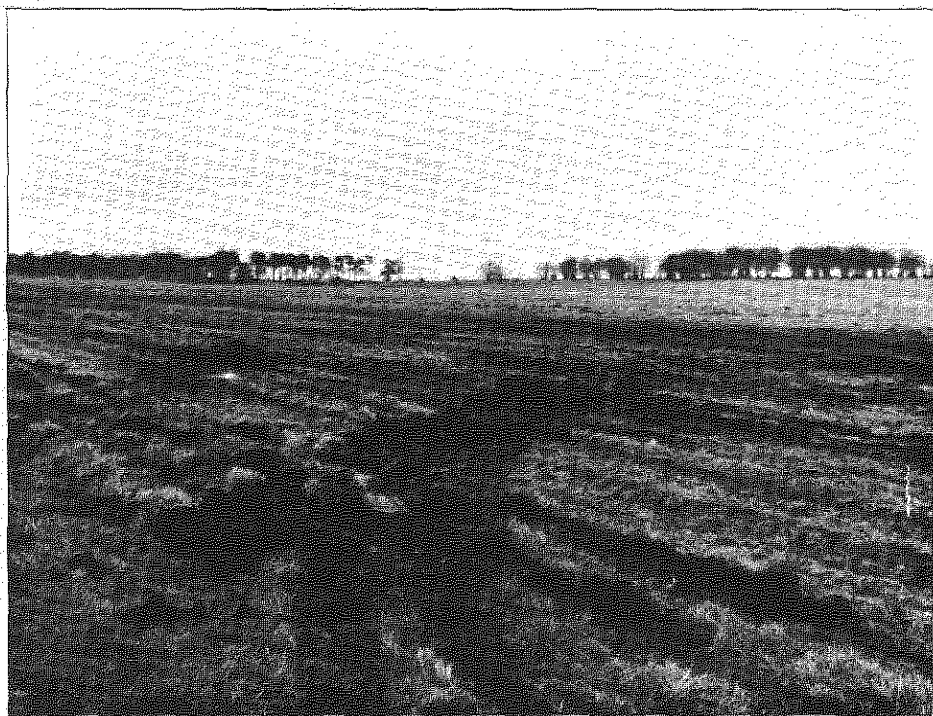
FIG. 15. UPAVON GALLOPS. TEXTURE OF WET, FIBROUS SOIL AREAS.

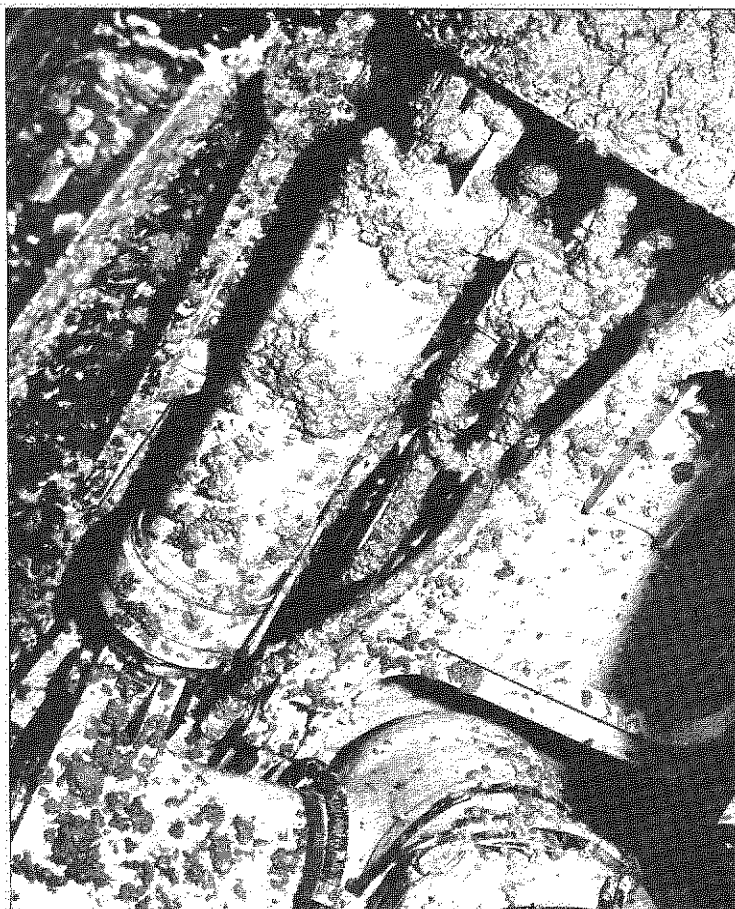
FIG. 20. CONTAMINATION IN MAIN UNDERCARRIAGE BAY.

Considerable aircraft contamination resulted from tests in these conditions (see Figs.16-25). All exposed forward and lower areas collected a heavy build-up of soil from which some of the moisture had been forcibly extracted on impact. The undercarriage wheel bays, door mechanism and hinges and flap tracks and hinges were heavily contaminated. There was considerable packing of soil between the wheels and in the brake units, which may have resulted in some sluggishness in the release of brakes during Maxaret operation. Several instances were observed of one or more wheels remaining stationary for several yards at a time, during a landing run. Similar instances observed during take-off may have been due to the packing of mud in the wheel providing sufficient rotational drag to cause the wheel to plane on the slippery surface. The feasibility of this kind of operation is discussed in para.5.2.

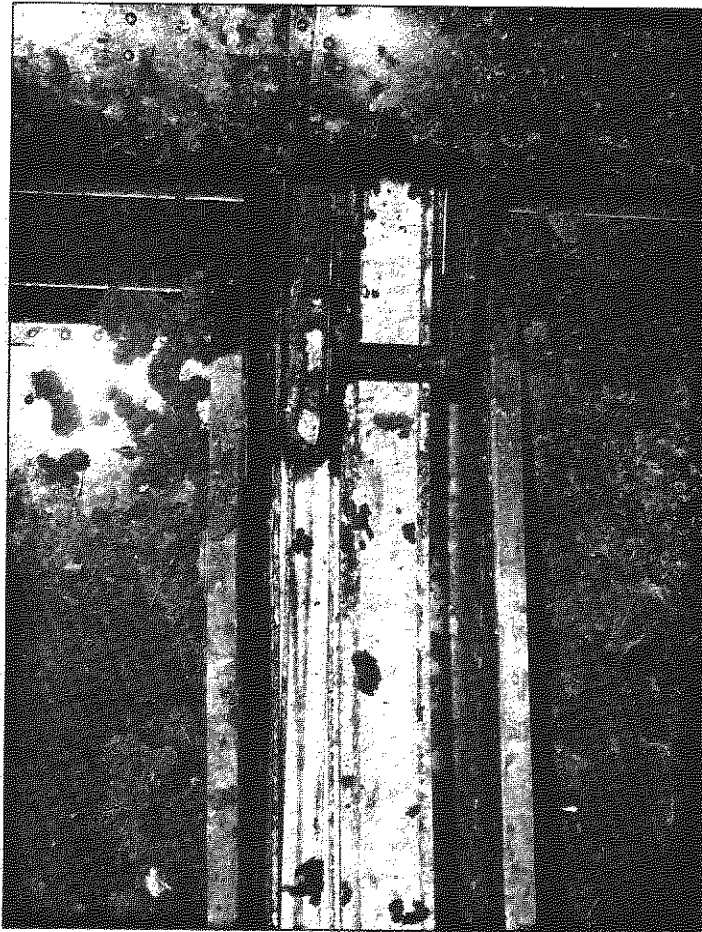
FIG. 22. CONTAMINATION OF FLAP TRACKS.

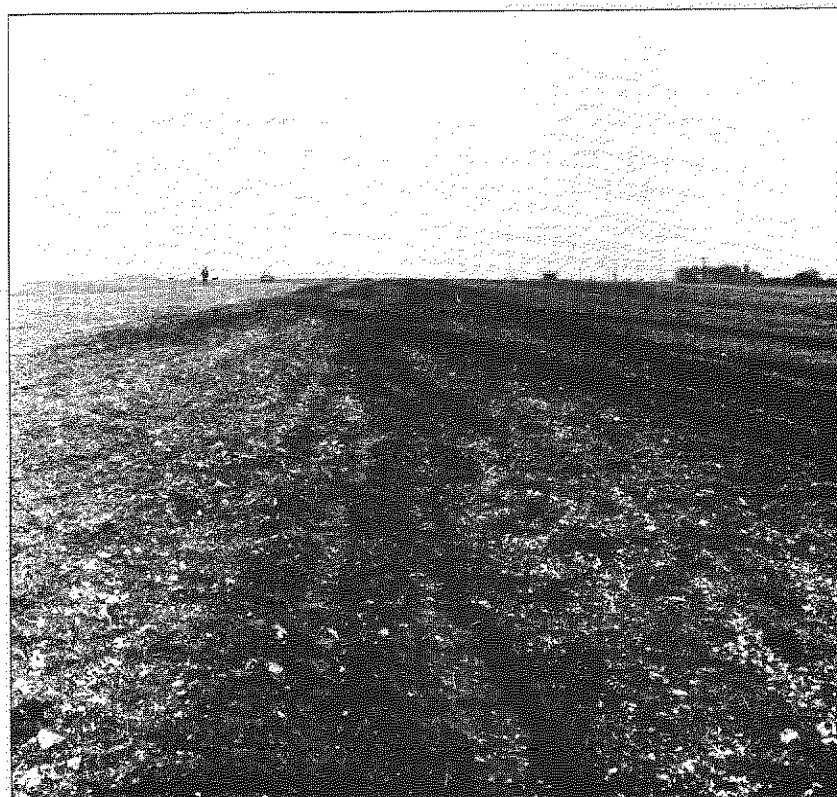
FIG. 28. A. & A.E.E. SOFT EARTH STRIP. RUTTING WITH SURFACE LAYER SOFTENED TO 3 INCHES.

When the soil surface was soft to 3 in. the general order of rutting was 1-2 in. for the nose-wheel and $\frac{3}{4}$ -1 in. for the mainwheels, there being some filling of the ruts by loose soil behind the wheels. The soil tended to form 1-2 in. banks at either side of the wheel ruts (Fig.28). Where the aircraft was stationary the local ruts were of the order of 5 in. and 3 in. for the nose and mainwheels respectively. In the later stages of the tests, when the soft layer was increased to a nominal 6 in., heavy braking resulted in severe rutting, necessitating some digging to free the mainwheels in order to avoid the use of extreme power to move the aircraft. This might have resulted in the scouring of the propellers and undersurfaces by debris. The ruts caused were of the order of 1 ft. with soil banked to 3 in. at the sides of the ruts.

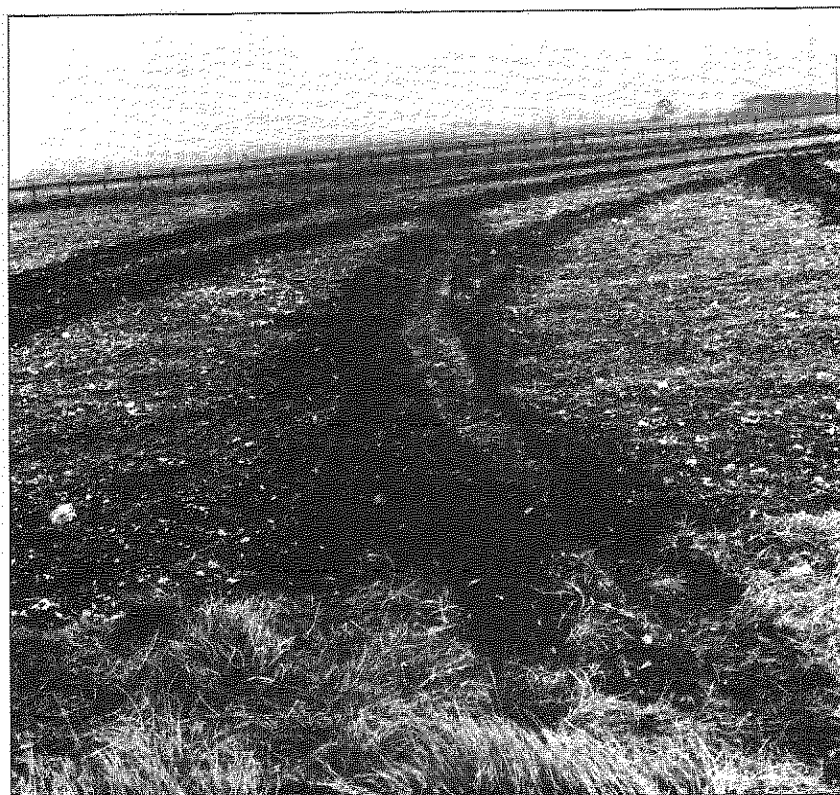
FIG. 29. A. & A.E.E. SOFT EARTH STRIP. RUTTING IN TURNING AREA. 2 INCH WET SOIL ON FROZEN SUBGRADE.

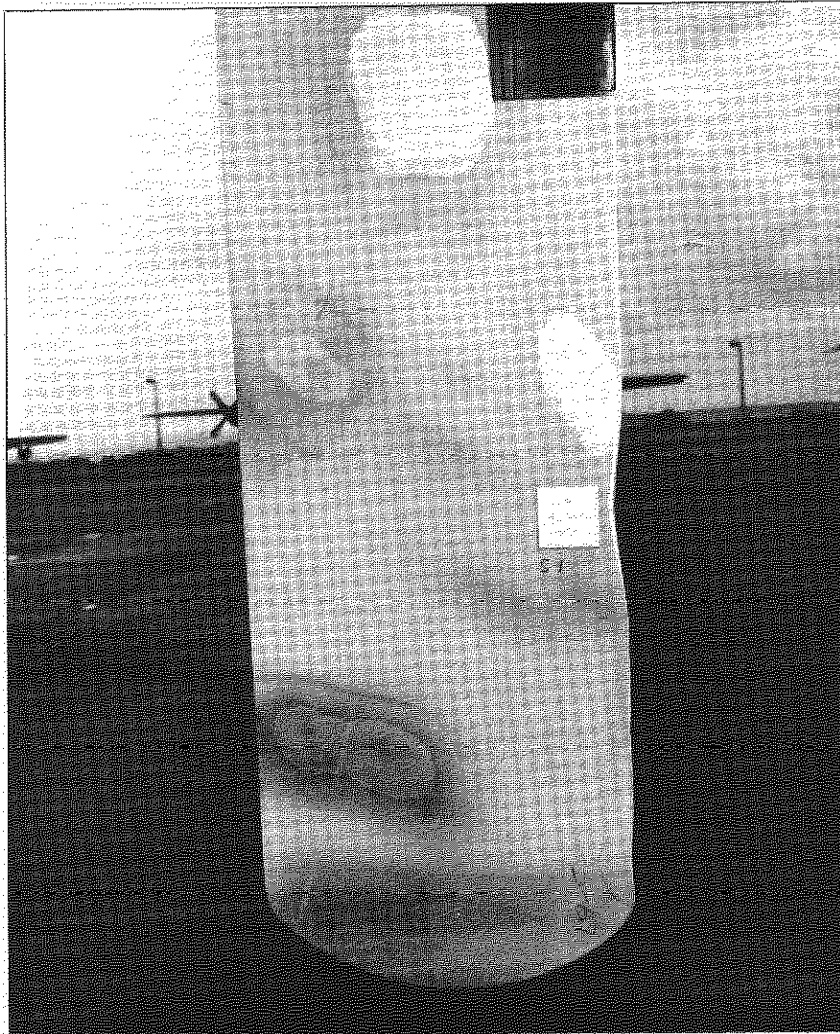
FIG. 37. TYPICAL PROPELLOR BLADE DAMAGE AFTER BLENDING,
FOLLOWING 60 MOVEMENTS ON A STONY SURFACE.

Many minor abrasions occurred to the flaps and flap tabs and several punctures of the flap skin necessitated local repair. Minor abrasive damage was also suffered by the inner wing leading edges, nacelle panelling and inner wing and fuselage bottom skins. Many minor nicks occurred to the propeller blades and a number of more serious chips which were near the accepted repair and blending limits. These were, however, all blended as the tests proceeded, but the propellers were considered to have reached the presently accepted limit of repair at the end of the tests (see Fig.37).
