# Investigation of the Fatigue of Extruded Tubular Booms

ROYAL AIRCRAFT ESTABLISHMENT  
BEDFORD.

Technical Note No. Structures 162

June, 1955

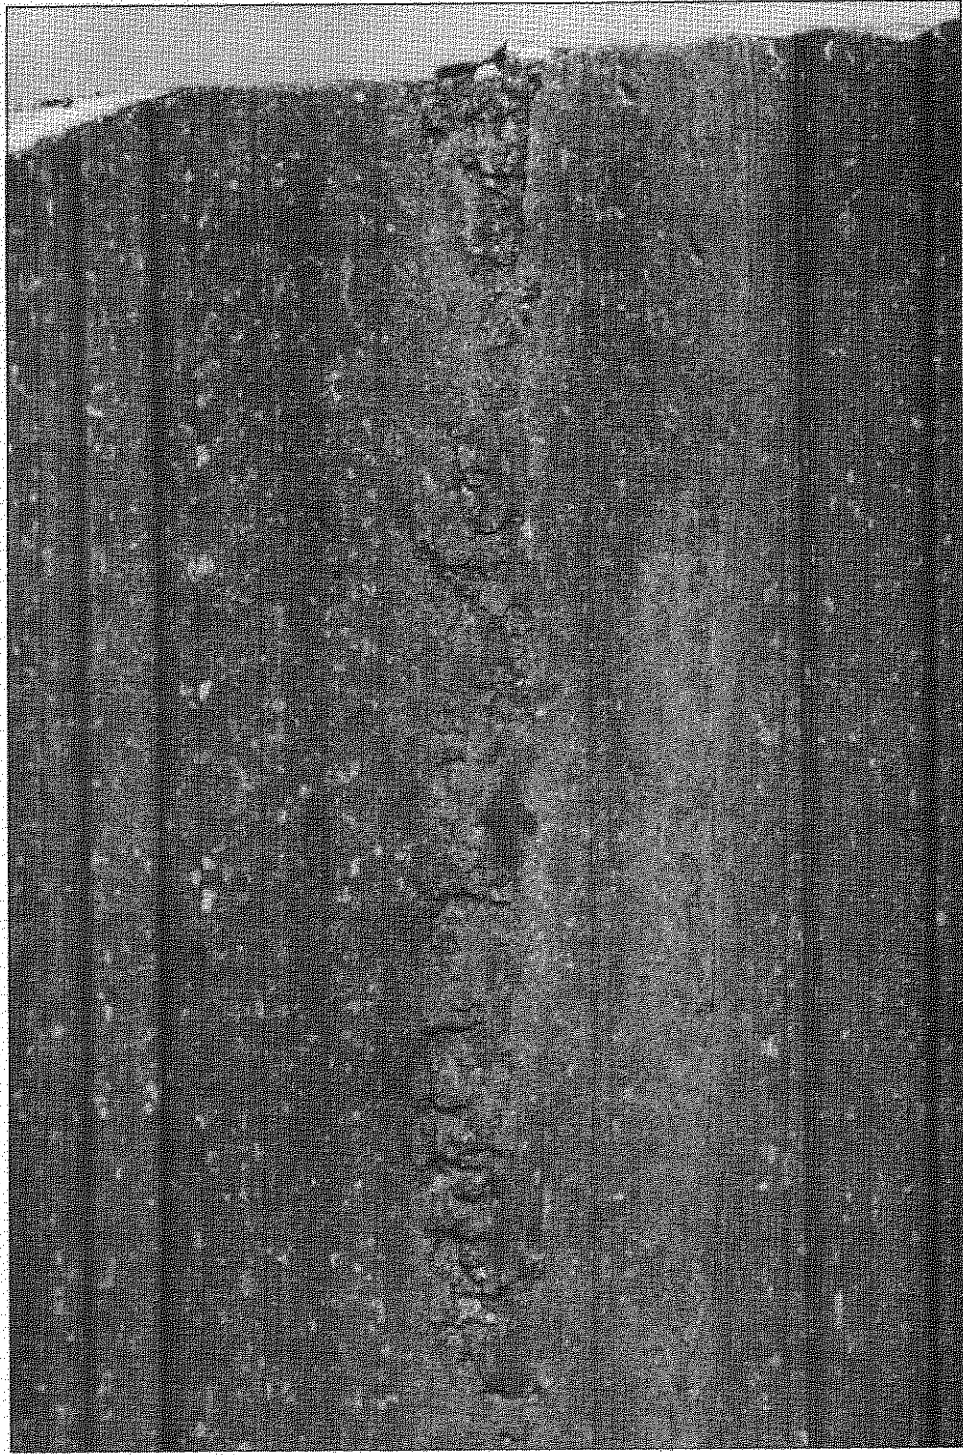
FIG.5. ENLARGED VIEW SHOWING FLAW ON  
INNER SURFACE OF TUBE  
SPAR TUBE NECKED SPECIMENS

On close examination of the specimens it was found that the cracks had started at flaws in the bore of the tube, having the appearance of longitudinal cavities. The interior of the cavities had a very irregular surface. Enlarged photographs of one of these flaws can be seen in Figs. No. 4 and 5.
