Some Fatigue Characteristics of a  
Two Spar Light Alloy Structure  
(Meteor 4 Tailplane)

Report No. Structures 195

January, 1956.

ROYAL AIRCRAFT ESTABLISHMENT

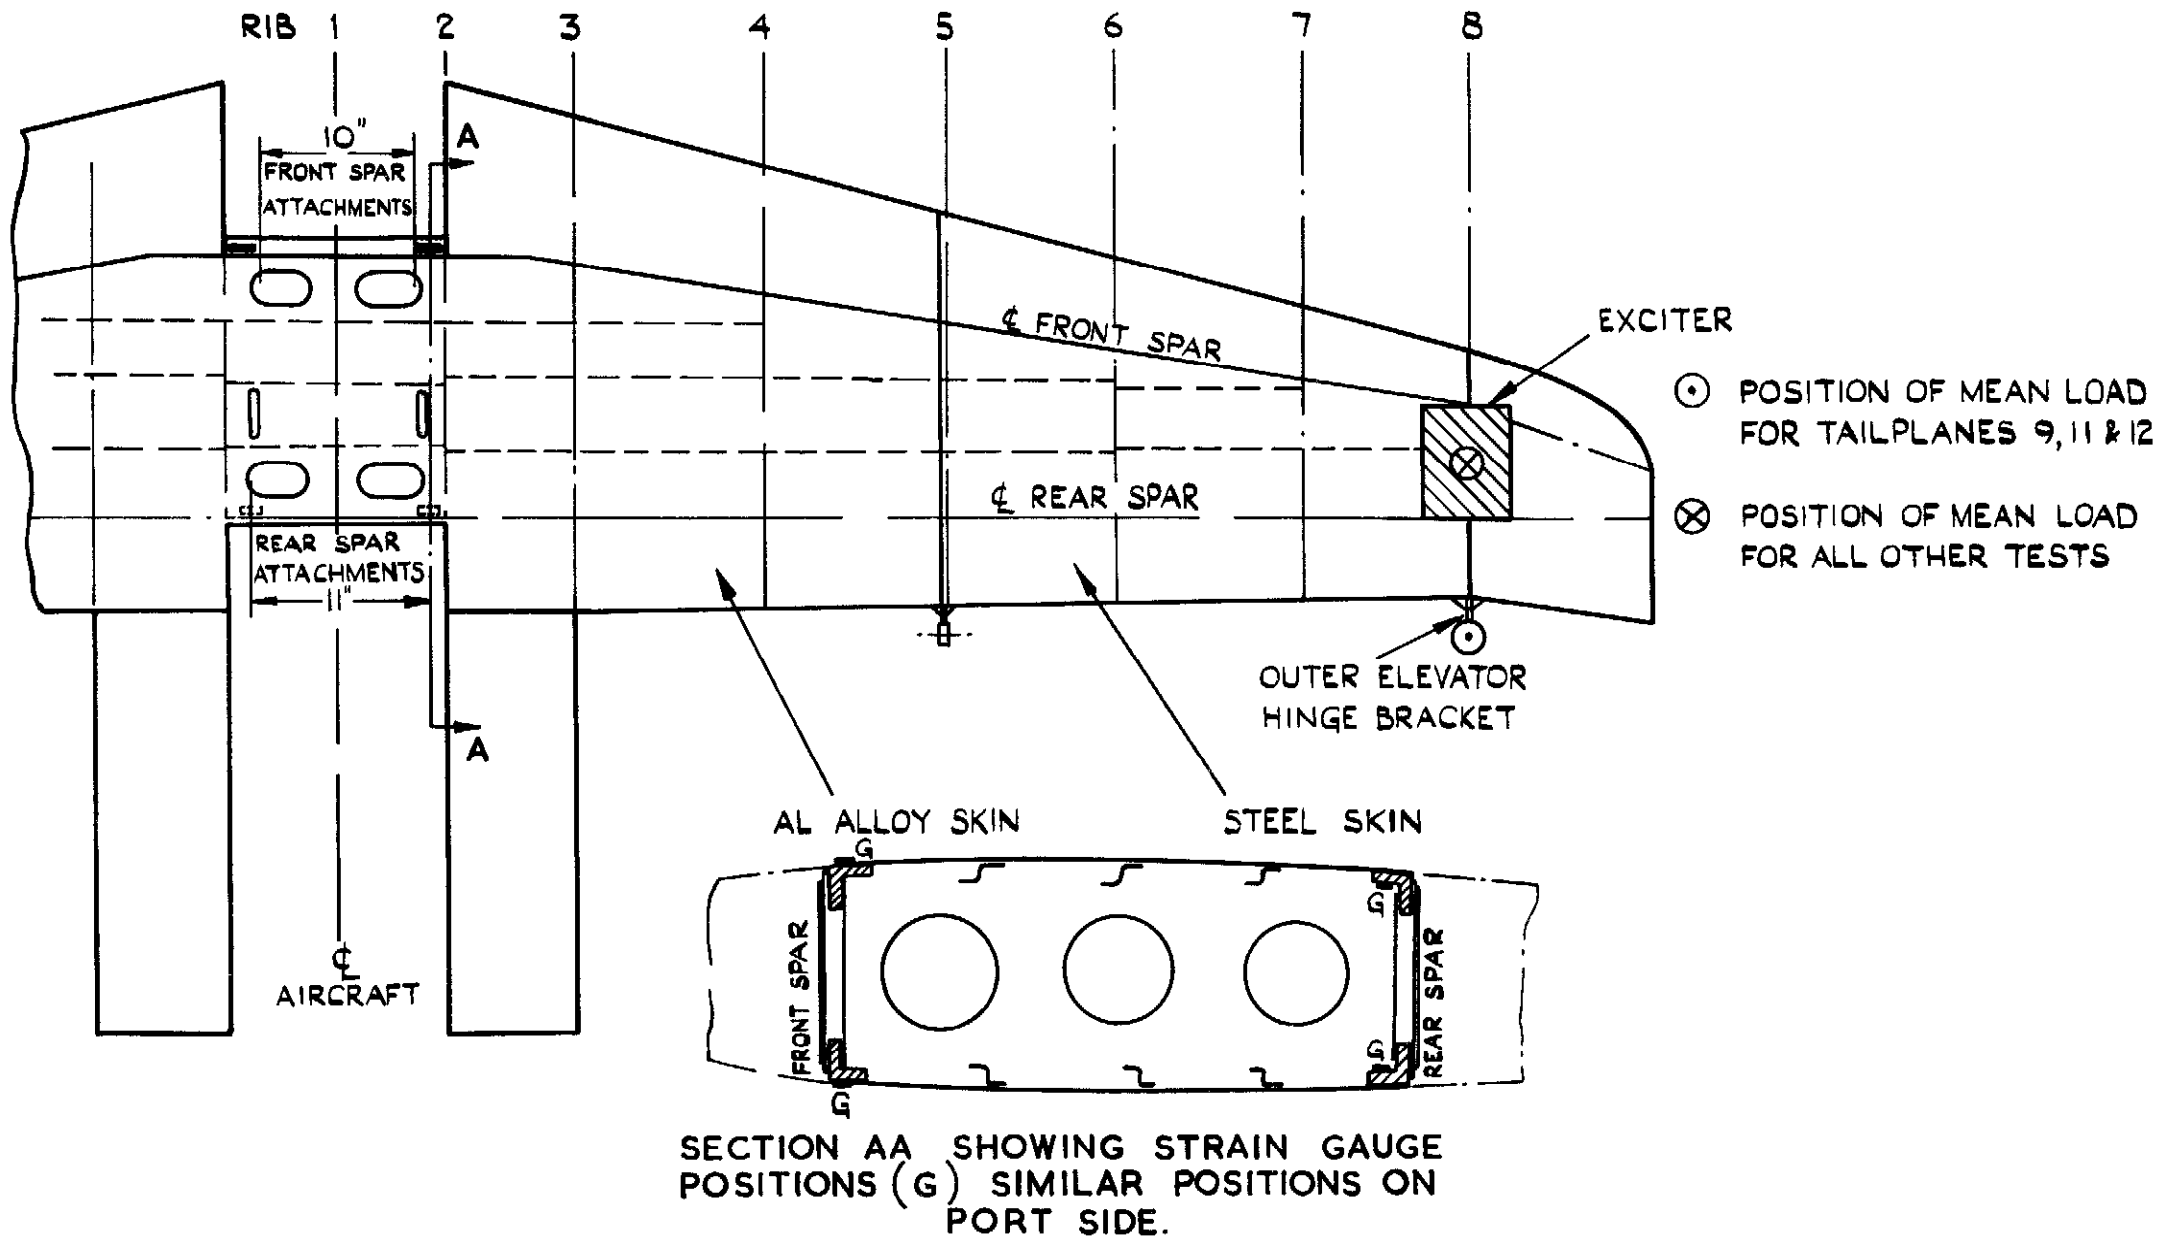
FIG. I. GENERAL ARRANGEMENT OF TEST SPECIMEN.

A general arrangement of a test specimen is shown in Fig.1. The tailplanes used for the tests were selected in small batches from the production line over a period of about a year.

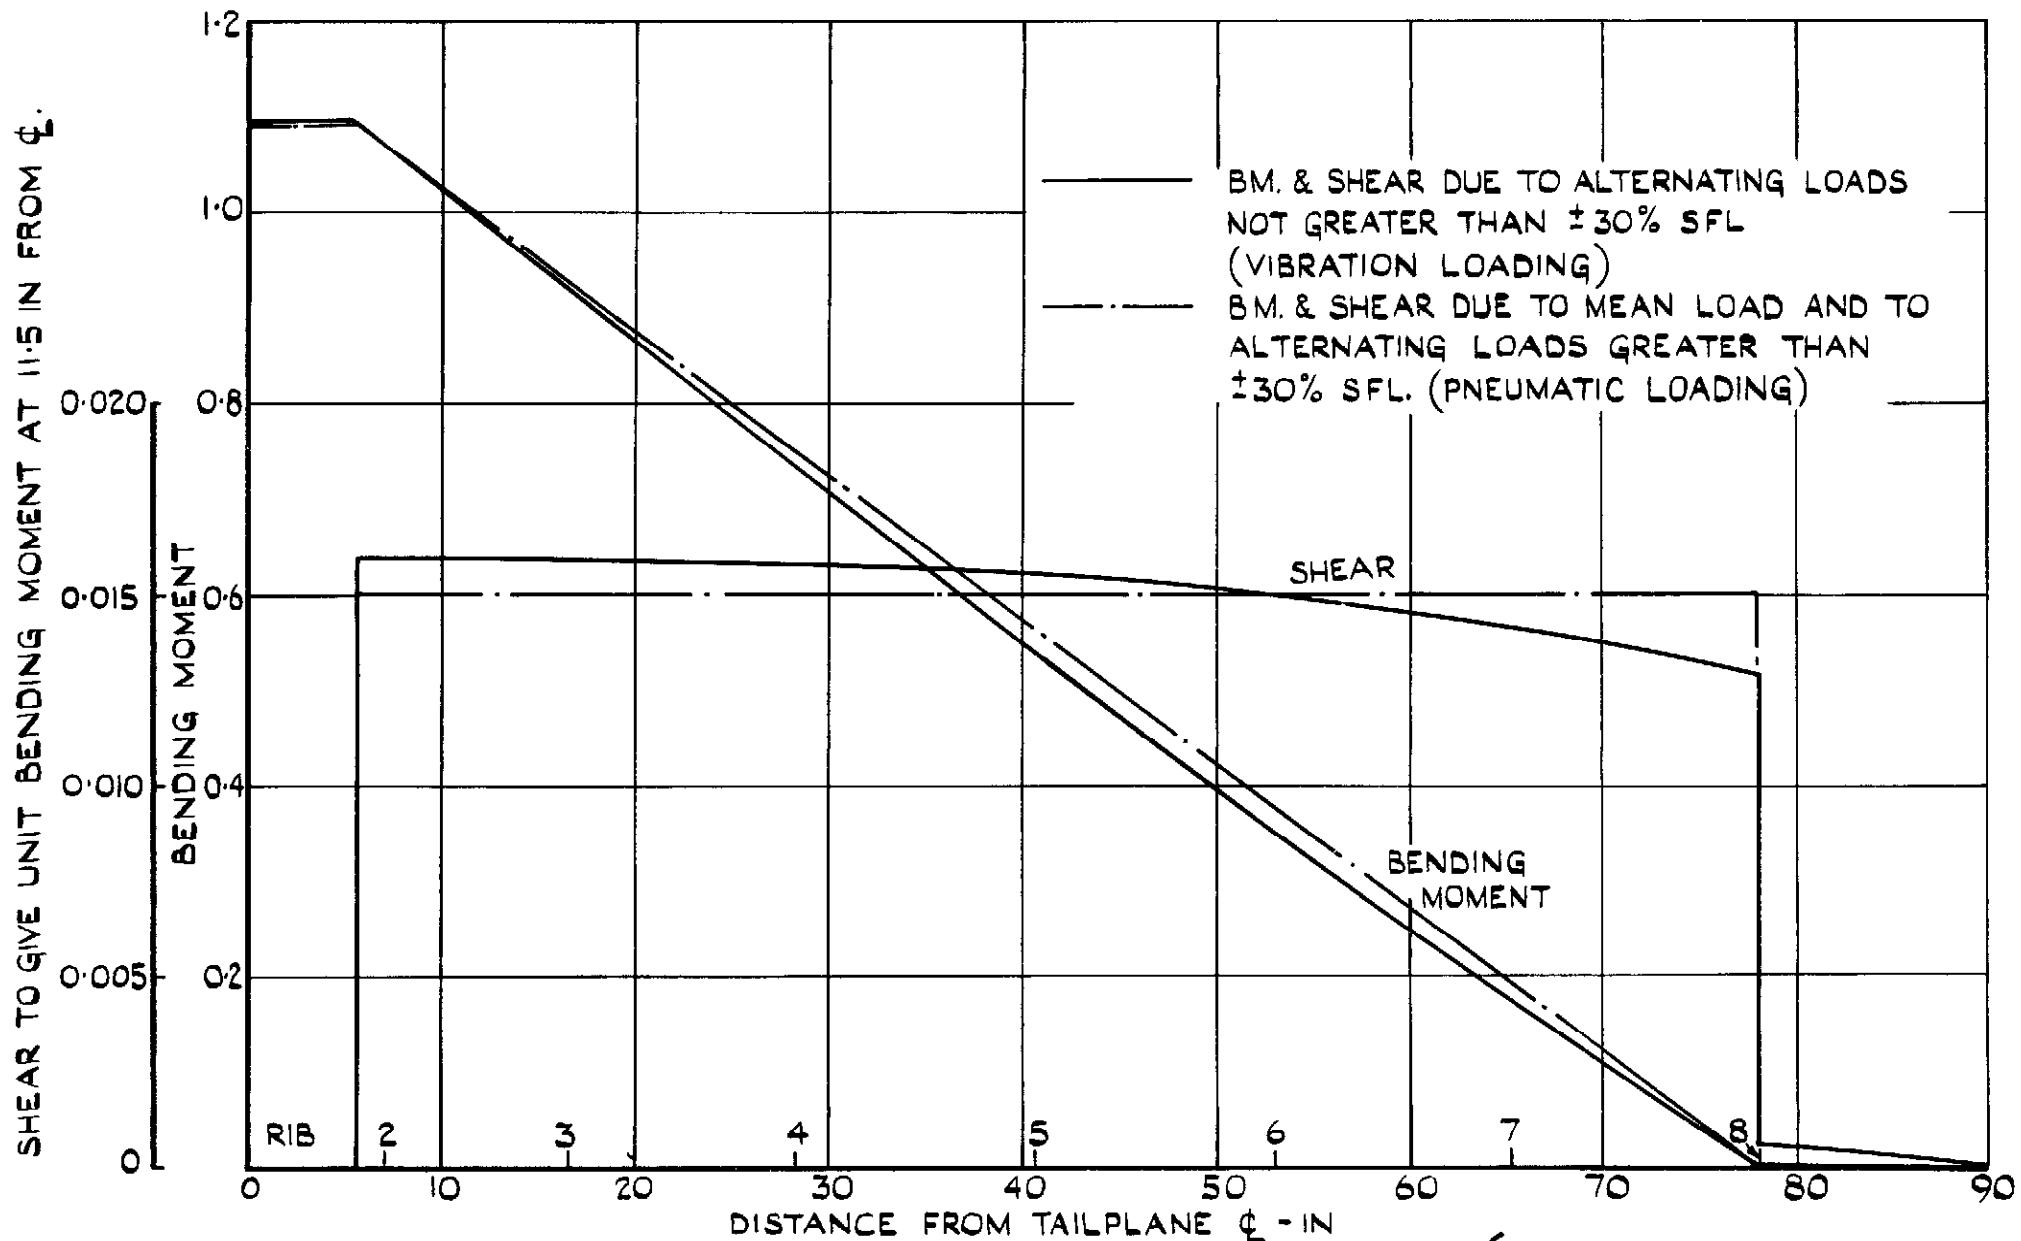
FIG. 2. SHEAR AND BENDING MOMENT CURVES (UNIT B.M. AT 11.5 IN. FROM  $\zeta$ .)

bending moment at failure in static strength tests on three tailplanes<sup>1</sup>. Shear and bending moment curves for both mean and alternating loads are given in Fig.2. Corresponding spar boom stresses at the beginning of the test, calculated from the applied bending moments, are given in Table VII. Except for one series of tests, in which the stress range in the rear spar top boom was kept constant, (Table IV) the loads were kept the same throughout a particular test, irrespective of any change in stiffness or stress distribution. Extensive skin cracking resulted in a considerable increase in the spar boom stresses over an appreciable proportion of the life.

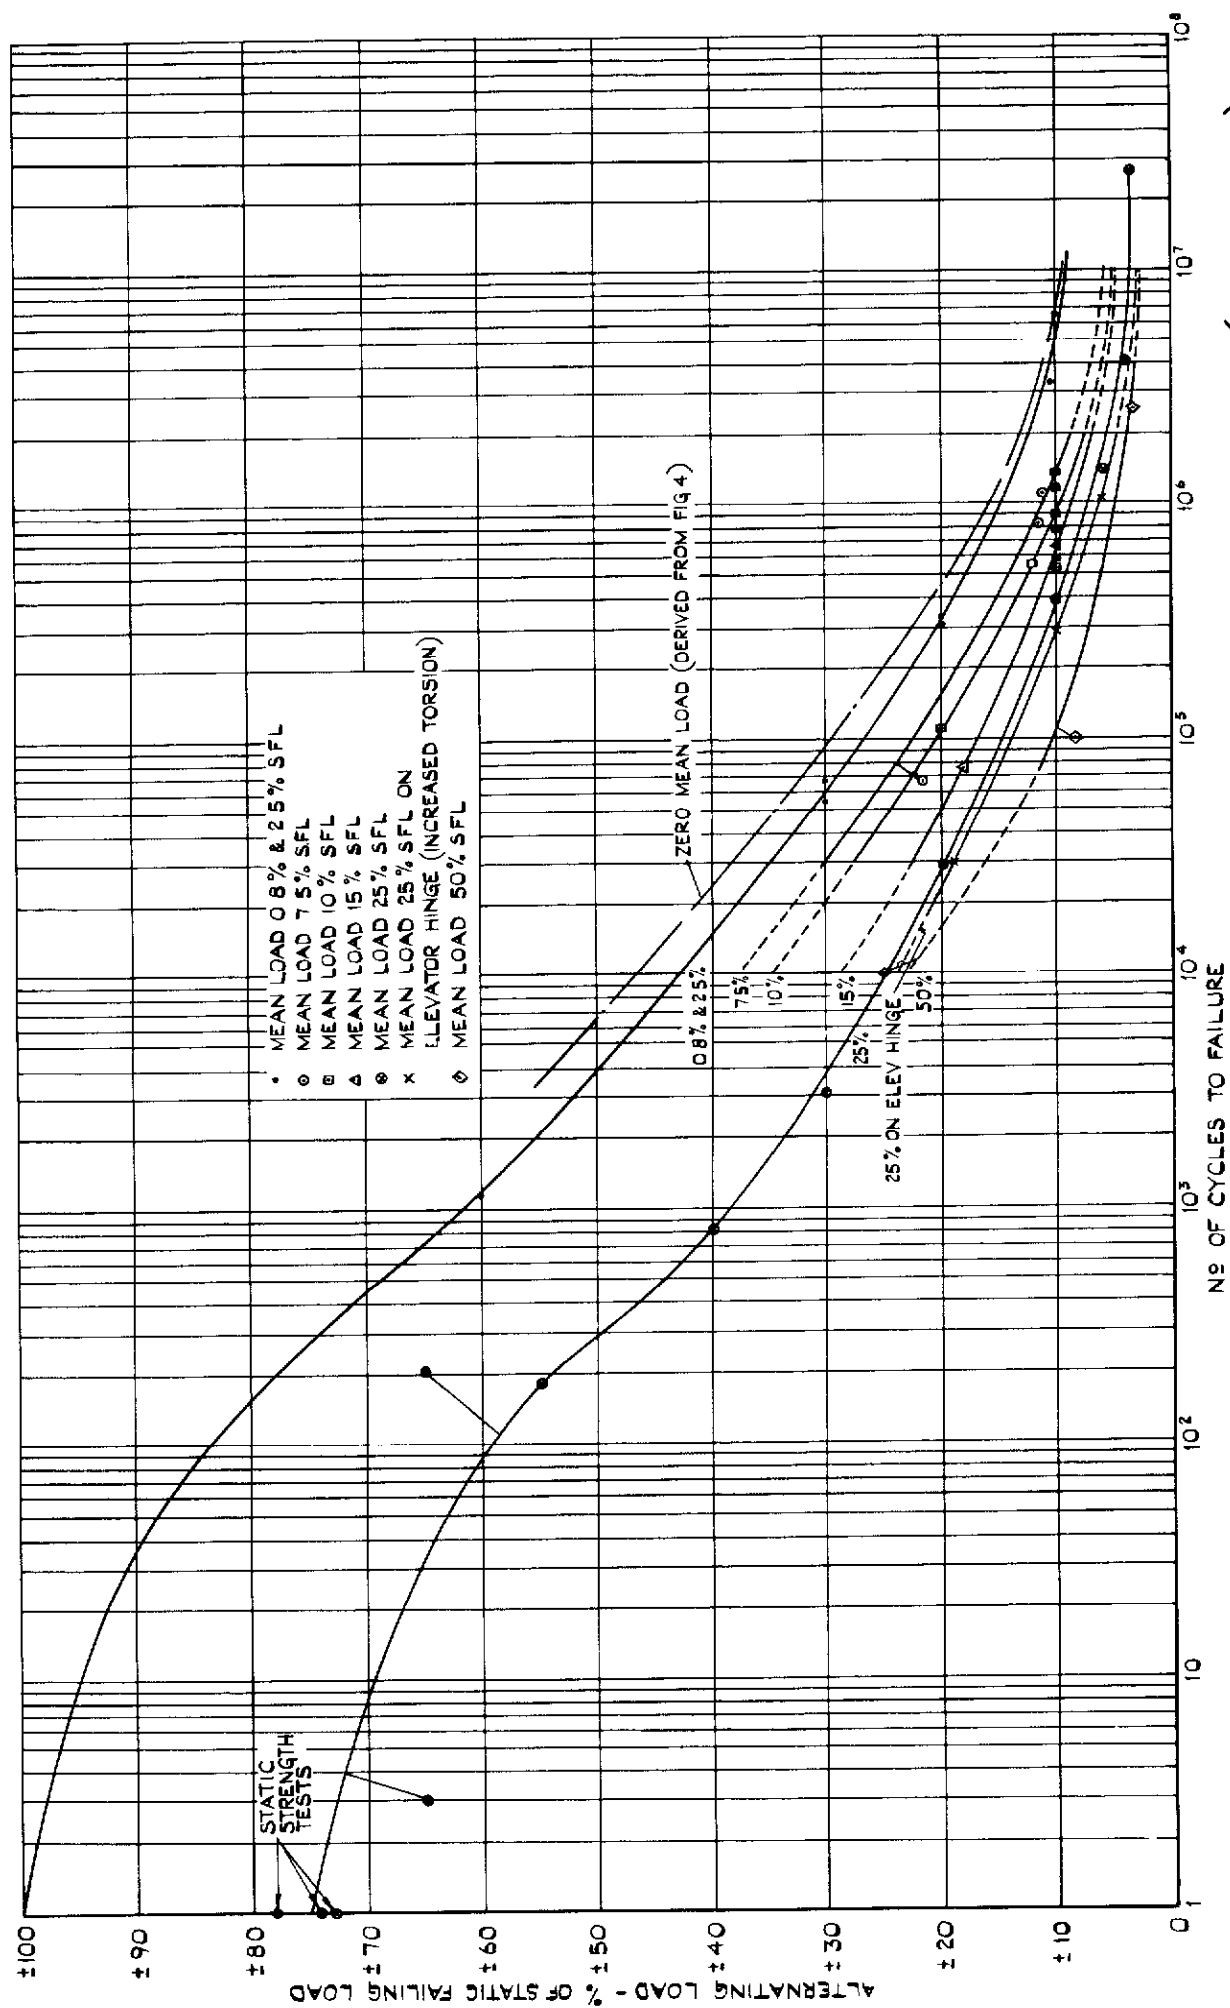
FIG. 3. ENDURANCE CURVES FOR VARIOUS MEAN LOADS (TABLE I.)

The results of each series of tests are given in Tables I to VI and Figs.3 to 9, in which the endurance of the tailplane is given as the number of load cycles to produce failure of one spar boom. In most cases extensive skin cracking developed at an early stage, sometimes starting at only about 1/10 of the total life, with the result that for an appreciable proportion of the life the spar stresses at the point of failure were increased by as much as 40% above the stresses given in Table VII.

In Fig.4 alternating load is plotted against mean load for failure in a given number of cycles, based on the endurance curves of Fig.3. Fig.4 agrees fairly well with the results of Australian tests on Mustang wings.<sup>3</sup> In Fig.12(a) the curves of constant endurance have been replotted in terms of the ratio of fatigue strength at a particular mean load to the fatigue strength at zero mean load, fatigue strength being defined as the alternating load that will cause failure in a given number of cycles at a particular mean load. It will be seen that the fatigue strength drops off very rapidly at small values of mean load.

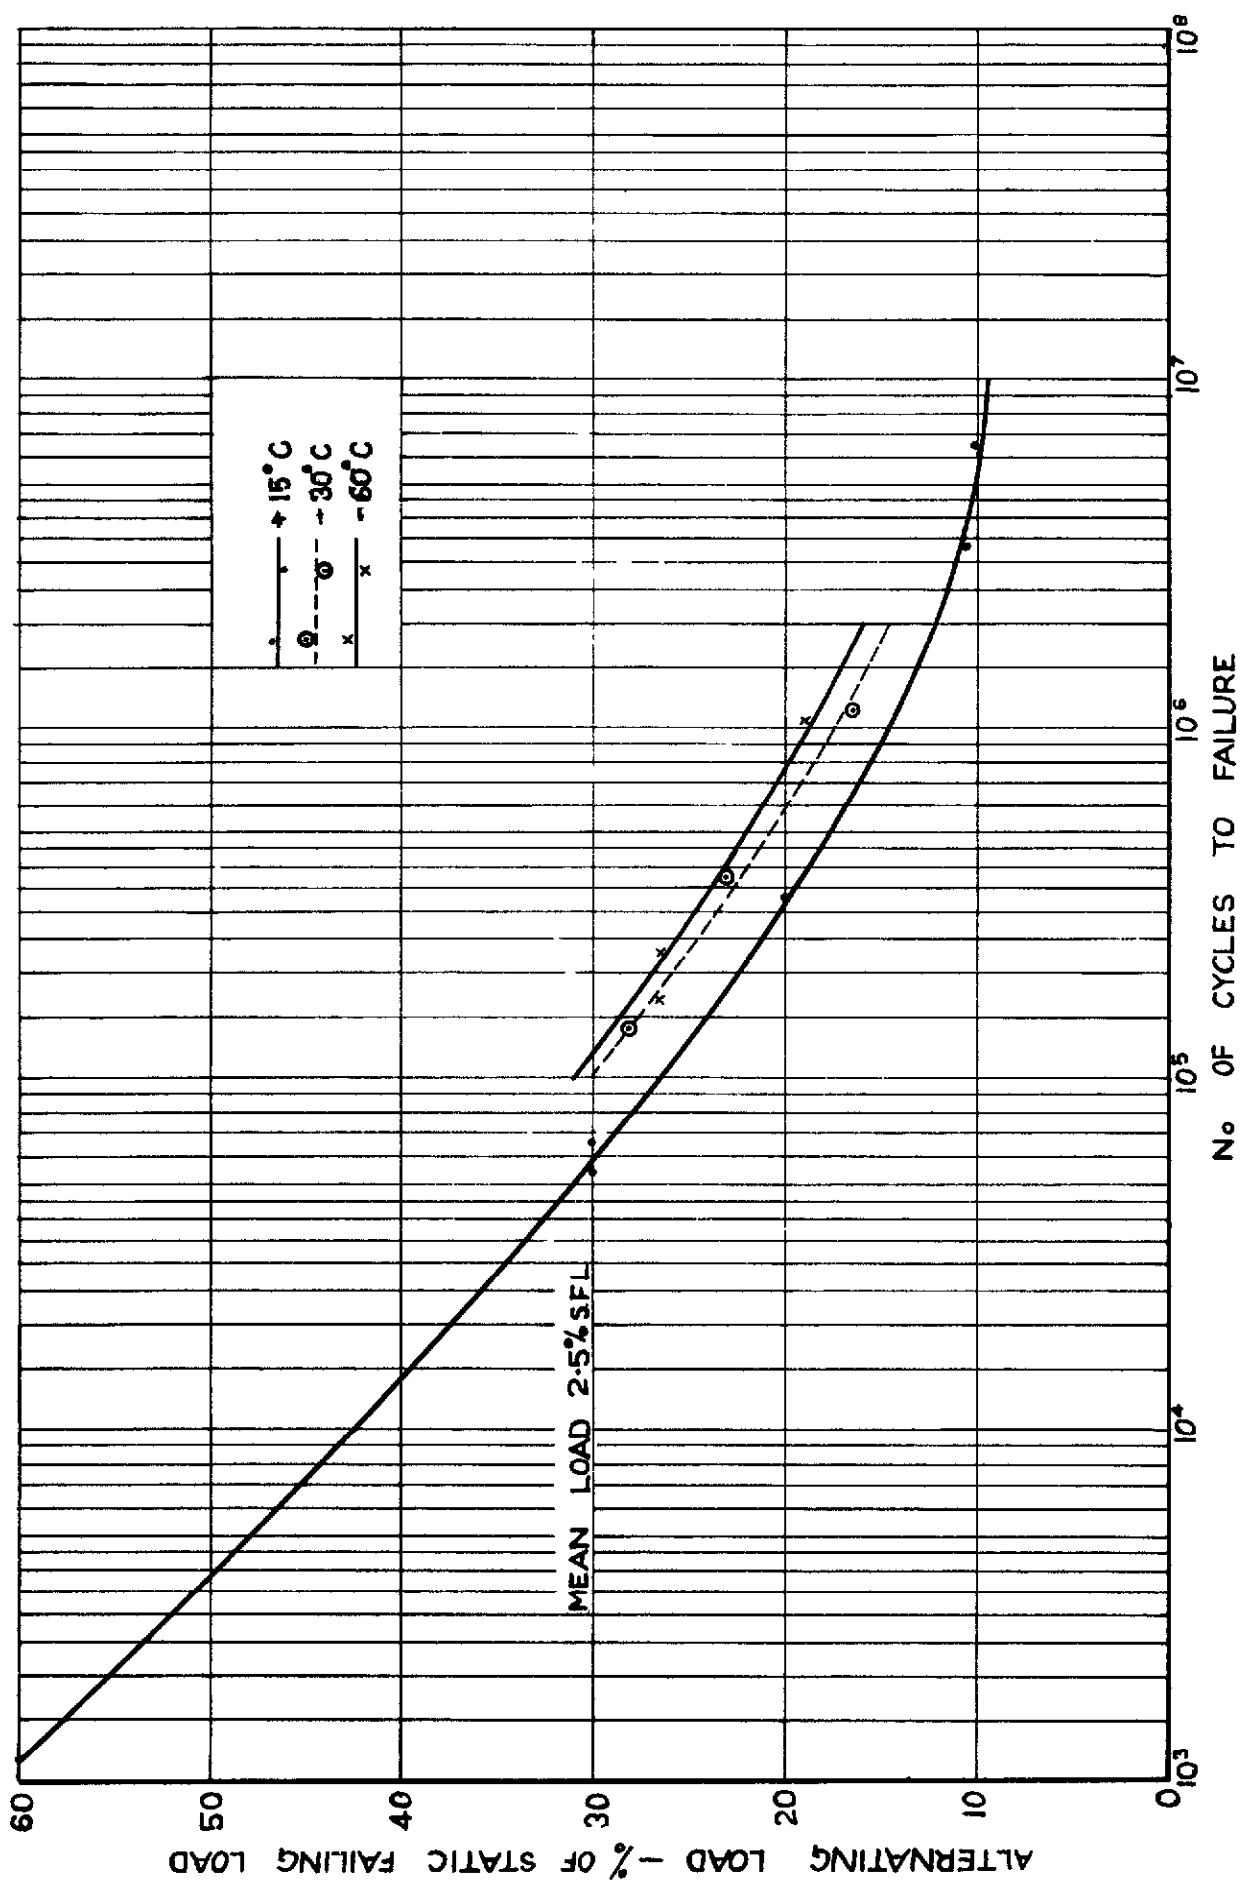
FIG.5. EFFECT OF LOW TEMPERATURES ON ENDURANCE (TABLE II.)

The effects of low temperatures have been dealt with in a previous report<sup>2</sup> but the results are given again in Fig.5. There appears to be a significant increase in endurance with reduction of temperature, the endurance at  $-60^{\circ}\text{C}$  being about twice that at room temperature. It is interesting to note that at  $-60^{\circ}\text{C}$  there appears to be a tendency for several independent cracks to develop in the spar booms before final failure.

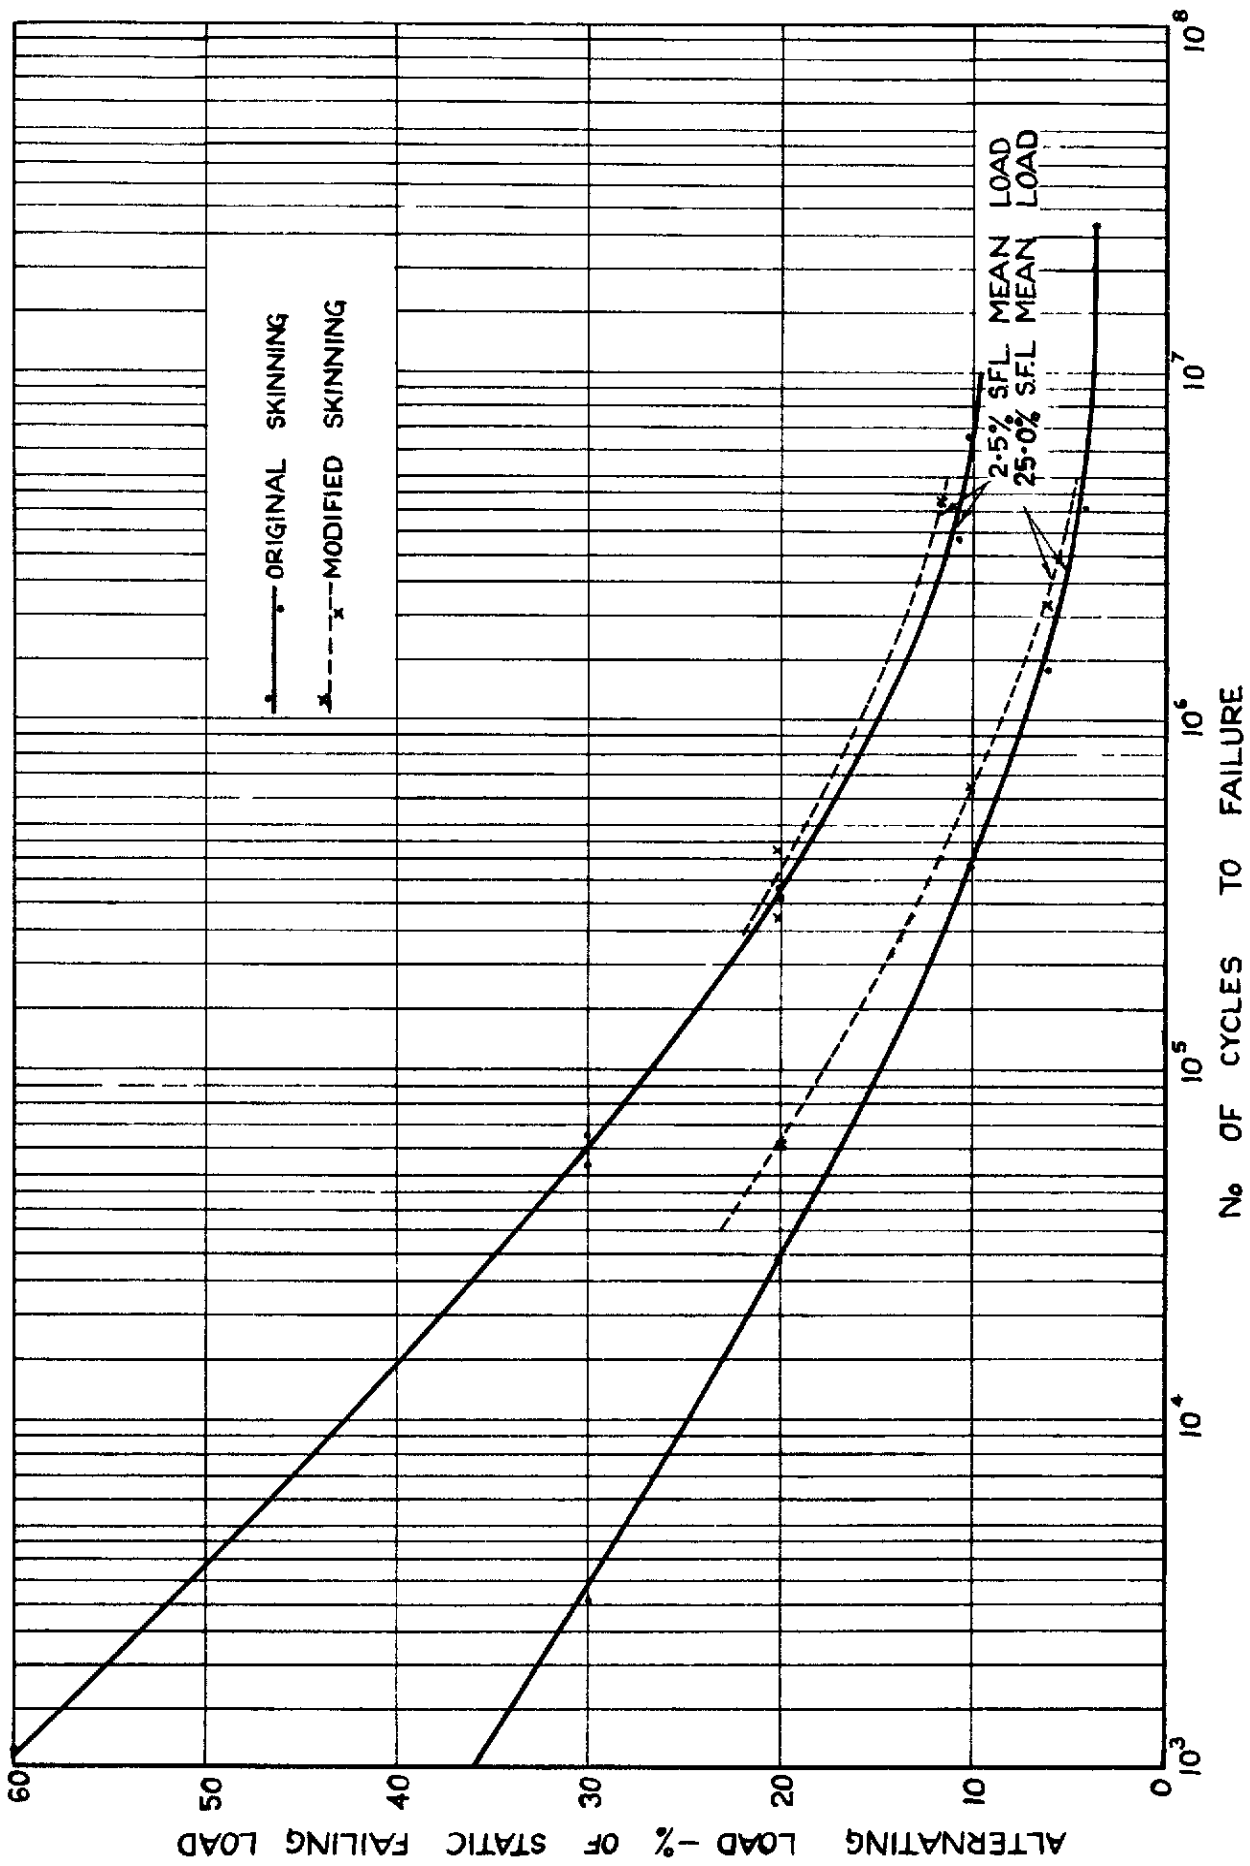
FIG. 6. ENDURANCE CURVES FOR ORIGINAL & MODIFIED TAILPLANES (TABLE III)

The presence of skin cut-outs has an appreciable effect on the endurance because of the increase in spar boom stresses resulting from major skin failures originating from the cut-outs. Tests on tailplanes with modified skinning (Fig.6) were inconclusive, since major skin cracks still developed sufficiently close to the final spar boom failure to have an effect on the spar boom stresses. Tests on standard tailplanes in which the range of stress in the rear spar tension boom was kept constant were insufficient in number to be conclusive, but they indicated an increase in endurance of between three and four times for a mean load of 25% of the static failing load. (Fig.7).

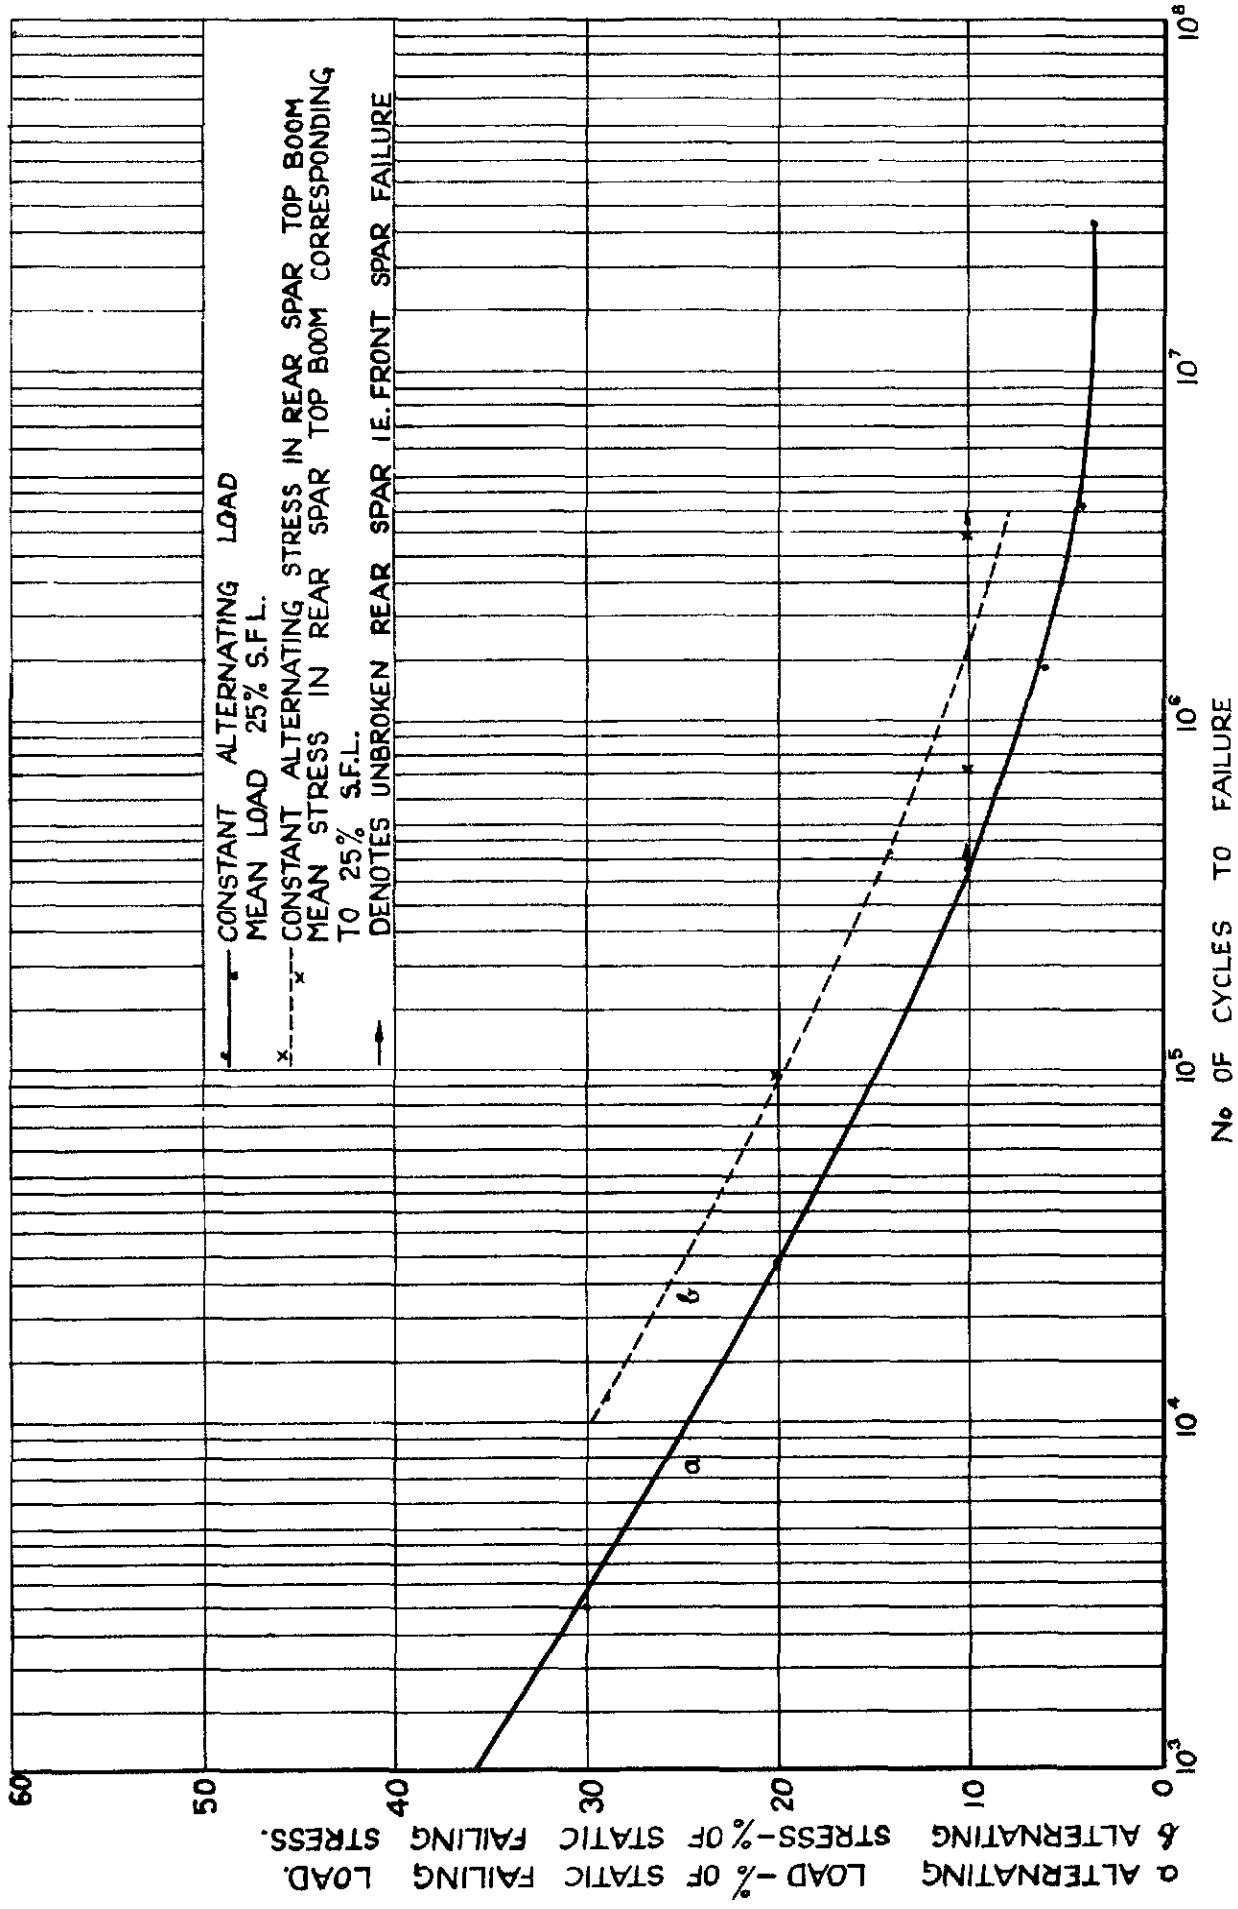
FIG. 7. ENDURANCE CURVES FOR 'CONSTANT LOAD' AND 'CONSTANT STRESS' TESTS. (TABLE IV)

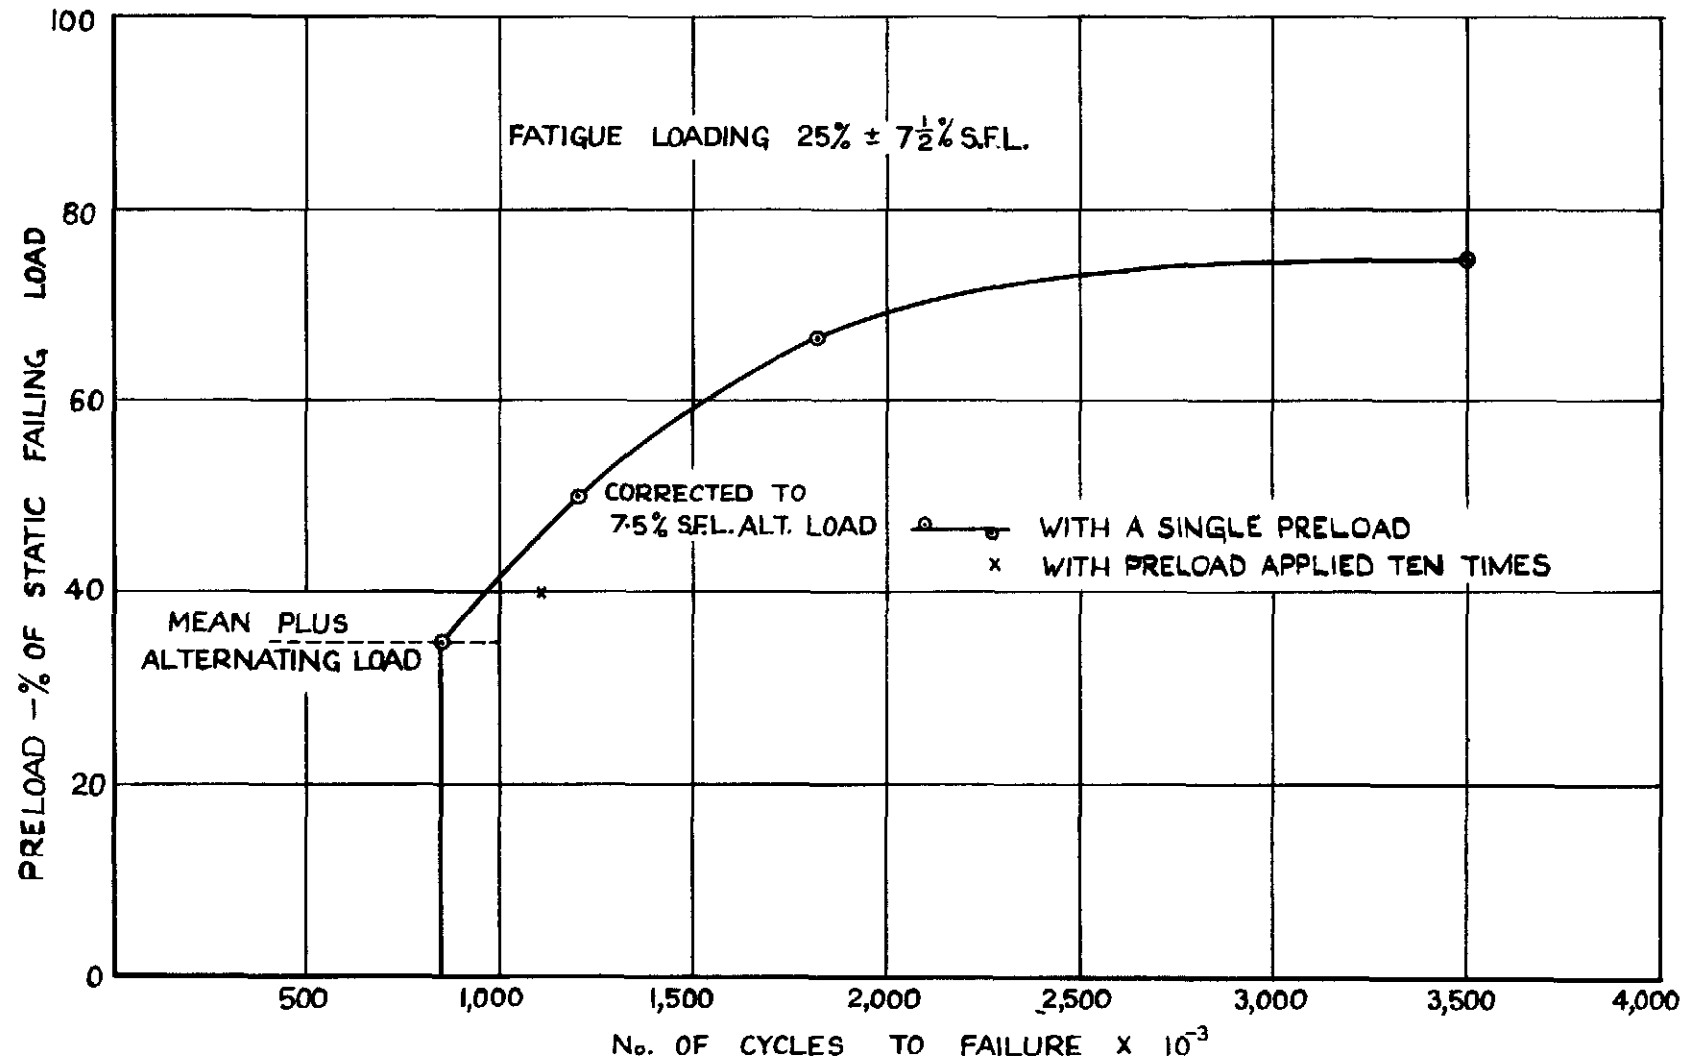
FIG. 8. EFFECT OF PRELOADING ON ENDURANCE (TABLE V.)

A single overload applied in the same sense as the mean load gives an appreciable increase in endurance under a fatigue loading of  $25\% \pm 7.5\%$  of the static failing load as shown by Fig.8, the increase being about four times for a preload of 75% of the static failing load. This effect may be partly due to delay in the development of skin cracks.

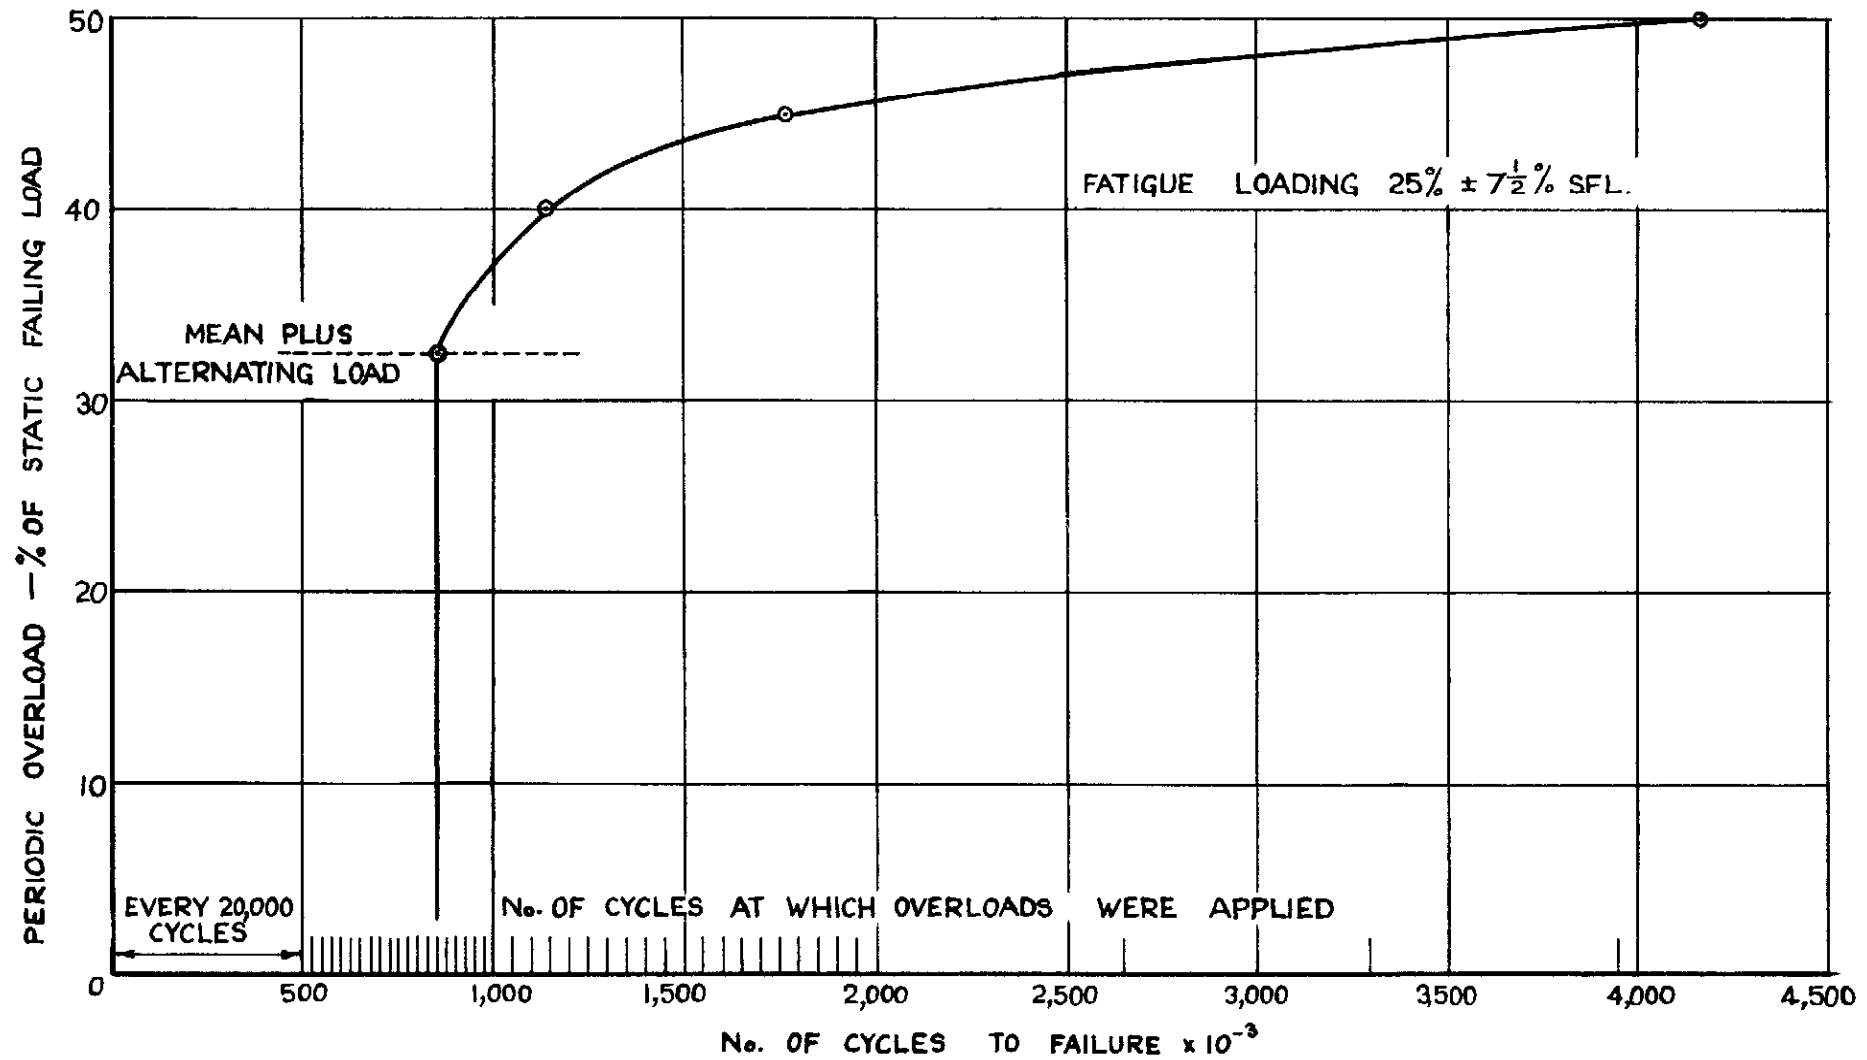
FIG. 9. EFFECT OF PERIODIC OVERLOADING ON ENDURANCE (TABLE VI.)

The effect of periodic overloading is to give a marked increase in endurance under a fatigue loading of  $25\% \pm 7.5\%$  of the static failing load as shown by Fig.9. An overload of 50% of the static failing load, applied periodically as indicated in Table VI, increases the endurance about five times, compared with about  $1\frac{1}{2}$  times for a single preload. Again, this increase may be partly due to delay in the initiation and slower propagation of the skin cracks.

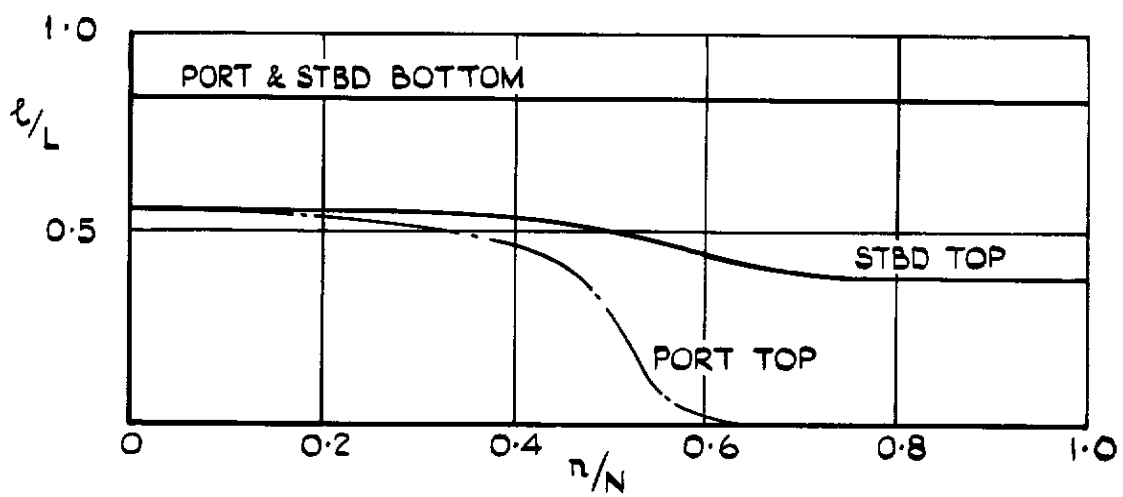
$l$  = EFFECTIVE WIDTH OF SKIN AFTER  $n$  CYCLES  
 $L$  = DISTANCE BETWEEN SPARS.  
 $N$  = NO OF CYCLES TO FAILURE OF SPAR BOOM

**FIG. 10. DEVELOPMENT OF SKIN CRACKS AT RIB 2. (TAILPLANE No. 22.)**

The effect of skin cracking on spar stresses is illustrated in Figs.10 and 11. In Fig.10 the effective width of skin, expressed as a proportion of the distance between the spars, is plotted against number of cycles; corresponding changes in spar boom stress are given in Fig.11. The actual skin failures and their relation to the final spar boom failure are shown in Fig.15. The increase in stress applies to both mean and alternating stress in the booms. Most of the major skin failures originated from unreinforced cut outs, although some originated from rivet holes. Skin cracks in the compression surface originated from local buckling of the skin where stringers were discontinuous across ribs.

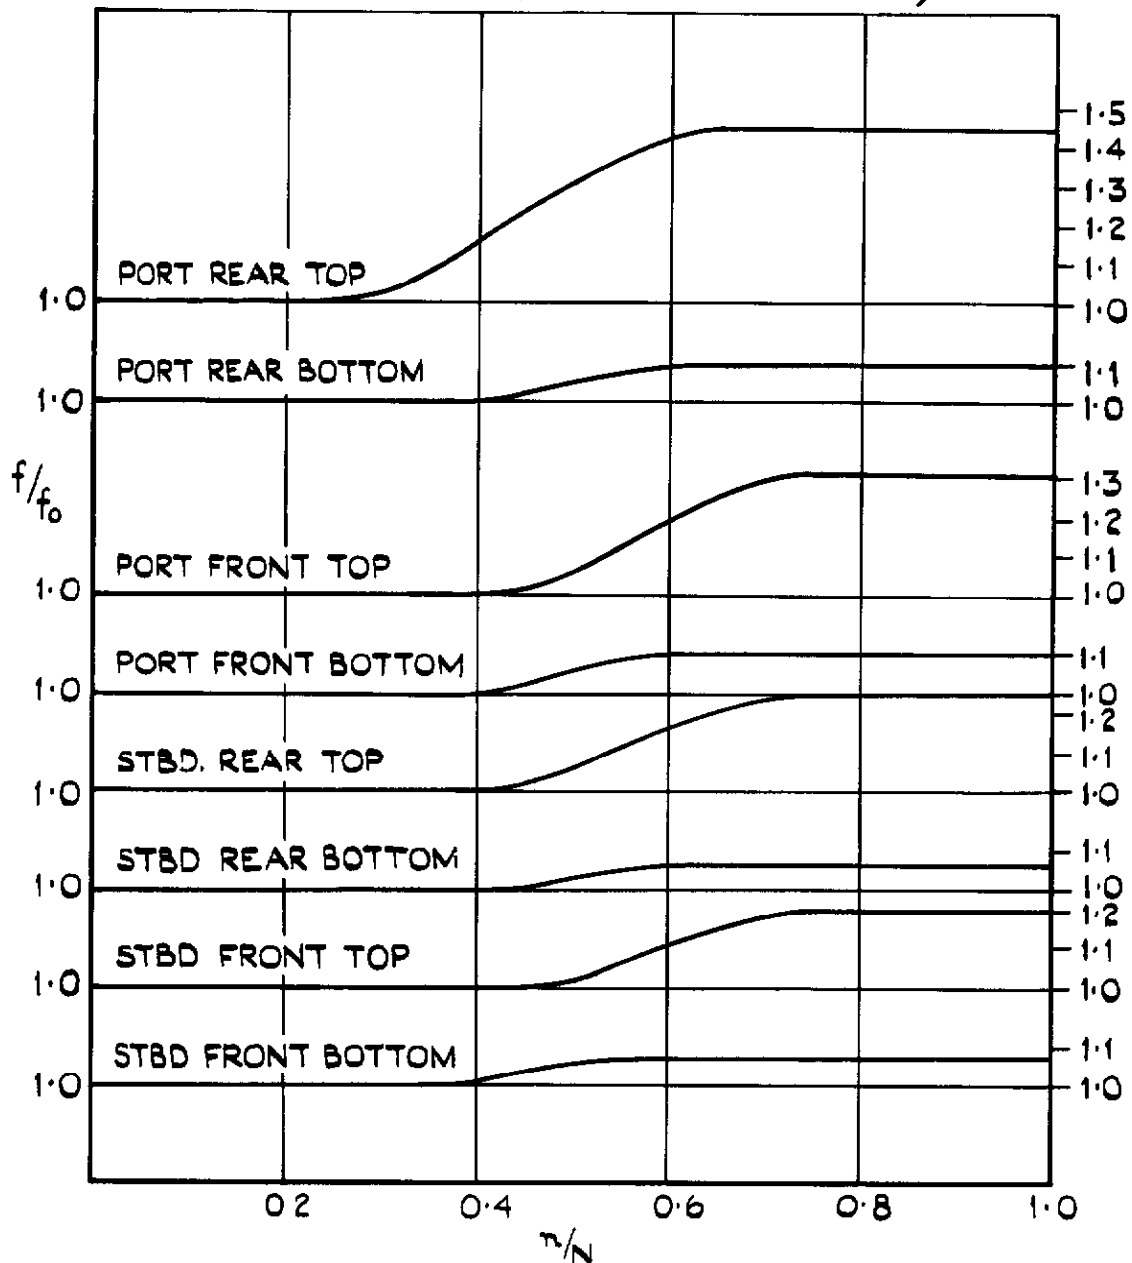
$f$  = SPAR BOOM STRESS AFTER  $n$  CYCLES.  
 $f_0$  = SPAR BOOM STRESS AT BEGINNING OF TEST.

**FIG. 11. VARIATION OF SPAR BOOM STRESSES WITH NO. OF CYCLES AT RIB 2. (TAILPLANE No. 22.)**
