Some Fatigue Characteristics of a  
Two Spar Light Alloy Structure  
(Meteor 4 Tailplane)

Report No. Structures 195

January, 1956.

ROYAL AIRCRAFT ESTABLISHMENT

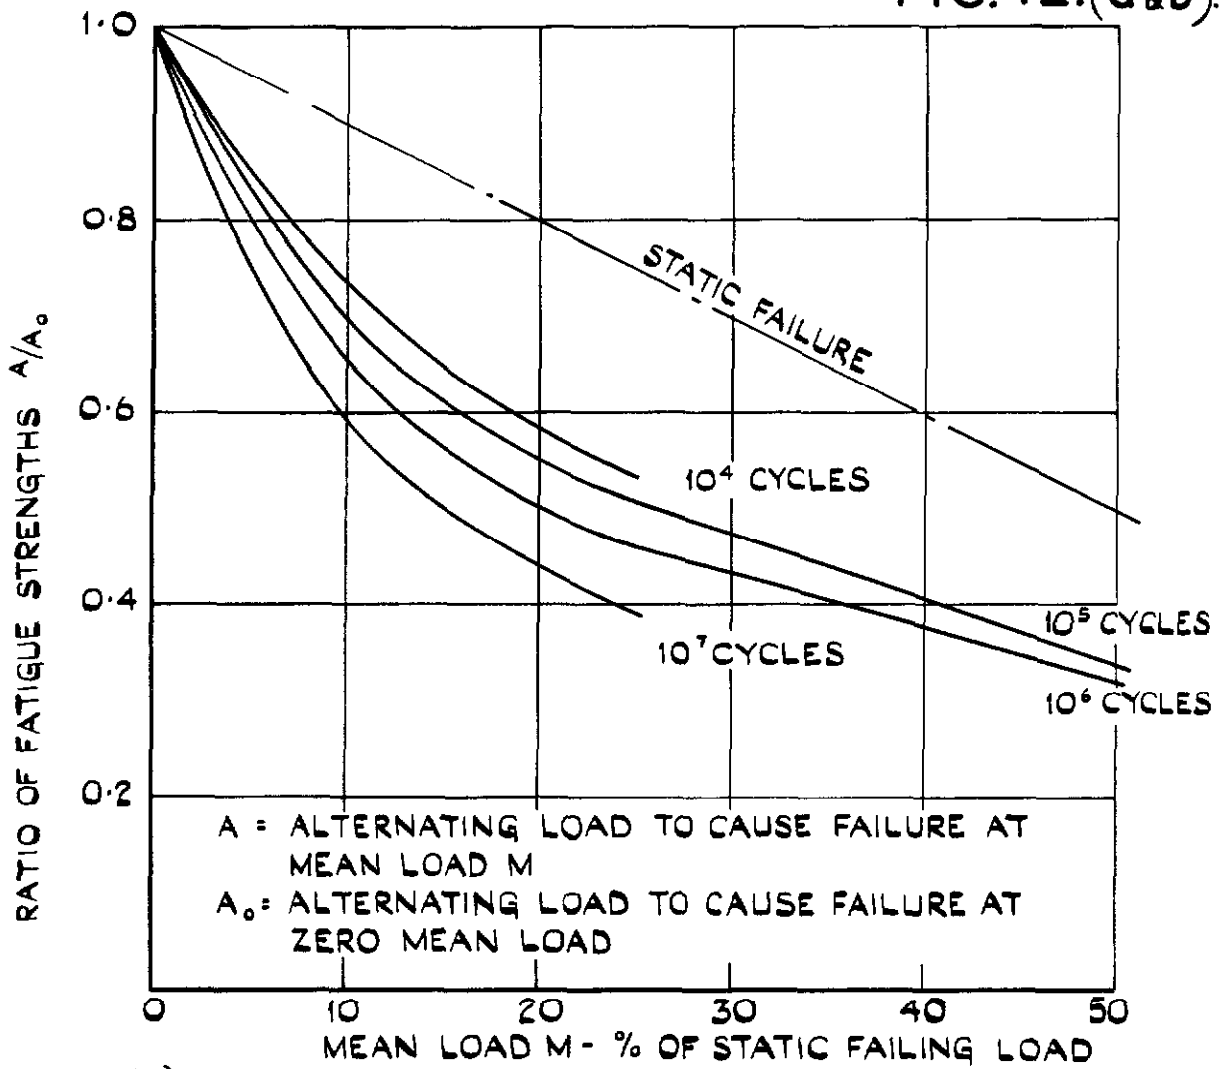
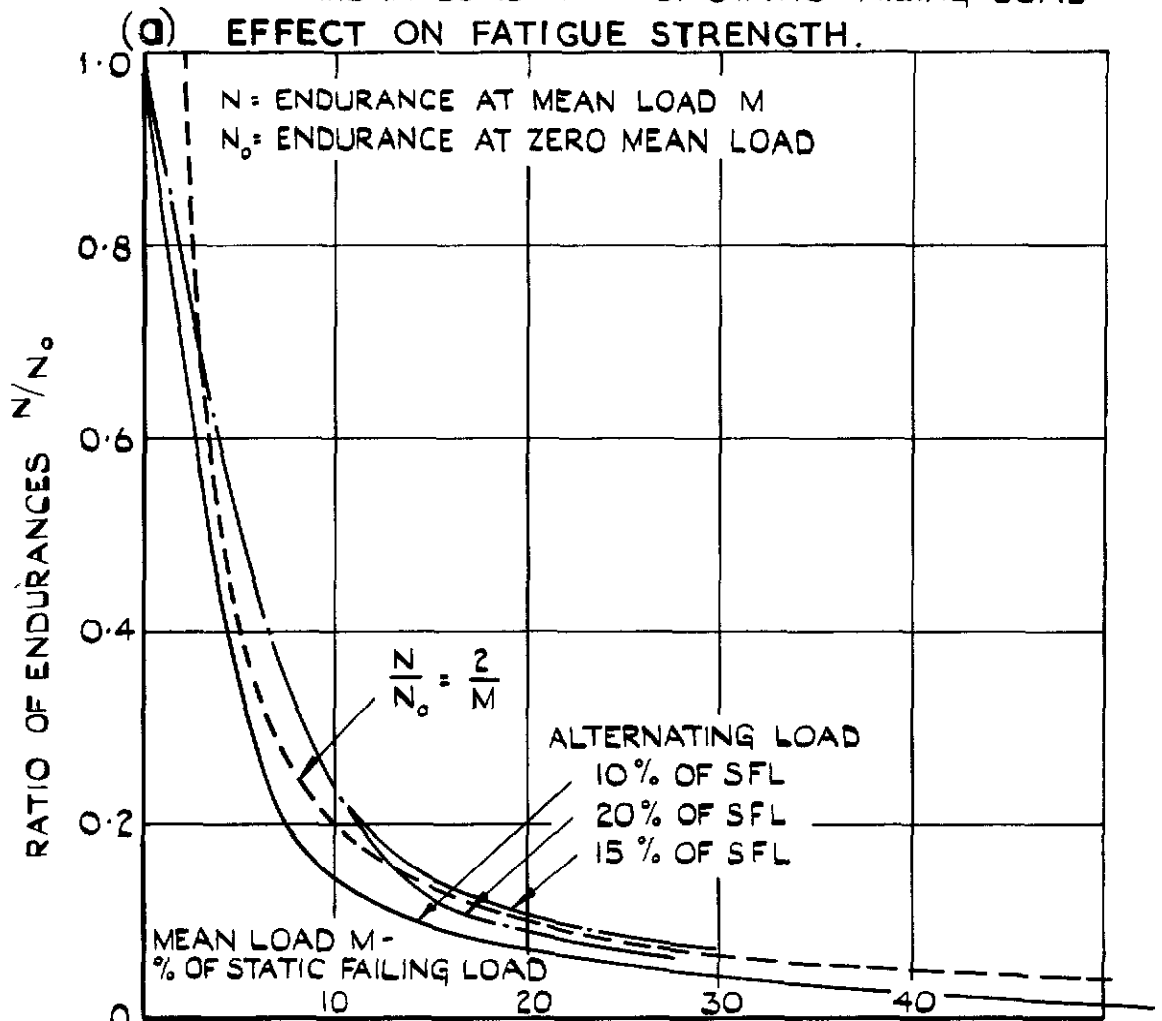
FIG. 12.(a&b).

(b) EFFECT ON ENDURANCE.

FIG.12 (a&b) EFFECTS OF MEAN LOAD ON FATIGUE STRENGTH AND ENDURANCE.

In Fig.4 alternating load is plotted against mean load for failure in a given number of cycles, based on the endurance curves of Fig.3. Fig.4 agrees fairly well with the results of Australian tests on Mustang wings.<sup>3</sup> In Fig.12(a) the curves of constant endurance have been replotted in terms of the ratio of fatigue strength at a particular mean load to the fatigue strength at zero mean load, fatigue strength being defined as the alternating load that will cause failure in a given number of cycles at a particular mean load. It will be seen that the fatigue strength drops off very rapidly at small values of mean load.

In Fig.12(b) the effect of mean load on endurance under a particular alternating load is shown. Over most of the range the endurance is roughly inversely proportional to the mean load.

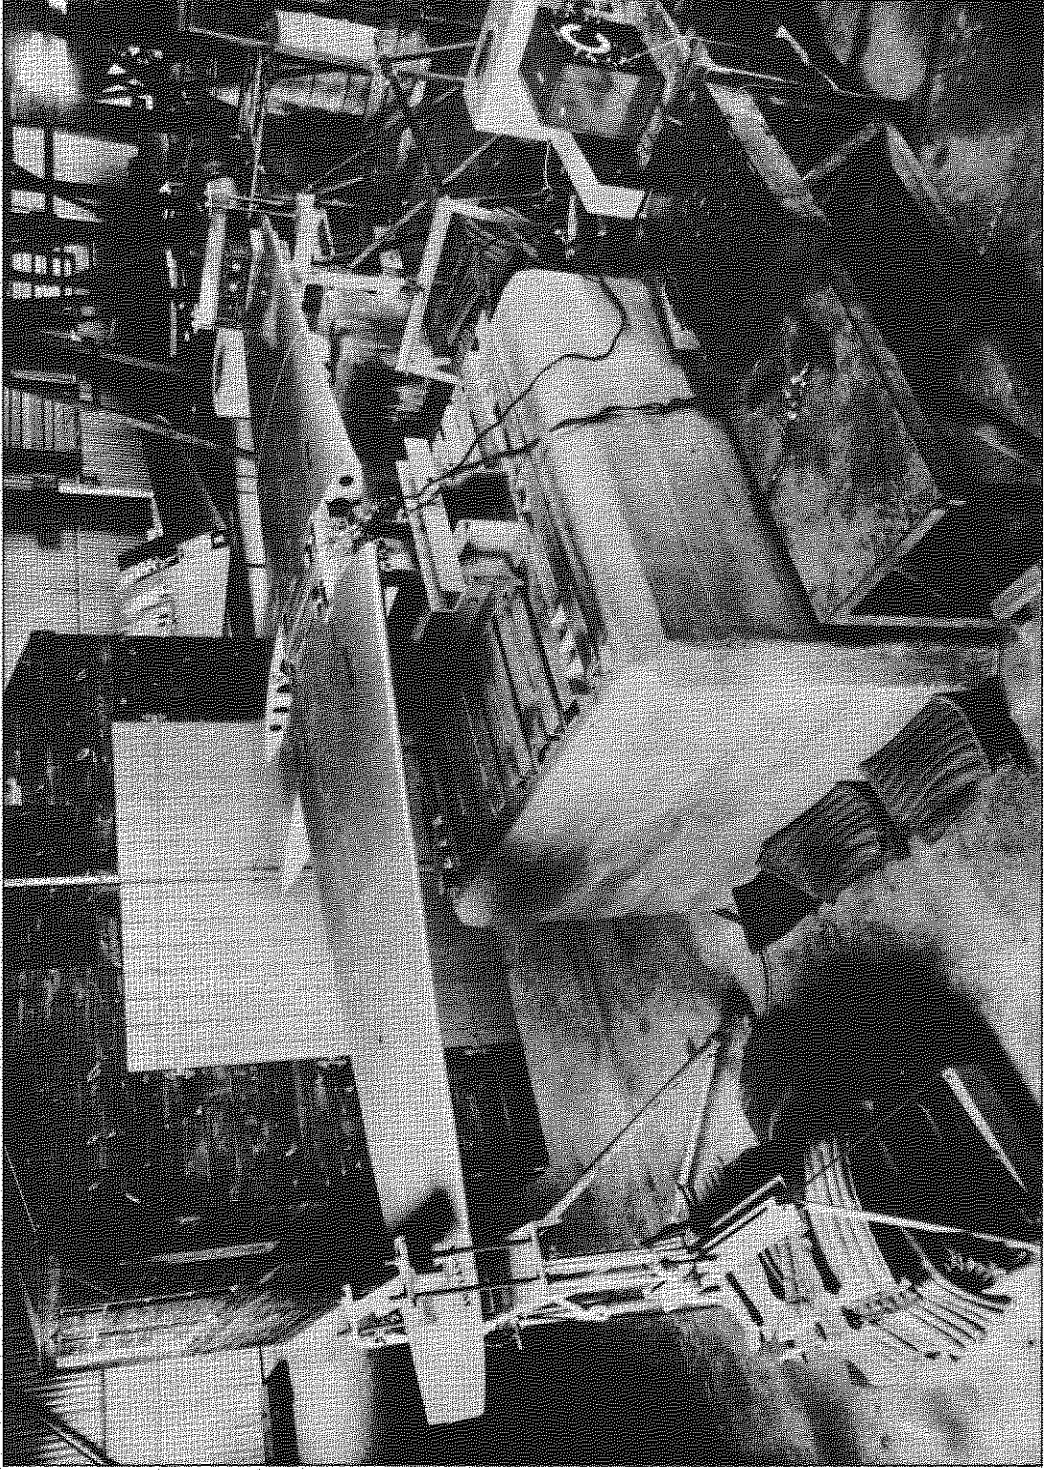
FIG.13. GENERAL VIEW OF TAILPLANE IN VIBRATION TEST RIG

For tests at low alternating loads the resonance method was used, load being applied by means of a rotating mass exciter as described in Ref.1. The mean load was applied at rib 8, near each tip, by dead load suspended through rubber shock absorber cord. The length of rubber cord was such that the natural frequency of the mean load system was about 1 c.p.s., compared with the tailplane frequency of about 12 c.p.s. Strain gauges on the spar booms were used to measure the alternating load, the gauges having first been calibrated by applying dead load to the tailplane at rib 8. A general view of a tailplane under test, showing the method of applying the mean load is given in Fig.13.

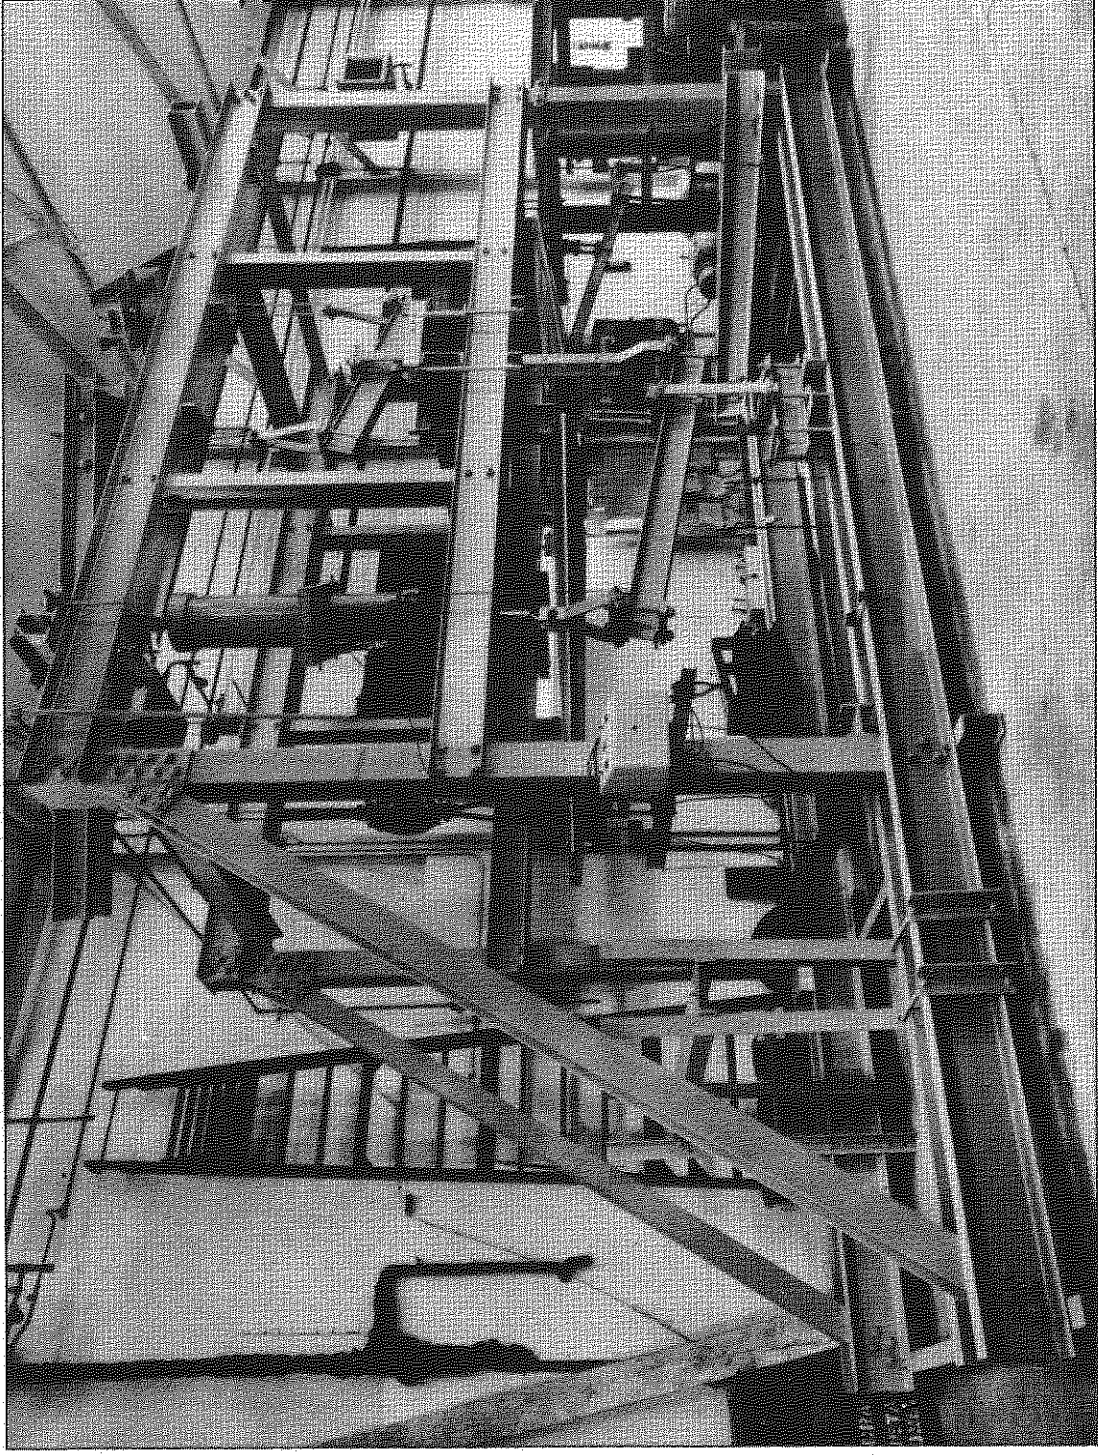
FIG.14. TAILPLANE IN PNEUMATIC TEST RIG

For tests at alternating loads greater than 30% of the static failing load the tailplane was mounted inverted in a test frame and load was applied at rib 8. The minimum load (i.e. mean load minus alternating load) was first applied through a shot-bag loaded link and lever system. A repeated up load, varying from zero to the maximum (i.e. mean plus alternating), was then applied by means of a pneumatic jack connected through levers and wire cables to the tailplane. The jack was controlled by electrical relays operated by the pointer of a spring balance used to measure the load on the tailplane. A general view of a tailplane in the test rig is given in Fig.14 (taken after failure of the specimen).

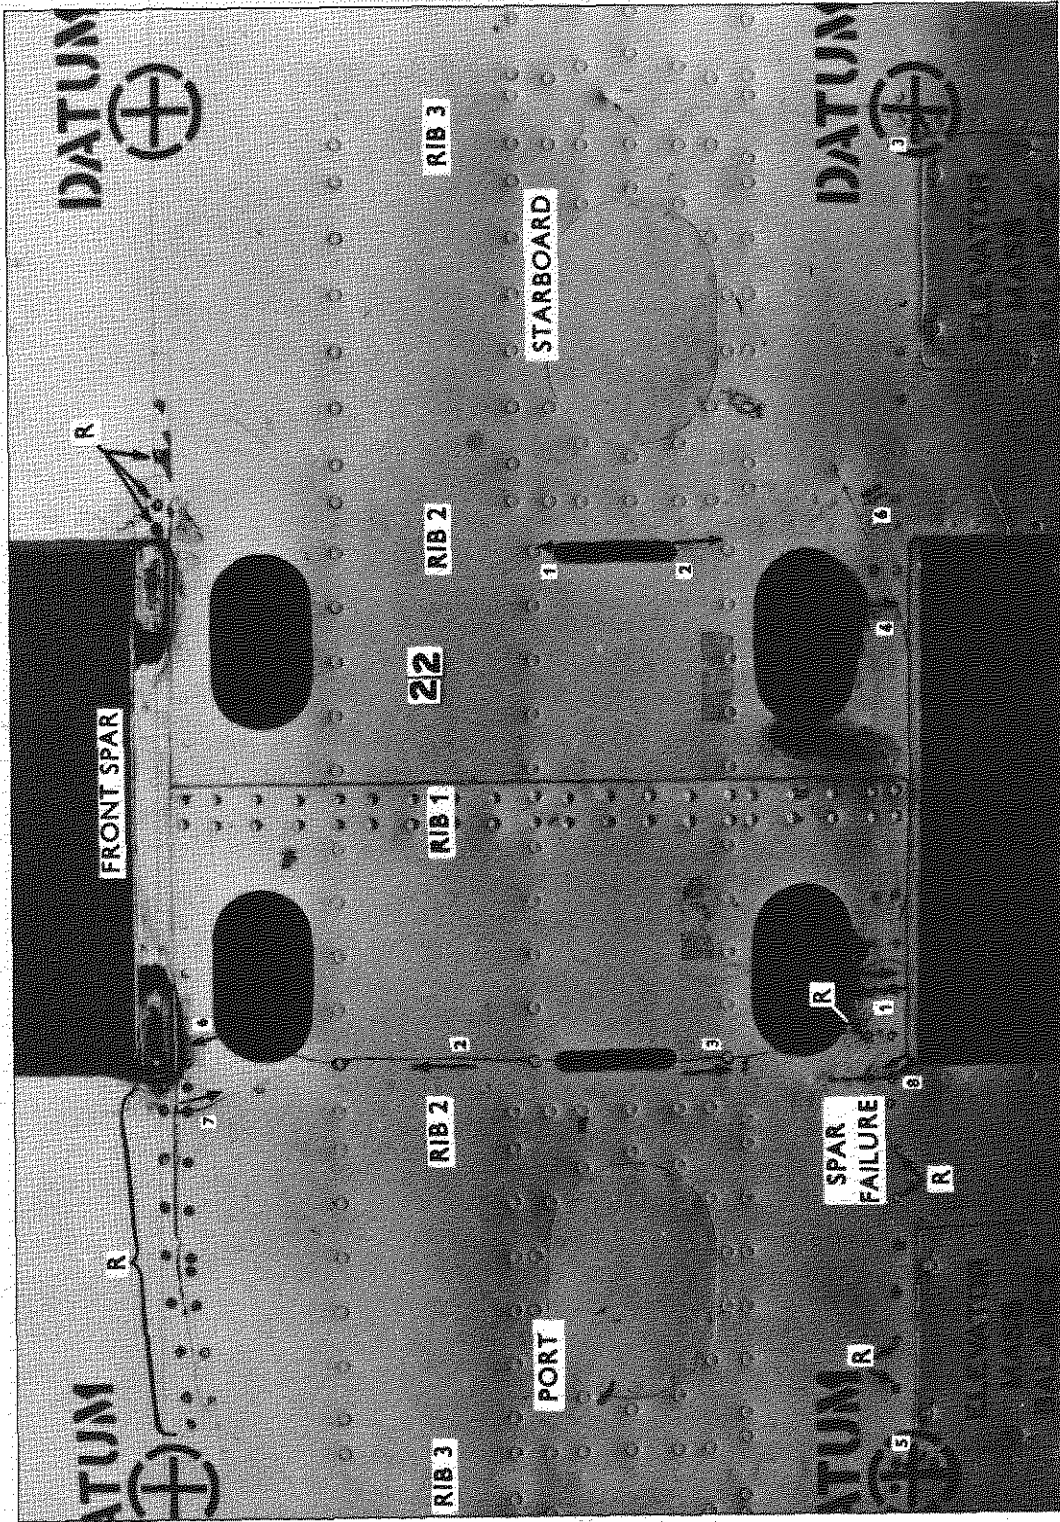
Rivet failures - R

FIG.15. TYPICAL SKIN CRACKS (TAILPLANE No.22)

The effect of skin cracking on spar stresses is illustrated in Figs.10 and 11. In Fig.10 the effective width of skin, expressed as a proportion of the distance between the spars, is plotted against number of cycles; corresponding changes in spar boom stress are given in Fig.11. The actual skin failures and their relation to the final spar boom failure are shown in Fig.15. The increase in stress applies to both mean and alternating stress in the booms. Most of the major skin failures originated from unreinforced cut outs, although some originated from rivet holes. Skin cracks in the compression surface originated from local buckling of the skin where stringers were discontinuous across ribs.

Rivet failures often occurred at the chordwise lap joint between the steel and aluminum alloy skins at rib 5. At later stages some failure of skin to spar boom rivets occurred, usually after skin cracks had developed. Typical rivet failures may be seen in Fig.15.

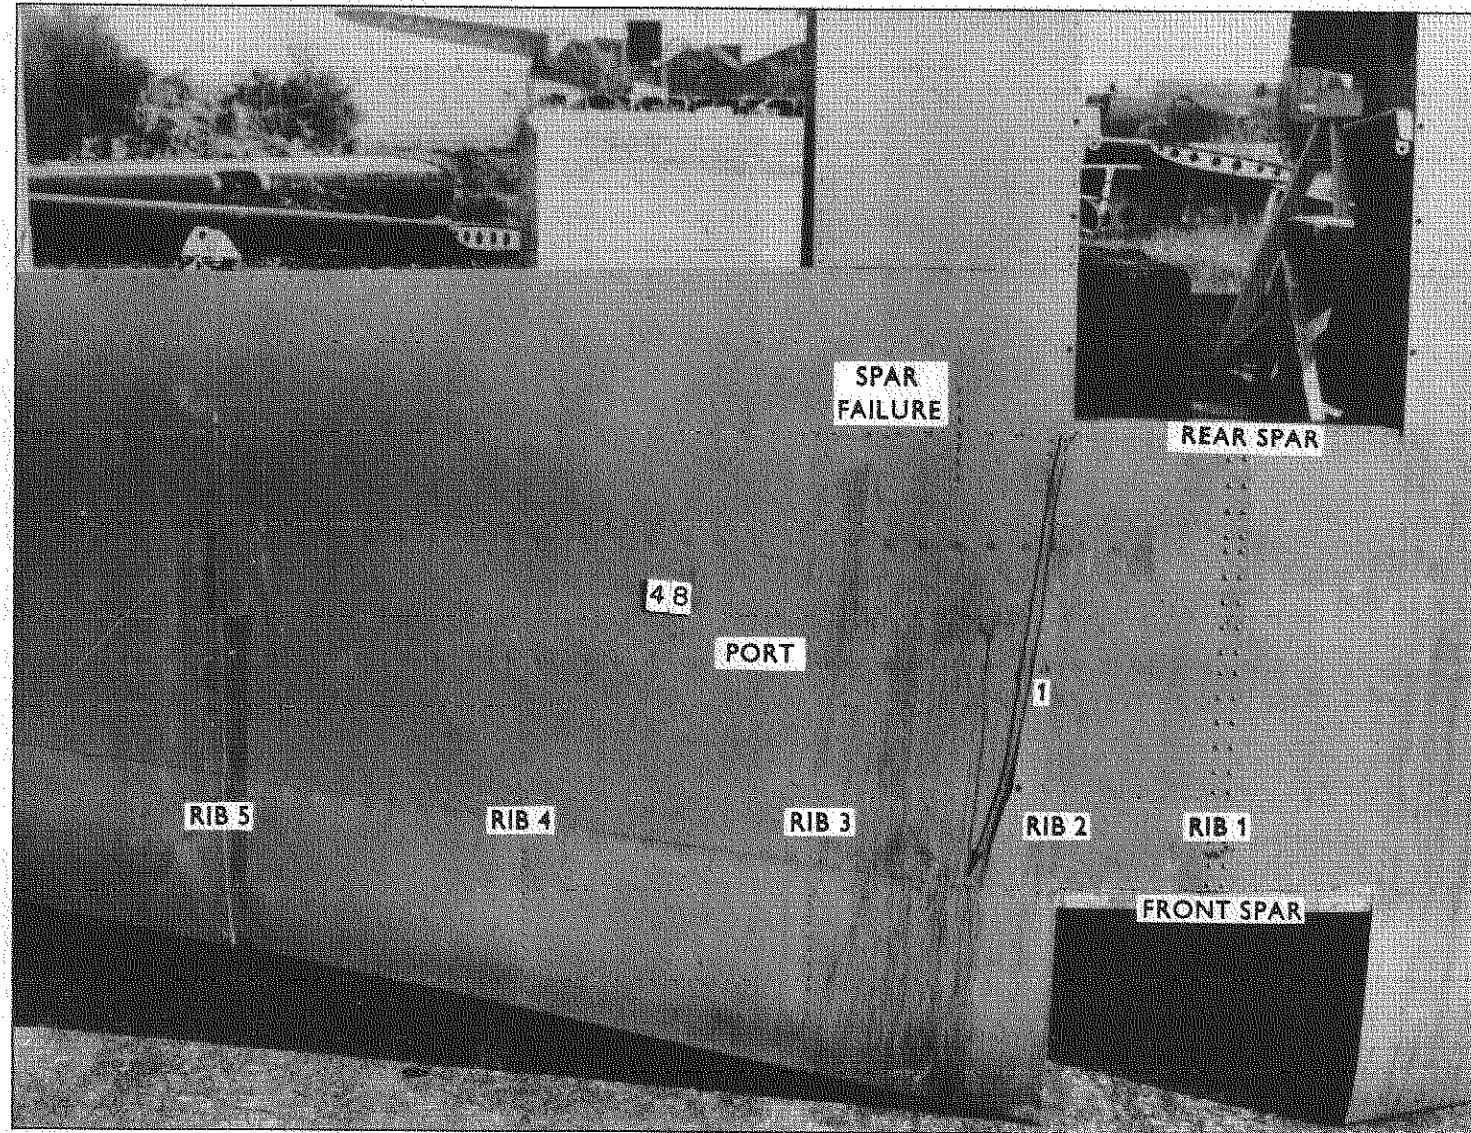
FIG.16. SKIN CRACK ON MODIFIED TAILPLANE

In an attempt to assess the effects of the skin cut-outs, tests were done on six modified tailplanes in which the cut-outs were eliminated. The results were still affected by major skin cracks, however, which developed either at the lap joint on the tailplane centreline or from the corner of the skin at the rear of rib 2, as shown in Fig.16.

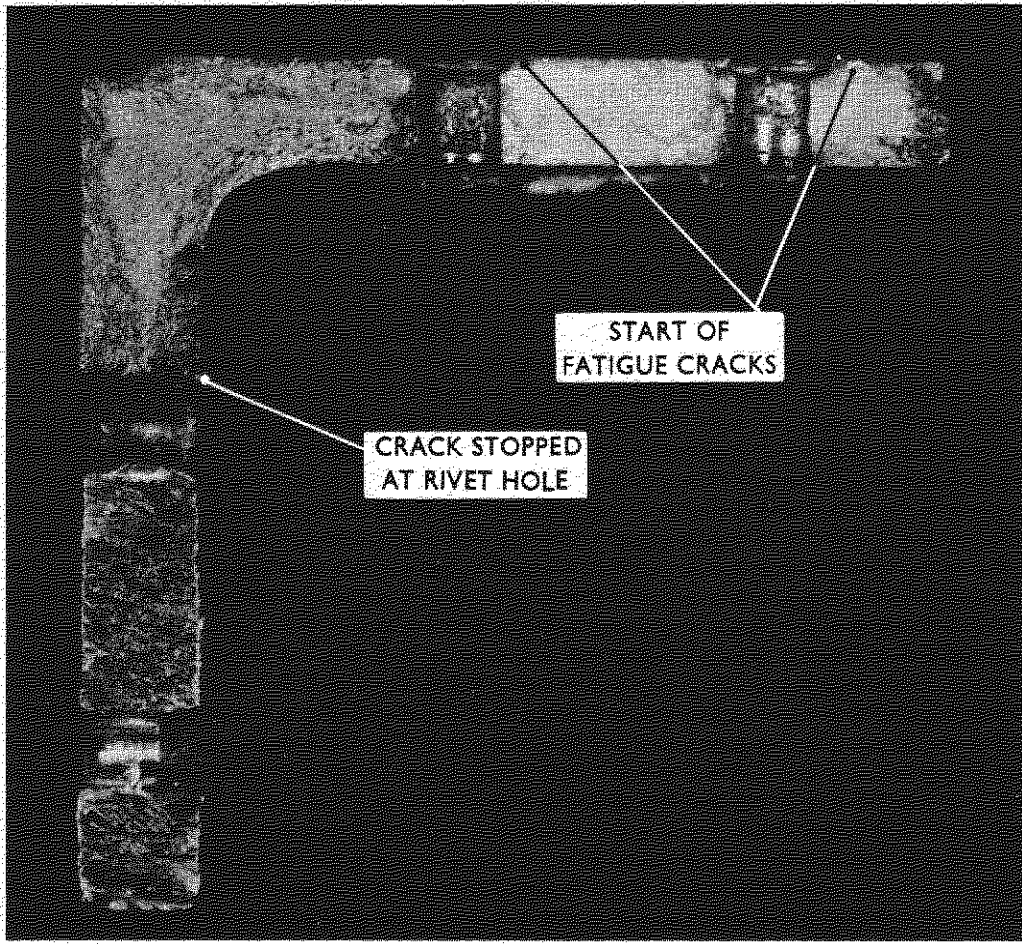
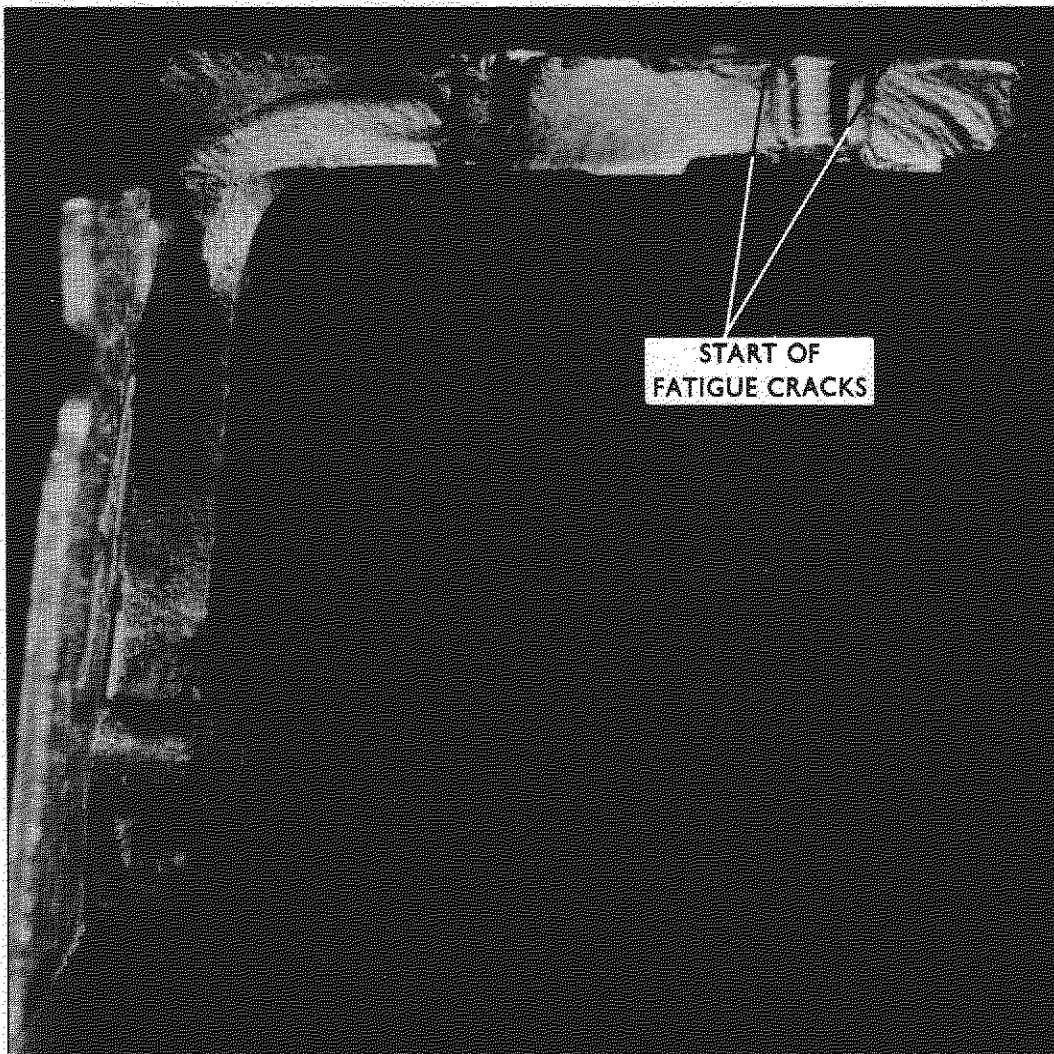
REAR SPAR, 5.5 in. FROM  $\phi$  (TAILPLANE No.11)

FRONT SPAR, 9.5 in. FROM  $\phi$  (TAILPLANE No.13)

FIG.17. TYPICAL SPAR BOOM FRACTURES

In the majority of cases the final spar boom failure occurred through rivet holes in the top (tension) boom of the front or rear spar near the root. Typical failures are shown in Fig.17. There was some variation in the position of failure, as indicated in Tables I to VI. In most cases, spar failure occurred on the side which had the more extensive skin cracking, i.e. the side on which the spar boom stresses became higher, but in some cases failure occurred on the less highly stressed side. Some failures, particularly those in the front spar, occurred where the boom had been formed during manufacture and were probably influenced by residual stresses, since the nominal stress at the point of failure was as low as 70% of the maximum stress in the rear spar.

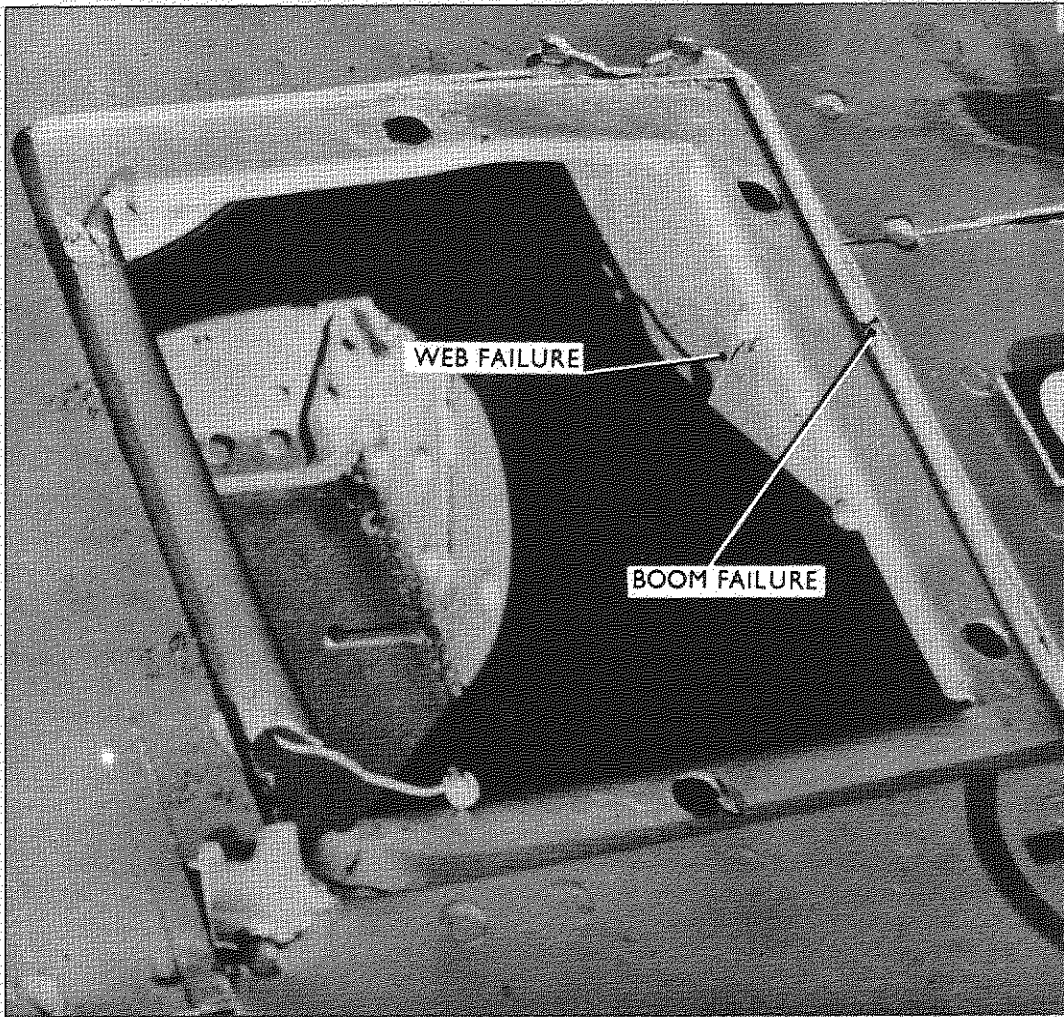
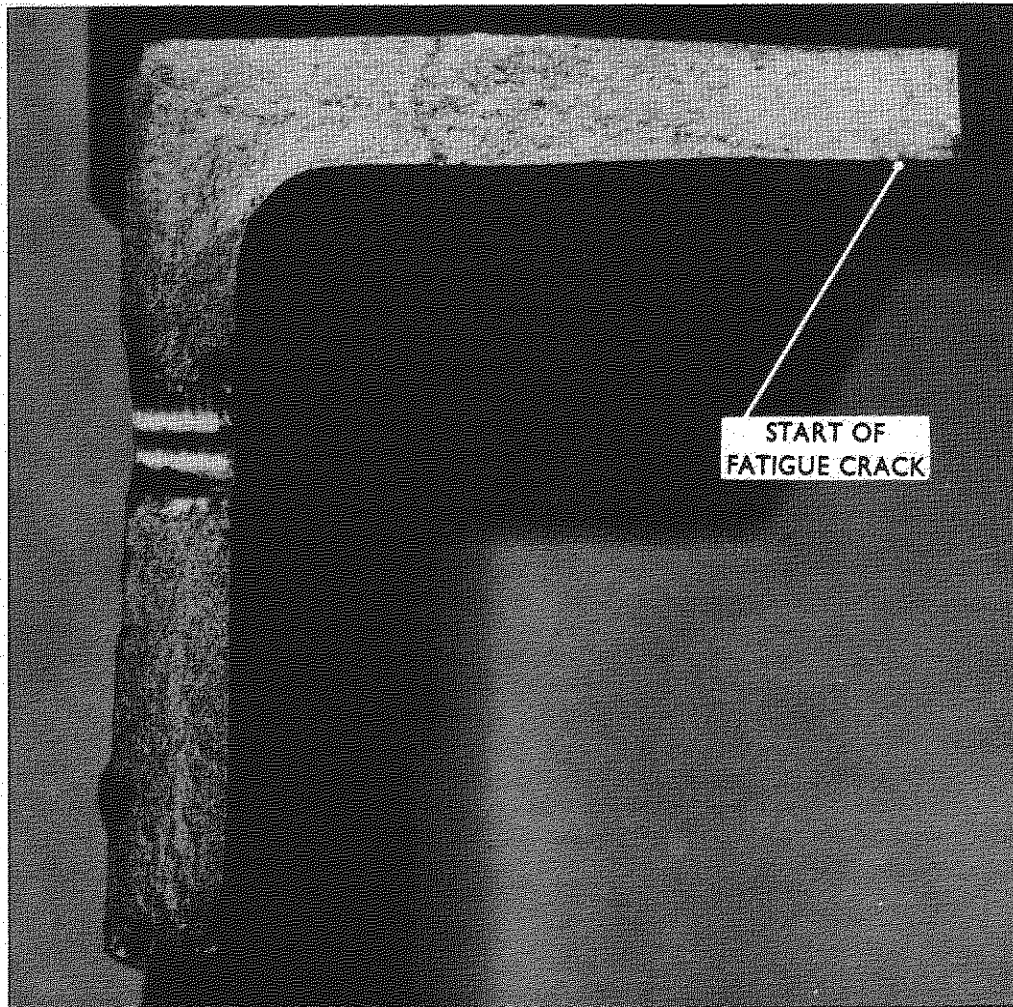
EXTERNAL APPEARANCE OF FAILURE

FIG.18. FRACTURE OF REAR SPAR TOP BOOM (TAILPLANE No.9)
