# Vibration Amplitudes Produced in St. David's Cathedral by Concorde Sonic Bangs

By F. L. HUNT

Structures Dept., R.A.E., Farnborough

*Reports and Memoranda No. 3736\**  
*June, 1971*

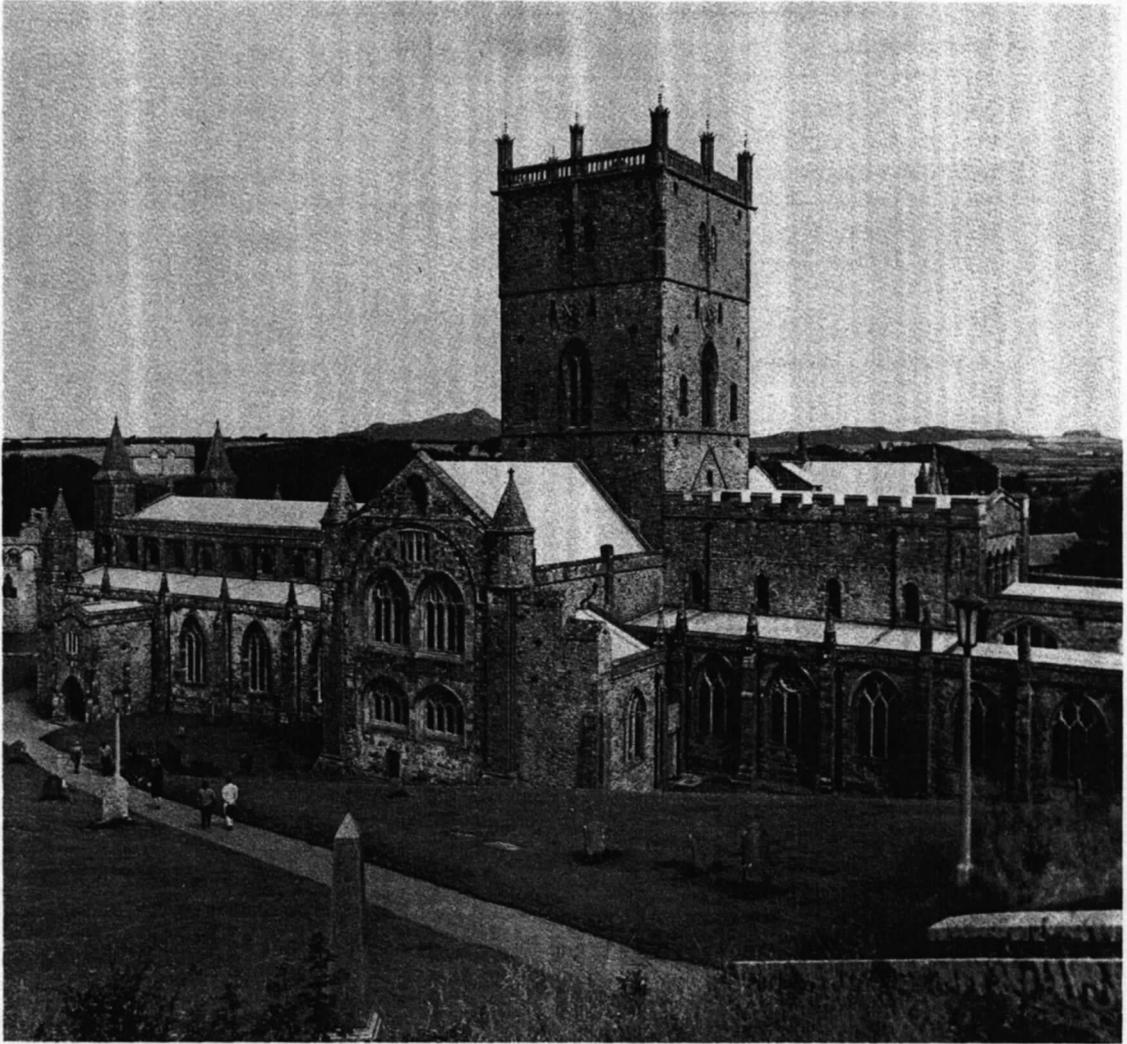
FIG. 1. St. David's Cathedral.

St. David's Cathedral (Figs. 1 and 2) is about 5 km west of the aircraft's nominal flight track which runs in a north to south direction. It lies in a hollow about 33 m above sea level, the ground rising sharply to about 70 m on the east side and to about 50 m on the north side.

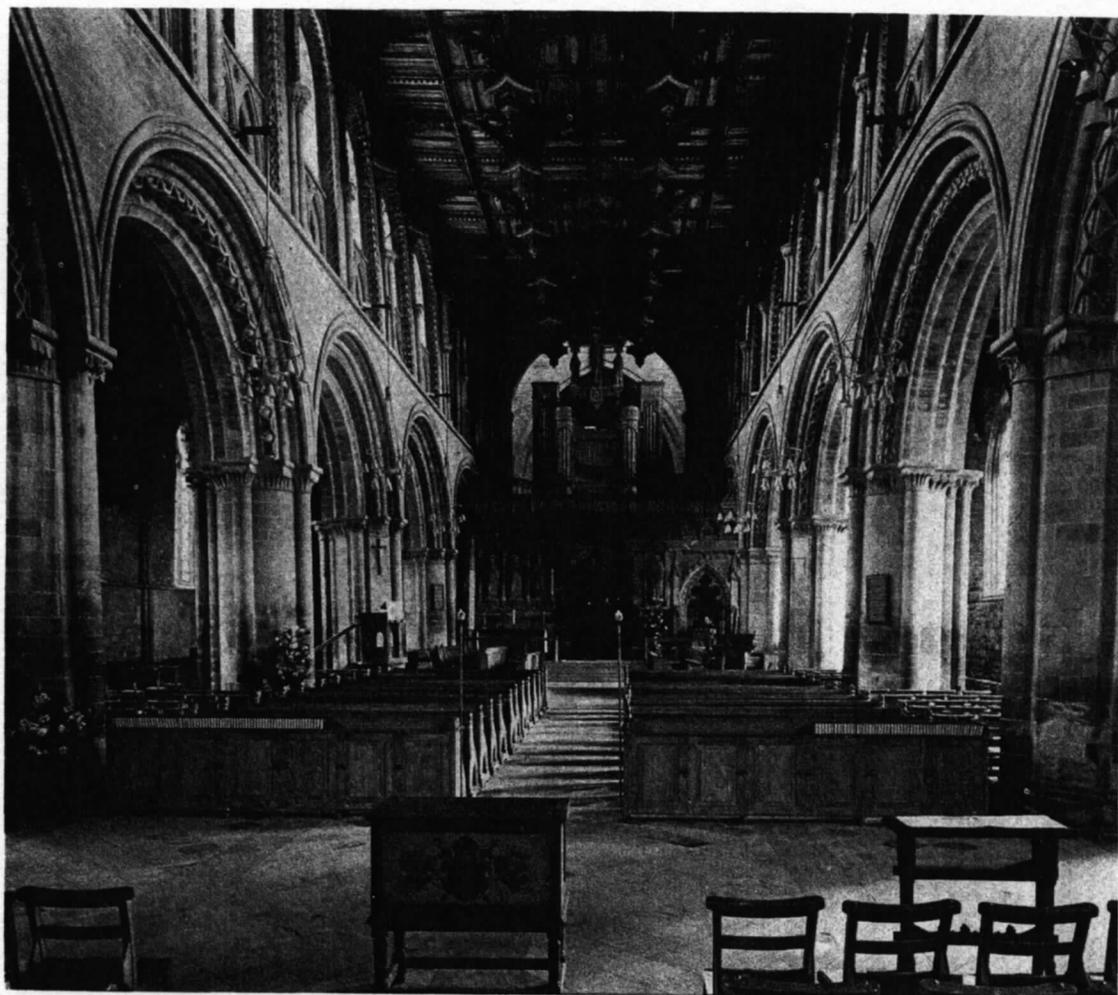
FIG. 3. Nave interior.

The building in its present form was started in 1180 AD. There have been alterations and additions since then. There is some evidence to show that the foundations were not adequately suited to the Cathedral's location. The outward and westward lean of the nave pillars (Fig. 3) is remarkable and in the fifteenth century enormous buttresses were built on the north side of the Cathedral (Figs. 2 and 4) to strengthen the nave. The west front was rebuilt in 1789 and again in 1863, and there are now cracks which show that there may again be some structural movement taking place.

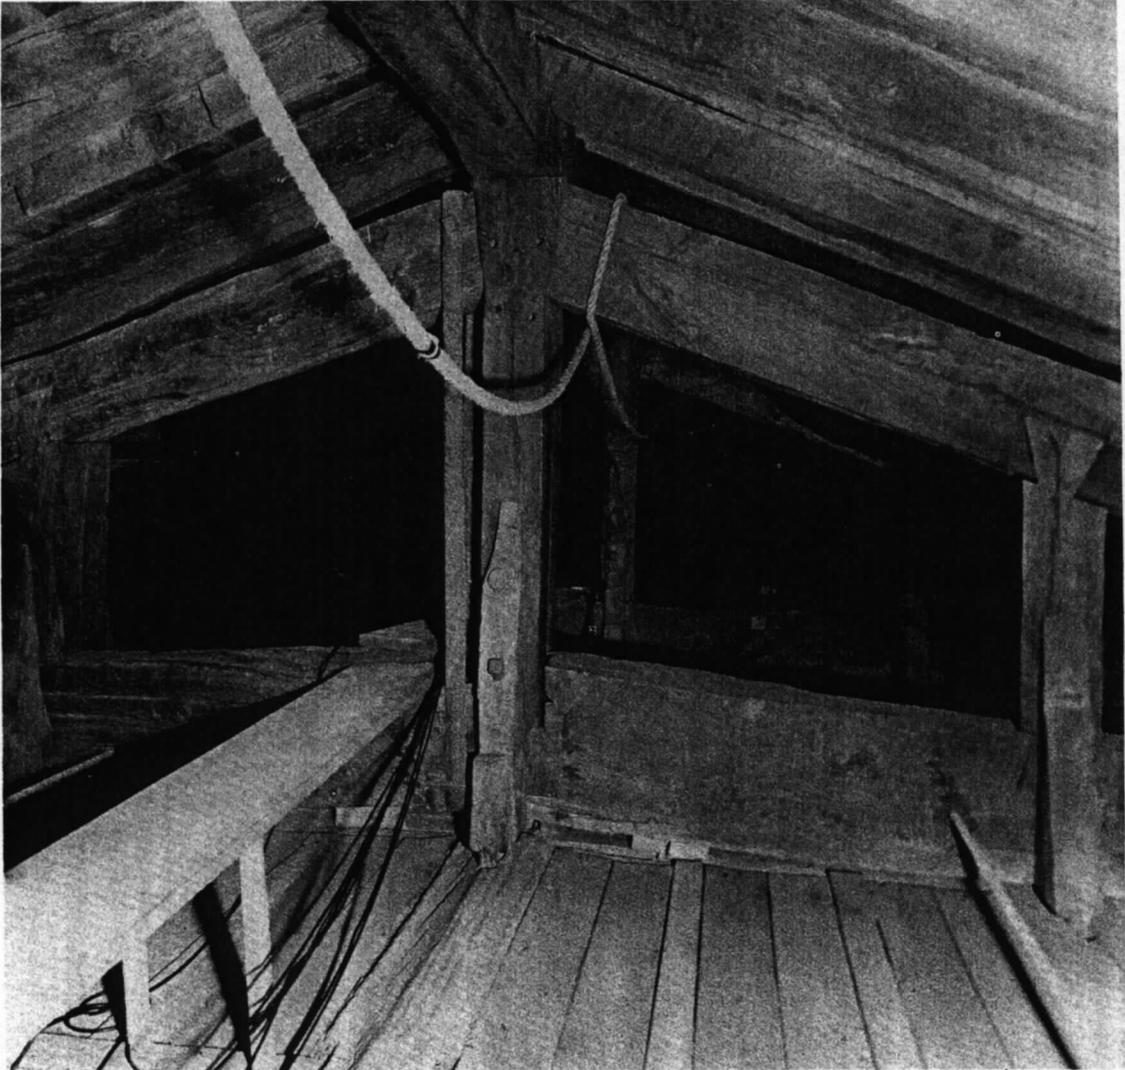
FIG. 7. Nave roof.

The nave roof was rebuilt in the late fifteenth or early sixteenth century and is unusually low pitched. The roof is boarded and lead covered and is about 40 m in length by about 15 m span. It has the appearance of being extraordinarily strong (Figs. 7 and 8). The main timbers of the trusses are of about 30 cm (1 ft) square section and the trusses are about 3 m apart. The five vertical posts in each truss are dovetailed into the main members and this probably makes the roof construction unique.

While checking the installation of the instrumentation a 12 stone (76 kg) man walked along the cat-walk in the nave roof space. The cat-walk rests on the roof tie beams and can be seen in Figs. 7 and 8. The resultant vibration was picked up by an adjacent seismometer on a tie beam and detected on the recording apparatus. The greatest vibration peaks were found to be about 0.2 of the peak vibration caused by sonic bangs.

Roof vibration measurements were taken on or near the fourth truss from the west end of the nave. Measurements were made on main rafters, common rafters, purlins and roof boarding as shown in Table 3. Accelerometers were used for this purpose and integrating amplifiers were used to obtain velocity measurements from the recorded accelerometer signals during replay. Table 3 shows the peak velocity of vibration measured on the various roof components. The results show that the environment, in this case a 10 m/s (20 kn) average wind or the organ playing loudly, produces vibration levels which are about 0.2 of those produced by the sonic bang. In the environmental vibration columns, the first figure shown is the amplitude of the greatest peaks which occurred during the environmental recording. The figure in brackets below shows the amplitude averaged over the whole of the recording time which was about 30 s. This value was obtained by reading the signal level on a slow response rms meter and averaging the reading visually over the recording period.

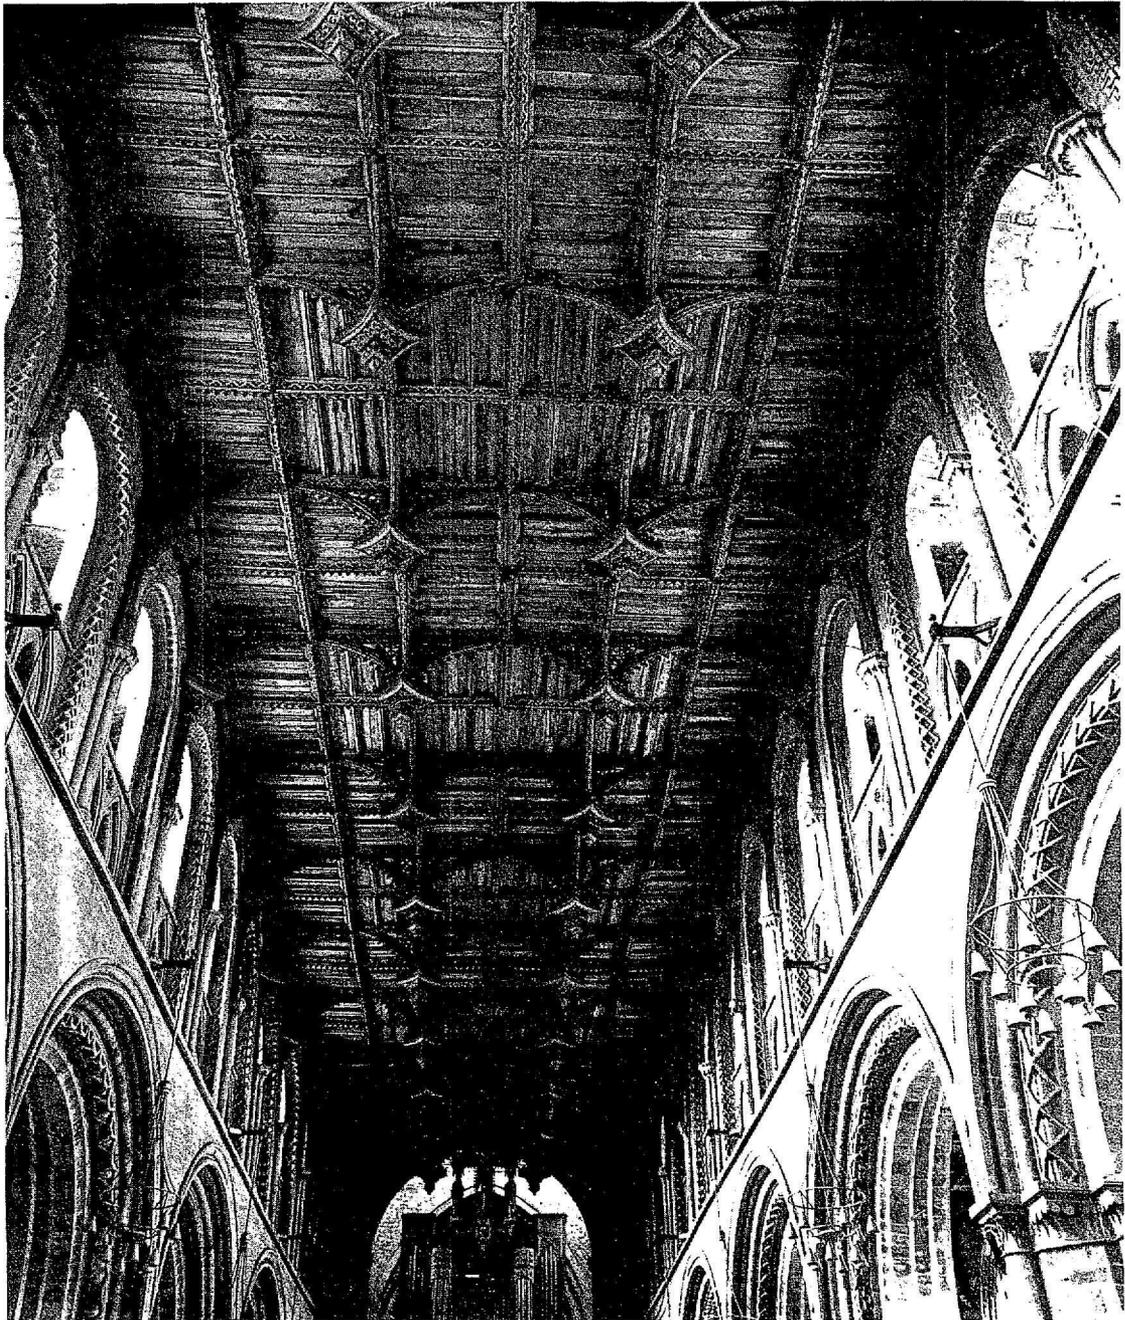
FIG. 9. Nave ceiling.

The nave ceiling (Fig. 9) is flat and is attached to the horizontal tie beams of the roof structure. It is of carved Irish oak and is prized for its artistic qualities. The ceiling appears to be very strongly constructed with regard to its main members, but the panelling is rather fragile. Some of the panels are loose or broken.

Ceiling vibration measurements were made on joists and main beams in the same general area of roof space as the roof vibration measurements. Acceleration transducers were used, their recorded signals being replayed through integrating amplifiers so that velocities could be estimated. The results (Table 5) show that the ceiling vibration levels are of the same order as roof vibration levels (Table 3) when excited by sonic bangs, but that winds caused comparatively little vibration in the ceiling; 24 m/s gusts (47 kn) produced ceiling vibration levels of only about 0.01 of bang-excited vibrations. On the other hand the effects of the organ on the ceiling were in general more pronounced than either the effect of the organ on the roof structure or the effect of the wind on the ceiling. This might be expected because the sound of the organ would act directly upon the ceiling and the ceiling is shielded from direct wind forces. Also, it was noticed during the recording, that the lower pitched organ tones excited resonances in the ceiling. The greatest vibration amplitudes induced in the ceiling structure by the organ playing were about 0.4 of the bang response.
