MINISTRY OF SUPPLY
AERONAUTICAL RESEARCH COUNCIL
REPORTS AND MEMORANDA

Service Failures in Aircraft Structures Associated with Fatigue, Repeated or Dynamic Loads

J. B. B. Owen, D.Sc., M.Sc., A.F.R.Ae.S.

*Reports and Memoranda No. 2688**

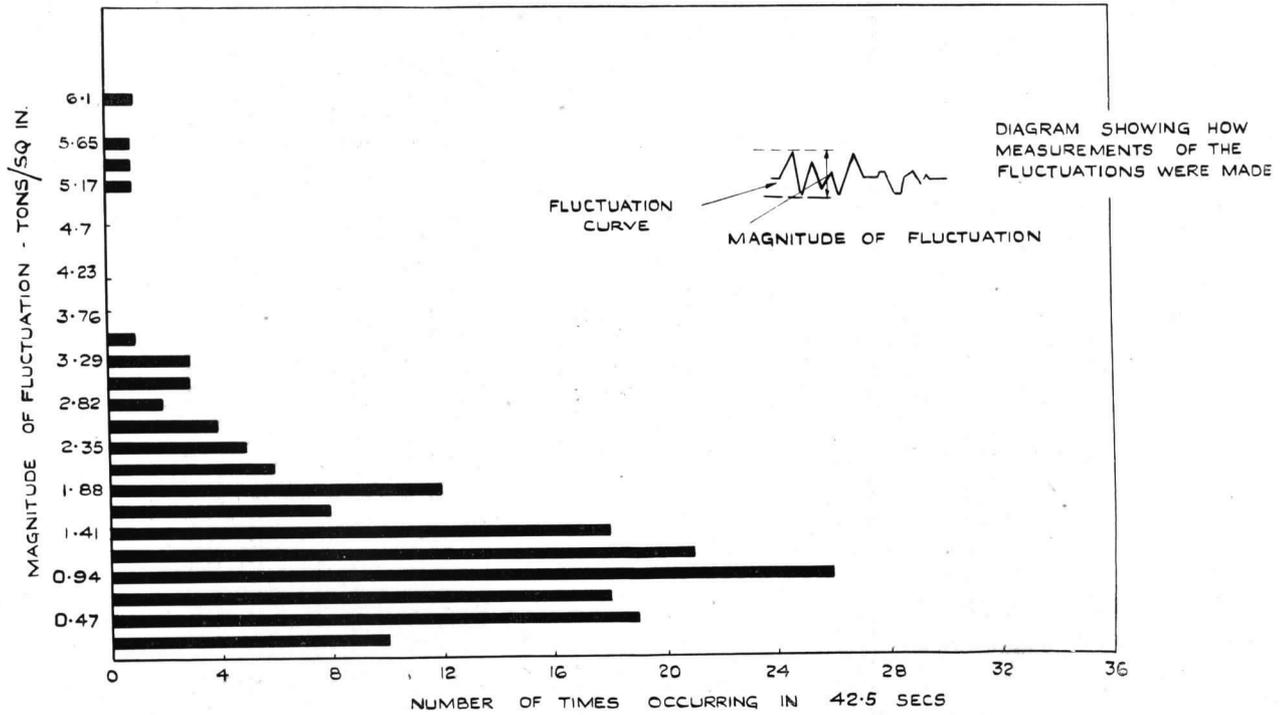
Flight and taxi-ing measurements² of boom stresses were made to ascertain the order of the working stresses. When the aircraft is at rest on the ground the boom stress is only about 1 ton/sq in., excluding any 'built in' stresses which may be present. The fluctuations which occurred in a severe taxi-ing run are shown in Fig. 2. In flight the mean steady stress is higher about 4 ton/sq in. and the predominant fluctuations in rough weather about ± 1 ton/sq in. at 2.7 c.p.s., *i.e.*, about 3 million cycles occur in 320 flying hours in *rough* weather.

FIG. 3. Fluctuation frequency diagram—taxi-ing at Upper Heyford.
